November 9, 2020

**Reference Number: T20828**

**Subject: Test Pit Investigation  
Proposed Residential Development  
Erin Property  
5520 8<sup>th</sup> Line, Erin, Ontario**

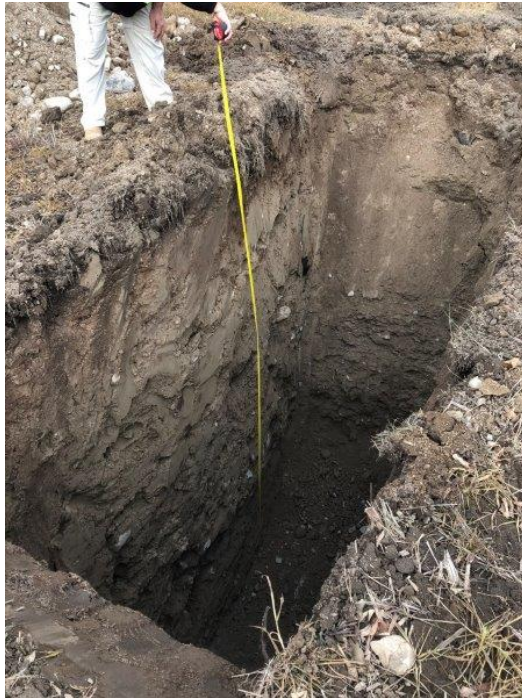
<b>Test Pit No.</b>	<b>Elevation (m)</b>	<b>Approx. Depth (m)</b>	<b>Soil Description</b>
1	454.60	0 - 0.2 0.2 - 0.5 0.5 - 5.0	<p>Topsoil Organic Stained Silty Sand with some gravel, damp Brown Silty Sand Till, with some silt seams, cobbles and boulders, damp to moist.</p> <p>Bulk Unit Weight@ -2.1 m: 2074 kN/m<sup>3</sup> Natural Moisture Content: 10% Hard excavating from 2.5 m to completion depth. Test pit dry upon completion and open for 3.0 hours. No cave-in of the sides and no water seepage observed.</p>
2	447.30	0 - 0.2 0.2 - 0.5 0.5 - 5.0	<p>Topsoil Organic Stained Silty Sand with some gravel and rootlets, damp to moist Brown Silty Sand Till, with some silt seams, cobbles and boulders, damp.</p> <p>Bulk Unit Weight@ -1.0 m: 2092 kN/m<sup>3</sup> Natural Moisture Content: 11% Hard excavating from 2.0 m to completion depth. Test pit dry upon completion and open for 3.0 hours. No cave-in of the sides and no water seepage observed.</p>

Photograph 1- View of excavation for TP1.

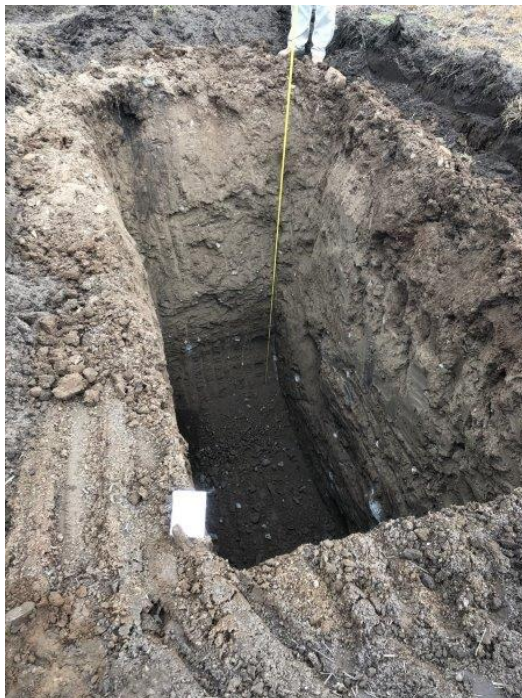
Photograph 2 – View of excavation for TP2.

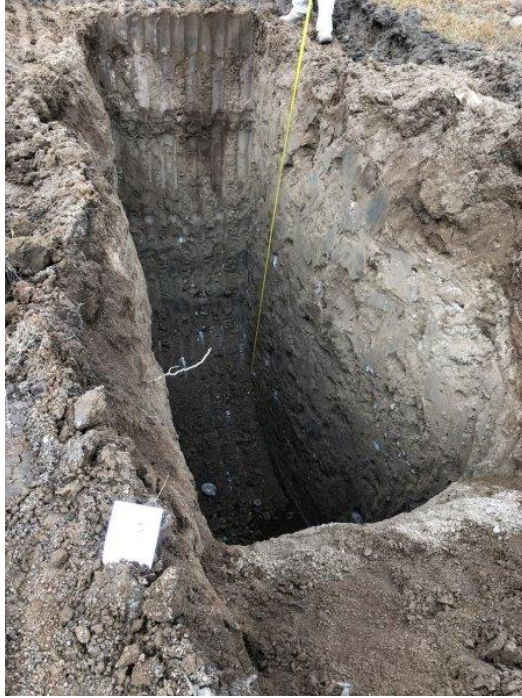
3	435.47	0 - 0.3 0.3 - 0.8 0.8 - 5.3	<p>Topsoil Organic Stained Silty Sand with some gravel, damp to moist Brown Silty Sand Till, with some cobbles and boulders, damp.</p> <p>Bulk Unit Weight@ -1.2 m: 1944 kN/m<sup>3</sup> Natural Moisture Content: 13.0% Hard excavating from 2.5 m to completion depth. Test pit dry upon completion and open for 2.5 hours. No cave-in of the sides and no water seepage observed.</p>
4  (TP location moved ~10 m south due to existing trees).	455.4	0 - 0.25 0.25 - 0.6 0.6 - 4.7	<p>Topsoil Organic Stained Silty Sand with some grave and rootlets, damp Brown Silty Sand Till, with some silt seams, cobbles and boulders, damp.</p> <p>Hard excavating from 2.0 m to completion depth. Test pit dry upon completion and open for 2.5 hours. No cave-in of the sides and no water seepage observed.</p>

Photograph 3- View of excavation for TP3.

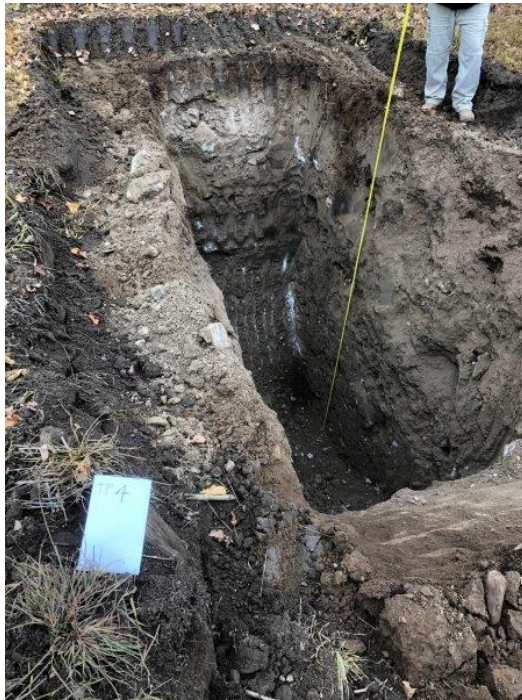
Photograph 4 – View of excavation for TP4.

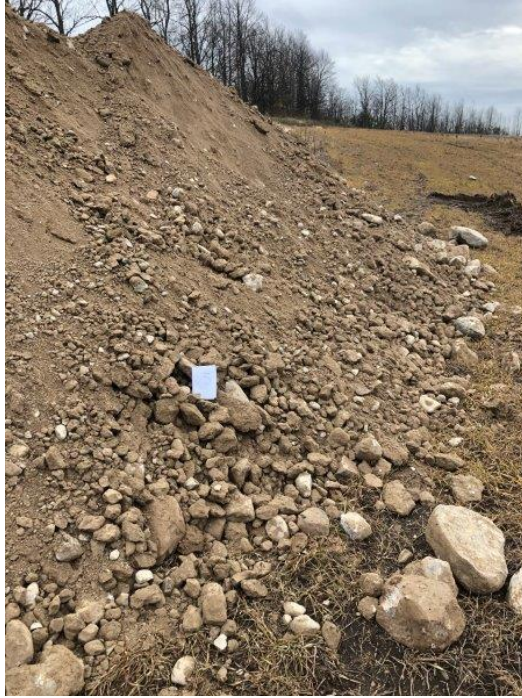
5	442.72	0 - 0.25 0.25 - 0.5  0.5 - 5.3	<p>Topsoil                      Organic Stained Silty Sand with some gravel and rootlets, damp to moist                      Brown Silty Sand Till, with some cobbles and boulders, damp.</p> <p>Hard excavating from 2.5 m to completion depth.                      Test pit dry upon completion and open for 3.0 hours.                      No cave-in of the sides and no water seepage observed.</p>
6	440.77	0 - 0.3 0.3 - 0.8 0.8 - 5.0	<p>Topsoil                      Organic Stained Silty Sand with some gravel and rootlets, damp                      Brown Silty Sand Till, with some silt seams, cobbles and boulders, damp.</p> <p>Bulk Unit Weight@ -1.5 m: 2058 kN/m<sup>3</sup>                      Natural Moisture Content: 8%                      Hard excavating from 4.0 m to completion depth.                      Test pit dry upon completion and open for 2.0 hours.                      No cave-in of the sides and no water seepage observed.</p>

Photograph 5- Excavated soils from TP5. Note large boulders in soil pile.

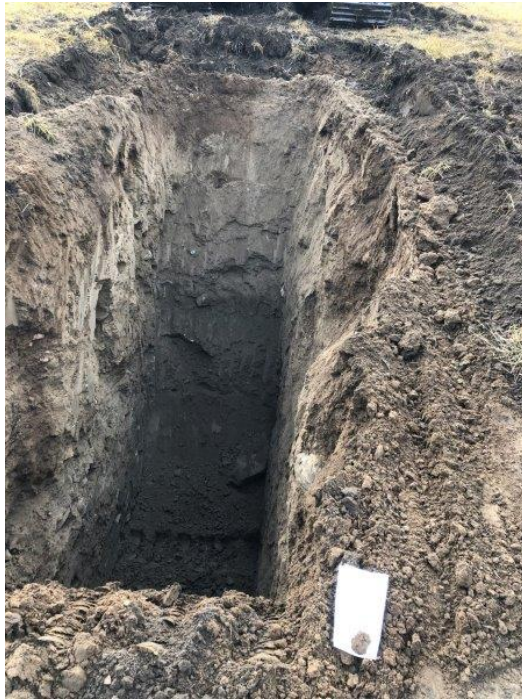
Photograph 6- View of excavation for TP6.

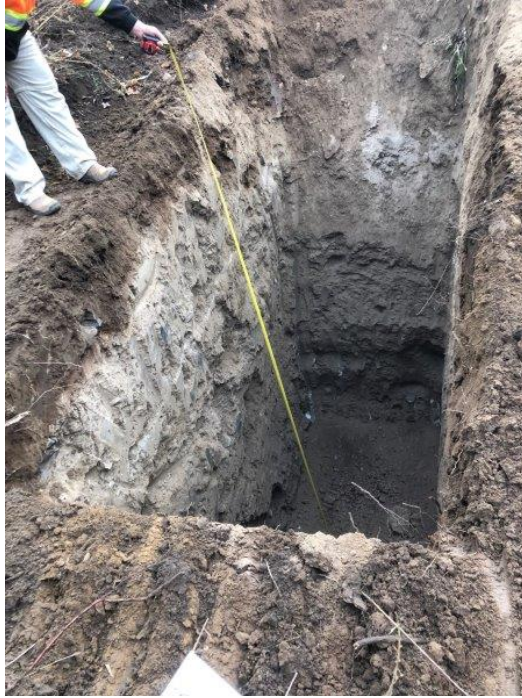
7	435.96	0 - 0.3 0.3 - 0.7  0.7 - 5.1	<p>Topsoil                      Organic Stained Silty Sand with some gravel and rootlets, damp to moist                      Brown Silty Sand Till, with some silt seams, cobbles and boulders, damp.</p> <p>Hard excavating from 3.0 m to completion depth.                      Test pit dry upon completion.                      No cave-in of the sides and no water seepage observed.</p>
8	429.15	0 - 0.3 0.3 - 0.7  0.7 - 5.1	<p>Topsoil                      Organic Stained Silty Sand with some gravel and rootlets, damp to moist                      Brown Silty Sand Till, with some cobbles and boulders, damp.</p> <p>Hard excavating from 2.5 m to completion depth.                      Test pit dry upon completion.                      No cave-in of the sides and no water seepage observed.</p>
9	435.36	0 - 0.3 0.3 - 0.7 0.7 - 5.3	<p>Topsoil                      Organic Stained Silty Sand with some gravel, damp to moist                      Brown Silty Sand Till, cobbles and boulders, damp.</p> <p>Bulk Unit Weight@ - 1.0 m: 1916 kN/m<sup>3</sup>                      Natural Moisture Content: 10%                      Hard excavating from 2.5 m to completion depth.                      Test pit dry upon completion.                      No cave-in of the sides and no water seepage observed.</p>

Photograph 7- View of excavation for TP7.

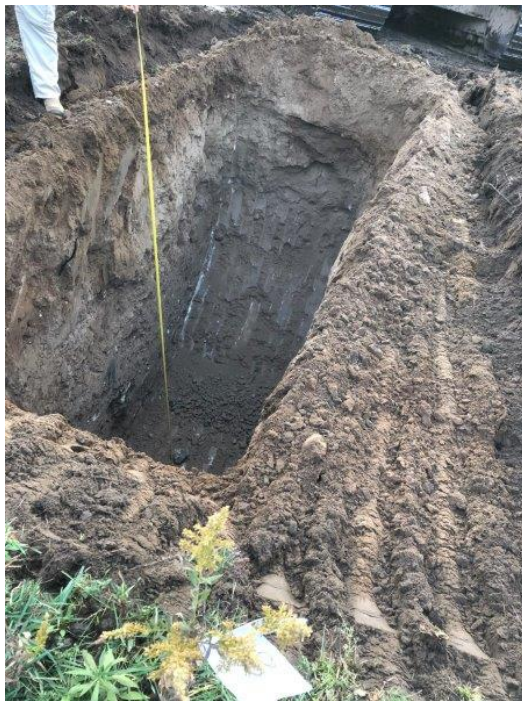
According to the preliminary information provided to us, we understand that a stormwater management pond may be construction at the site. Test Pit 8 is located within the proposed pond. Based on the subsurface conditions encountered at this test pit, below the surficial topsoil and organic stained silty sand, the site is predominantly underlain by compact to very dense silty sand till, that extended down to its completion at approximately 5.1 m below existing ground surface. During the test pitting program, no groundwater seepage was observed.

Photograph 8- View of excavation for TP8.

Considering the above information, an impermeable liner would be required to minimize any surface water infiltration or groundwater exfiltration. Furthermore, slope stability analysis would need to be carried out to ensure pond stability under various ponding and loading conditions.

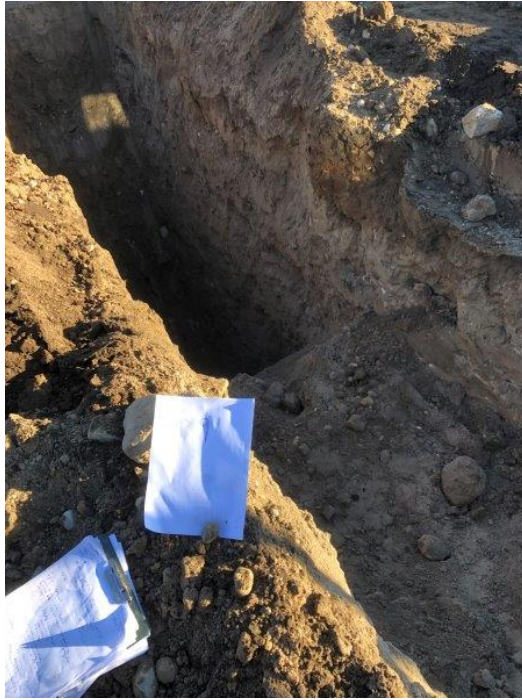
Photograph 9- View of excavation for TP9.

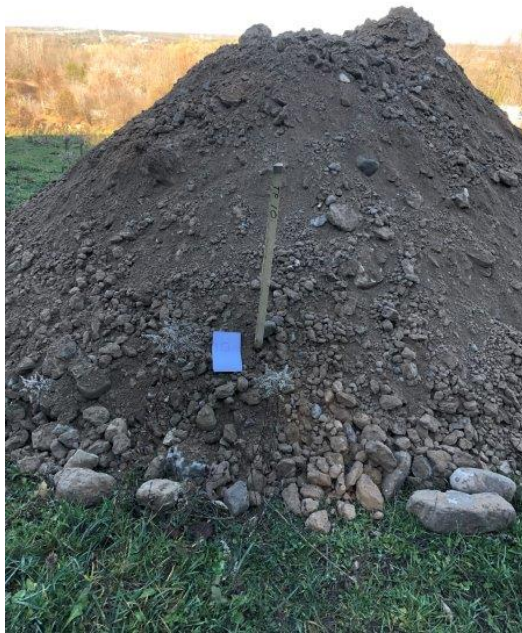
10	445.70	0 - 0.2 0.2 - 0.5 0.5 - 5.0	<p>Topsoil                      Organic Stained Silty Sand with some gravel and rootlets, damp                      Brown Silty Sand Till, with some cobbles and boulders, damp.</p>

(TP location moved ~7 m south due to proximity to the existing manure pile and fence).

Photograph 10- View of excavated soil from TP10. Note large boulders in soil pile.

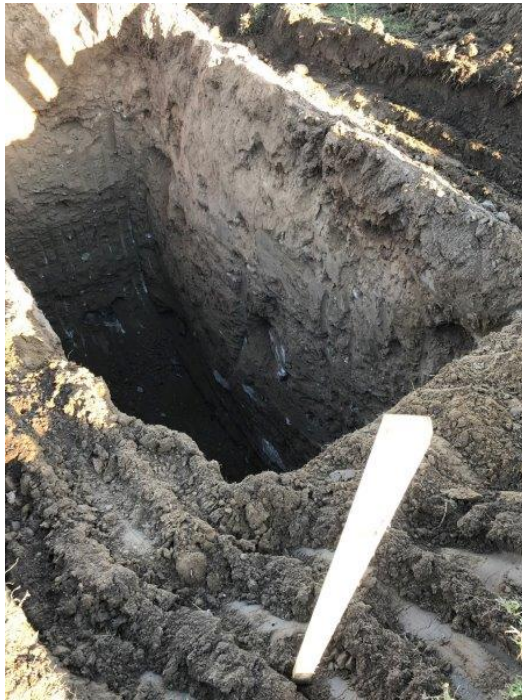
Hard excavating from 2.5 m to completion depth. Test pit dry upon completion and open for 1.5 hours. No cave-in of the sides and no water seepage observed.
11	447.90	0 - 0.3 0.3 - 0.5 0.5 - 5.1	Topsoil Organic Stained Silty Sand with some gravel, damp Brown Silty Sand Till, with some silt seams, cobbles and boulders, damp.  Hard excavating from 3.0 m to completion depth. Test pit dry upon completion and open for 3.0 hours. No cave-in of the sides and no water seepage observed.

Photograph 11- View of excavation for TP11.

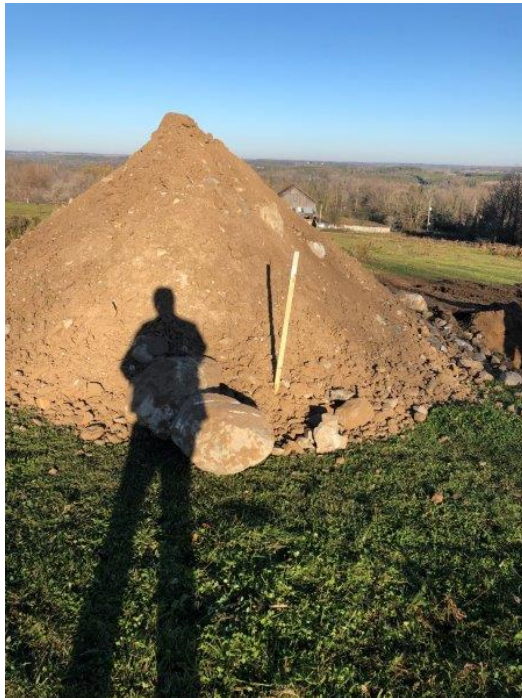
Photograph 12- View of excavated soils from TP11. Note large boulders in soil pile.
