Summary Action Report

Structure 2064 (MTO Site No.)

Bridge 2064

Inspection Date 06/06/2013 mm/dd/yyyy

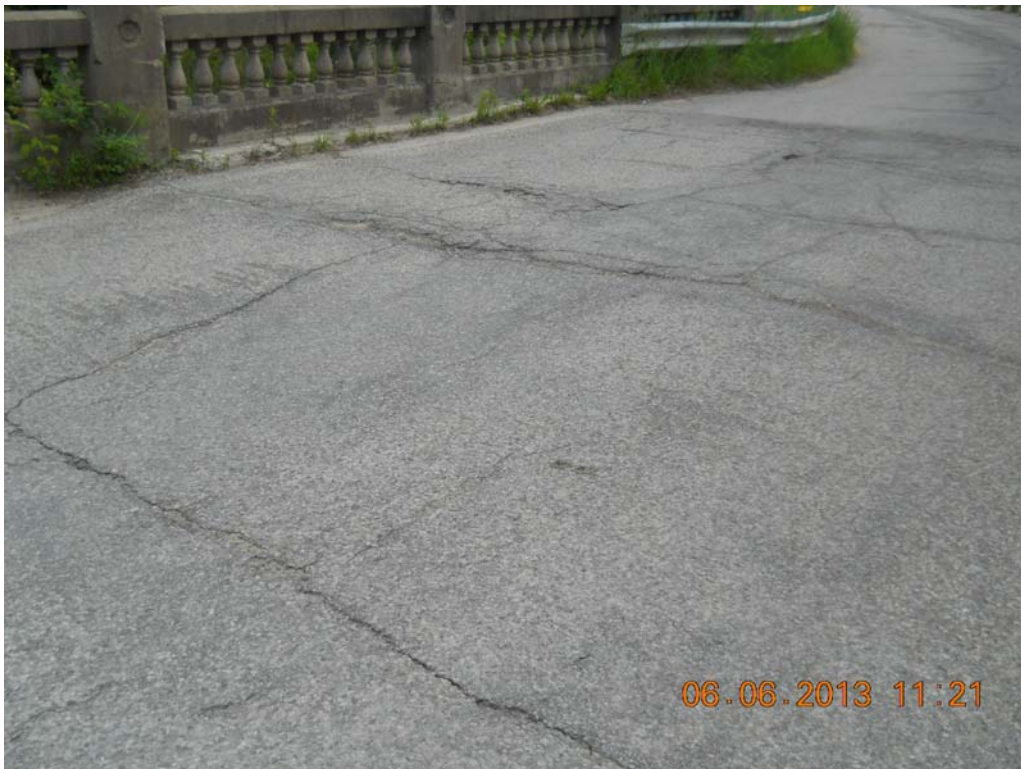
Narrow to wide transverse cracks and ocalized potholes.

Narrow to wide cracks on wearing surface.

Surface patches

Seal cracks

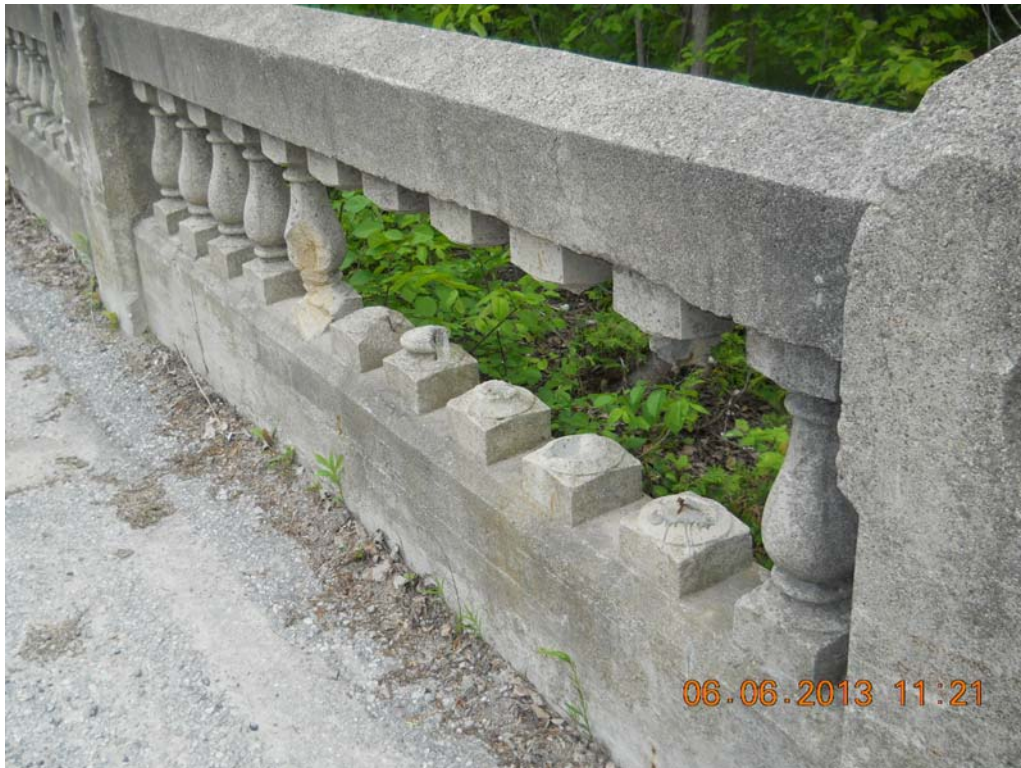
5 missing spindles on the northside, narrow to wide cracks, abrasions, isolated delaminations. Missing 3 of 4 end cap pieces (decorative feature), section of barrier in SW quadrant has been fitted with steel beam guiderail.

Missing spindles on barrier.

Reconstruct missing spindles and repair cracks

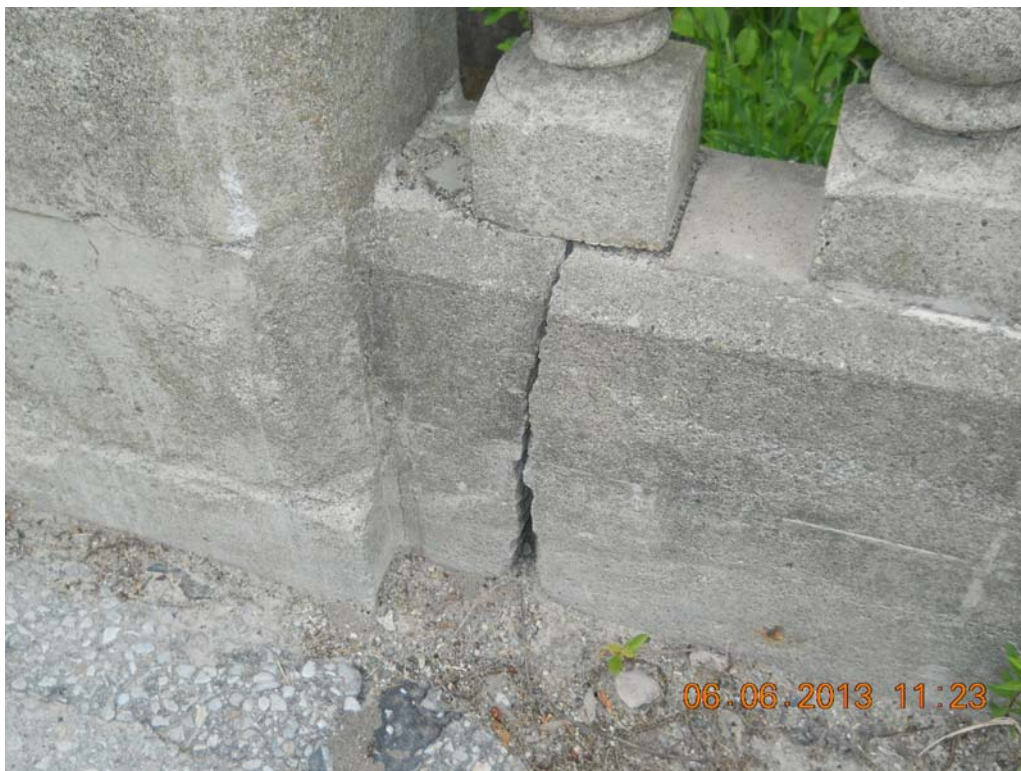
Wide crack on barrier.

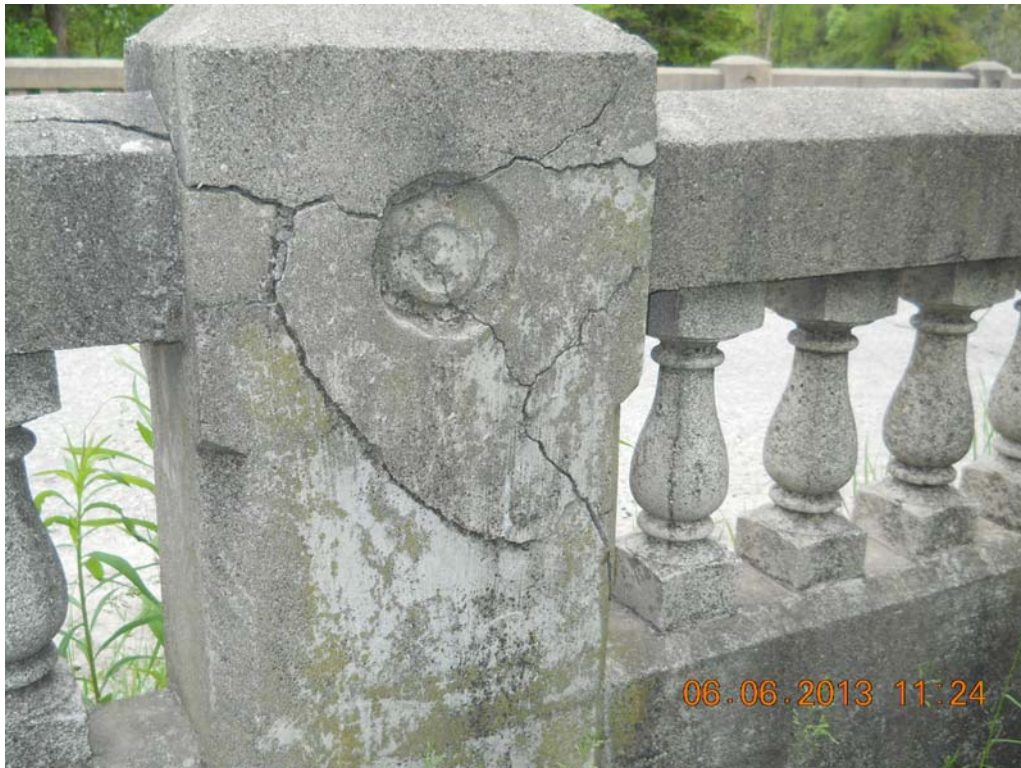
Delaminations, wide cracks on barrier post.

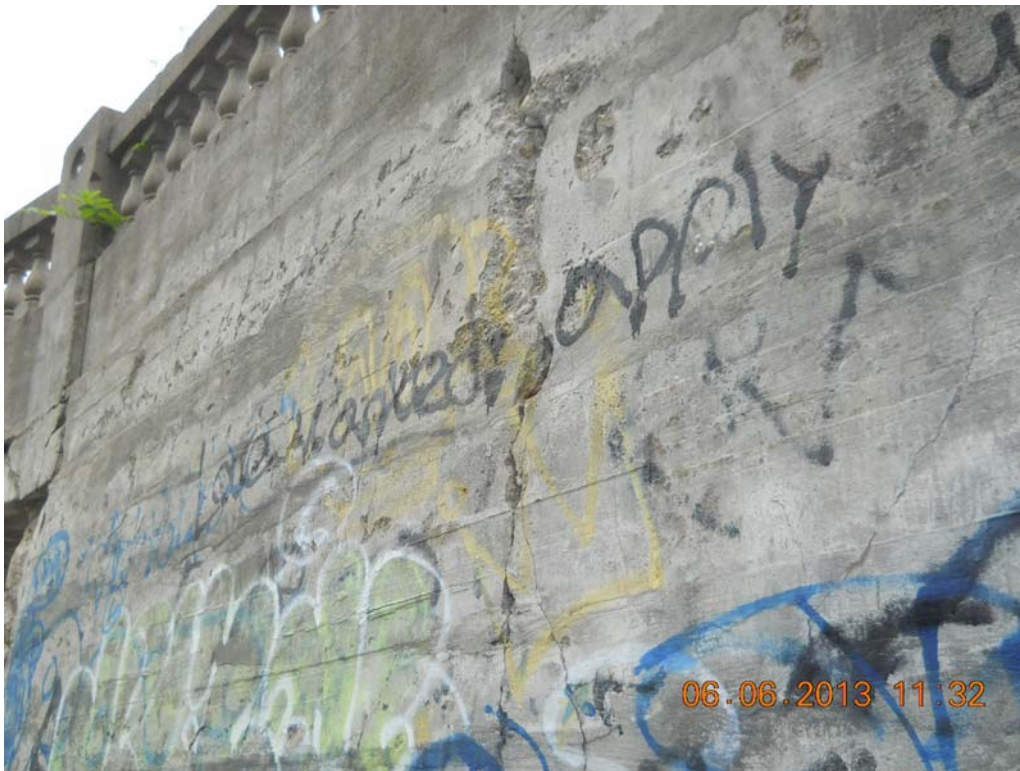
Narrow to wide cracks, light to severe scaling, spalls, delaminations.

Spalls, wide crack on wingwall.

Patch repair and crack repair

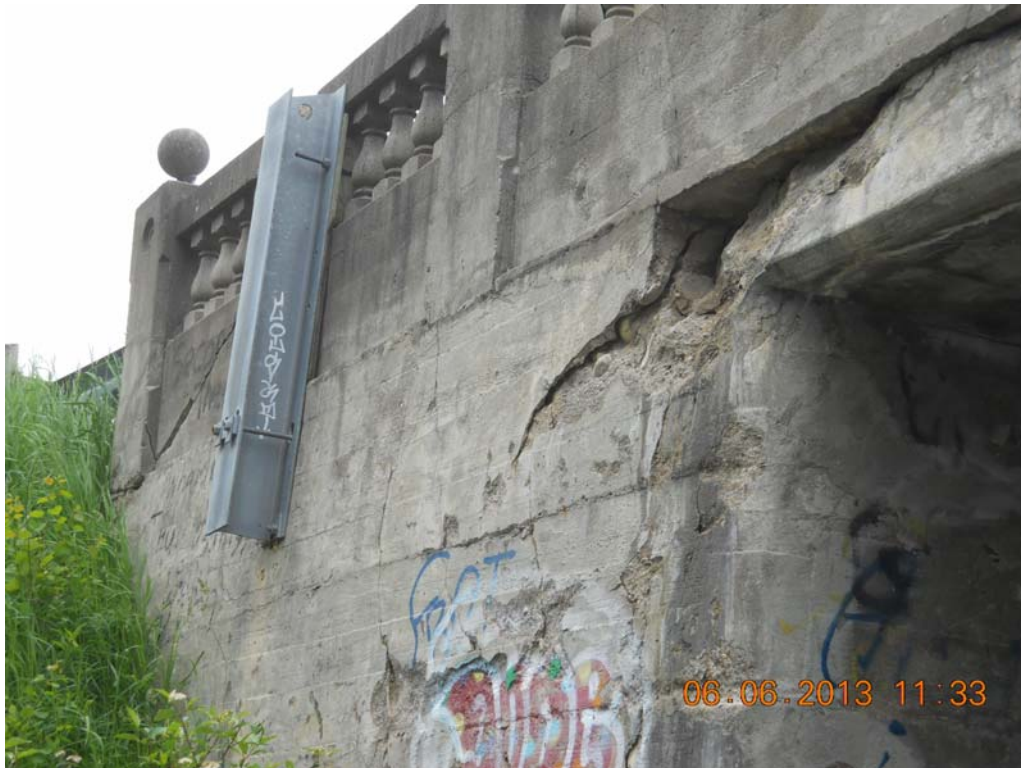
Spalls, delamination on wingwall and fascia.

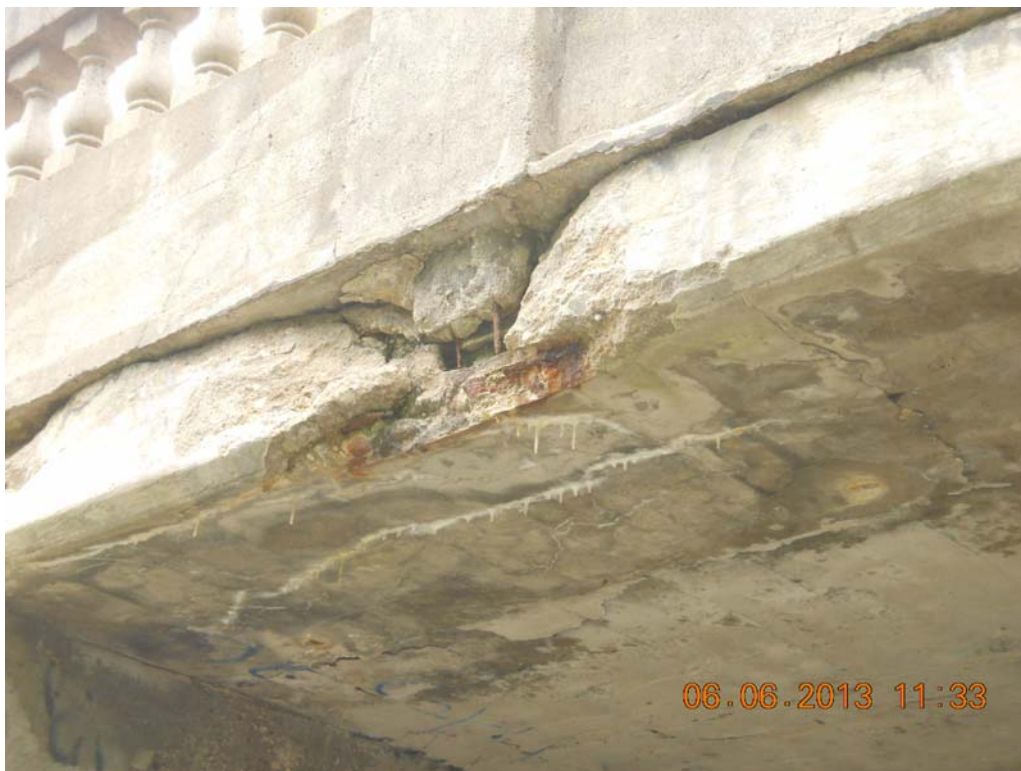
Spalling and delaminations, narrow stained cracks, exposed corroded rebar, spalls on south fascia and efflorescence.

Spalls, exposed corroded rebar on fascia.

Patch repair

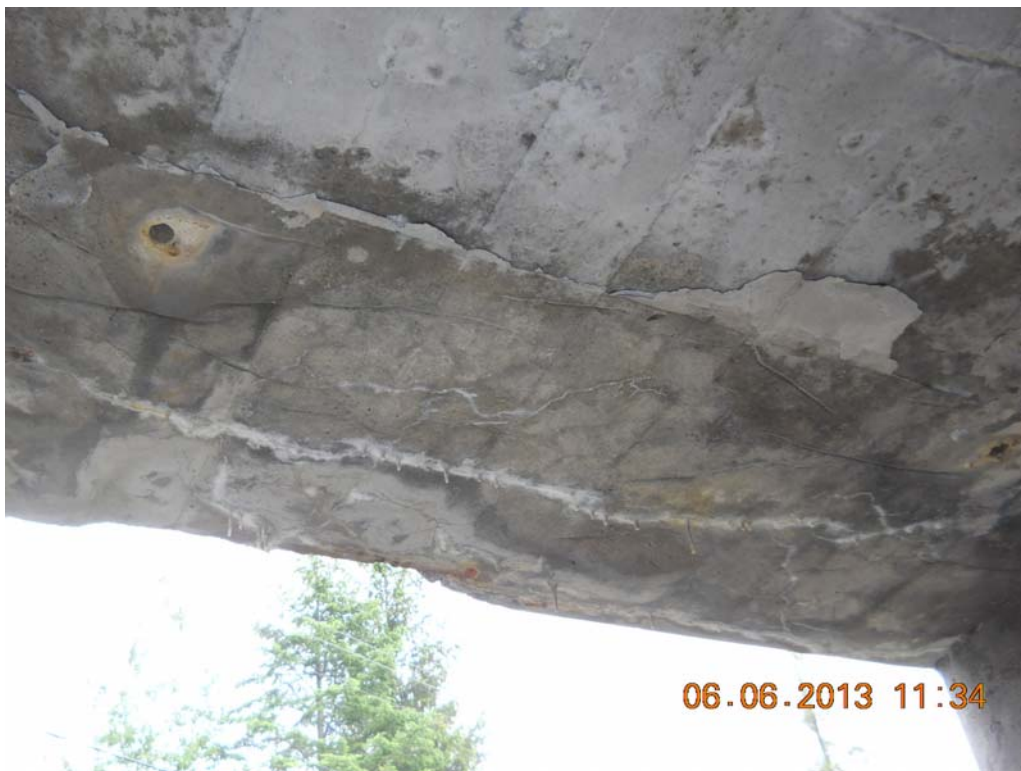
Delamination and efflorescence on soffit.

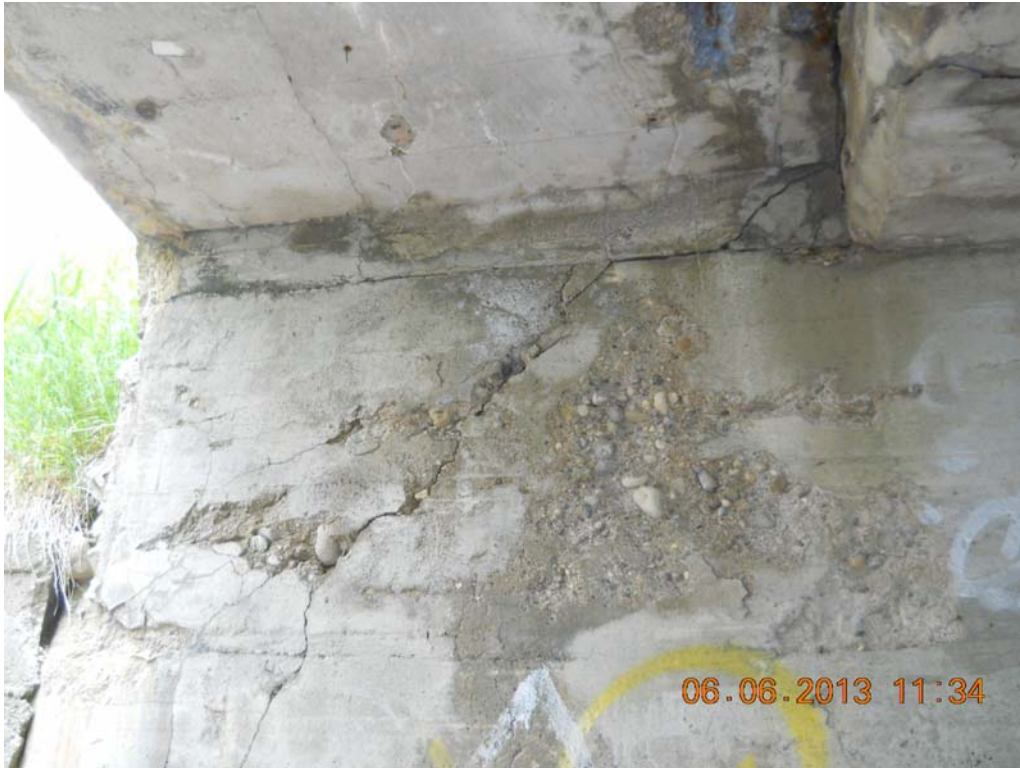
Narrow to wide cracks, light to medium scaling. Delaminations, spalls.

Delamination, spalling and scaling on abutment.

Seal cracks

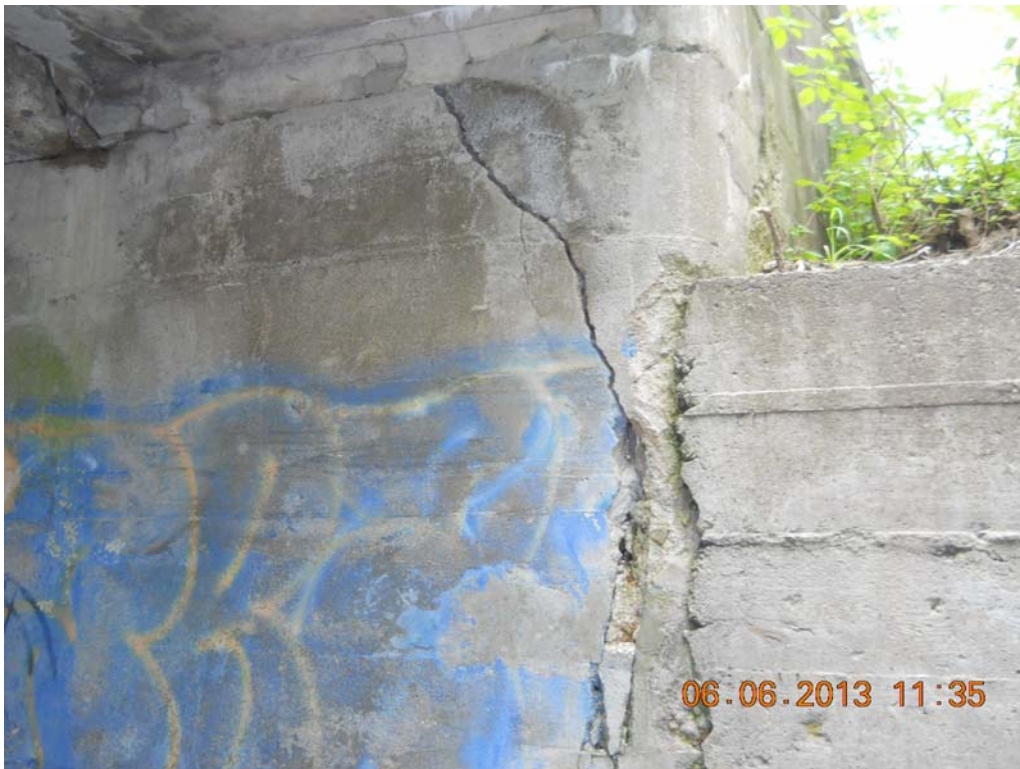
Wide crack on abutment.

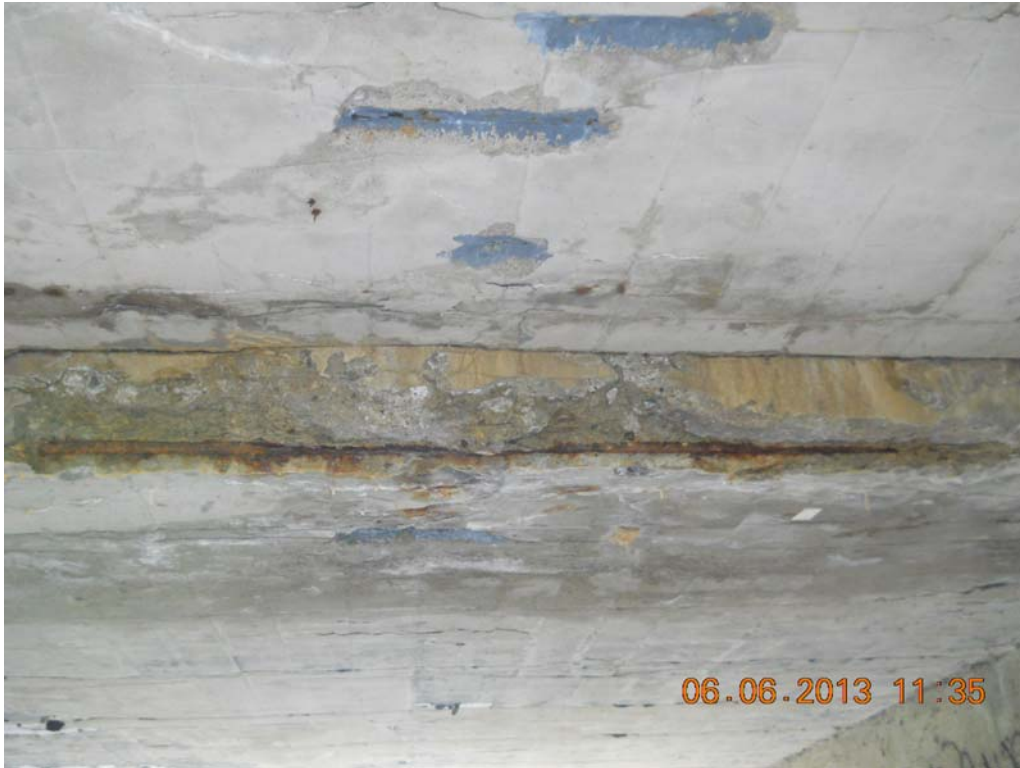
Delamination, spalling and exposed corroded rebar on soffit.
