Re: Erin Heights Golf Course - Erin - Arborist Report and TPP

Arborist Report
&
Tree Protection Plan

Erin Heights Golf Course
Erin, ON

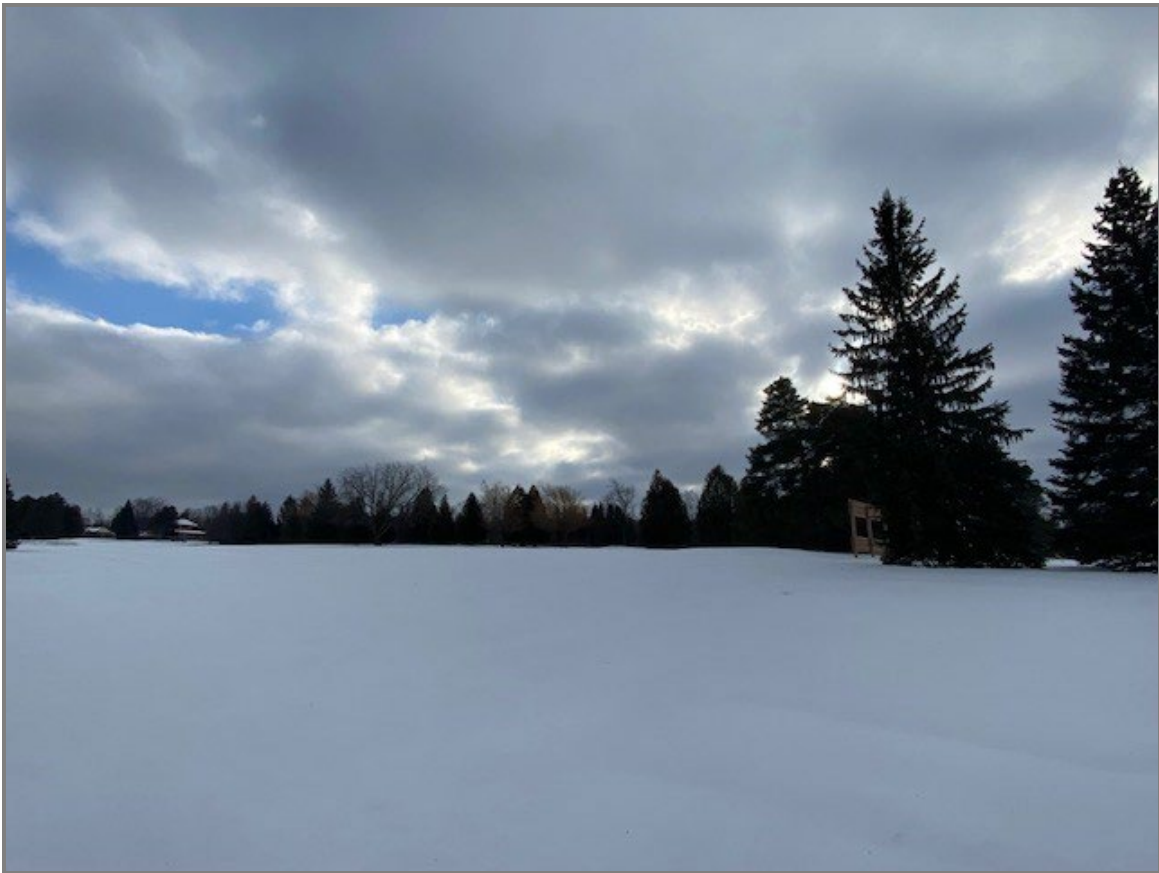
Photo #1: Trees no. 315-323 looking south.

316	Eastern White Cedar <i>Thuja occidentalis</i> (16)	35-58	F	1	- in conflict with proposed grading	R	
317	Willow <i>Salix spp.</i>	35	F	1	- poor form, in decline, deadwood, storm break - in conflict with proposed grading	R	
318	Willow <i>Salix spp.</i>	40	F	1	- poor form, in decline, deadwood, storm break, poor union - in conflict with proposed grading	R

Tree #	Species Common Name (Biological Name)	D B H (cm)	Condition	Category	Comments	Recommendation	M T P Z (M)
319	Willow <i>Salix spp.</i>	33	F	1	- poor union, in decline, deadwood, storm break - in conflict with proposed grading	R	
320	Sugar Maple <i>Acer saccharum</i>	99	F	1	- deadwood, storm break, poor union with included bark - in conflict with proposed grading	R	
321	White Spruce <i>Picea glauca</i>	54	G	1	- deadwood - in conflict with proposed grading	R	
322	Larch <i>Larix spp.</i>	26	F	1	- deadwood - in conflict with proposed grading	R	
323	Larch <i>Larix spp.</i>	27	F	1	- deadwood - in conflict with proposed grading	R	
324	Willow <i>Salix spp.</i>	92	F	1	- poor union, in decline, deadwood, storm break - in conflict with proposed grading	R	
325	White Spruce <i>Picea glauca</i> (4)	32-48	F	1	- deadwood, in decline - in conflict with proposed grading	R	
326	Silver Maple <i>Acer saccharum</i>	78	F	1	- deadwood, storm break, poor union - in conflict with proposed grading	R

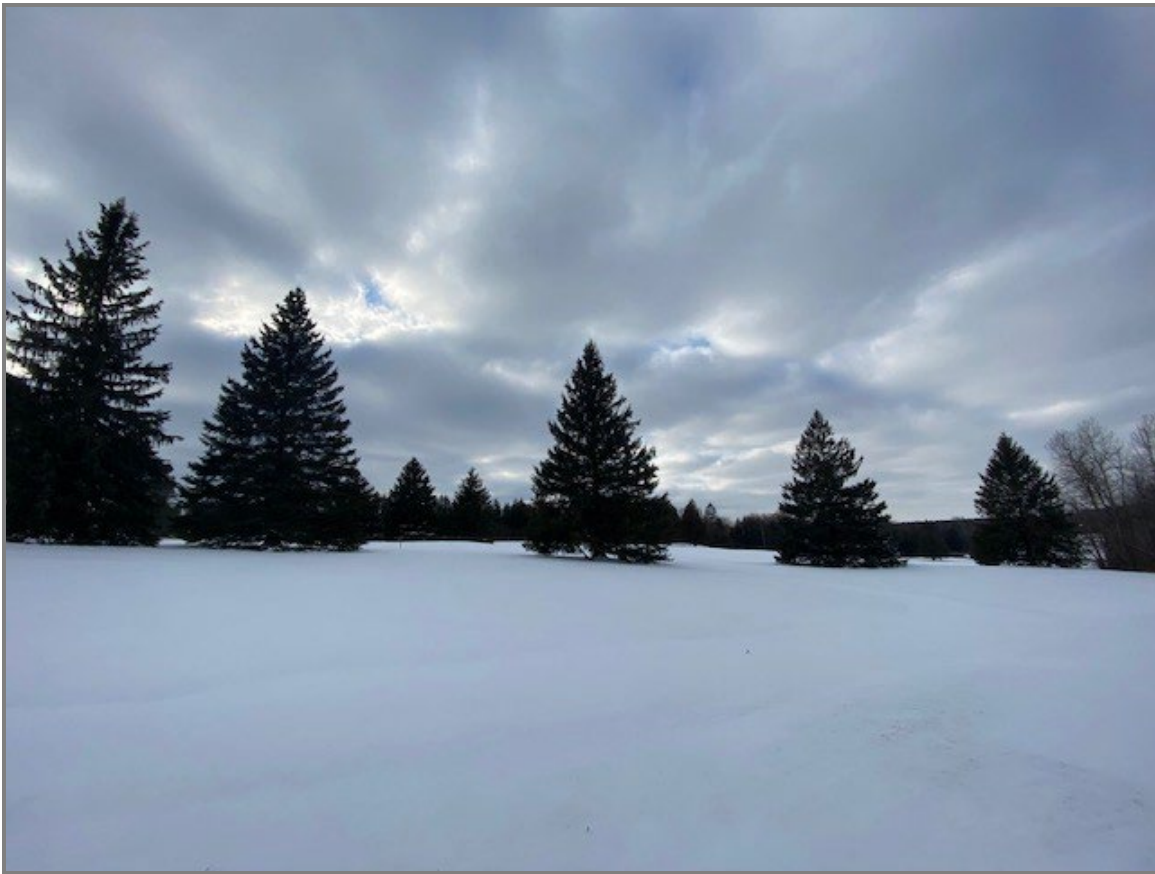
Photo #2: Trees no. 335 looking west.

335	Eastern White Cedar <i>Thuja occidentalis</i> (5)	32-45	F	1	- in decline, discoloured - in conflict with proposed grading	R	
336	Willow <i>Salix spp.</i> (stump)		F	1	- trunk failure - in conflict with proposed grading	R

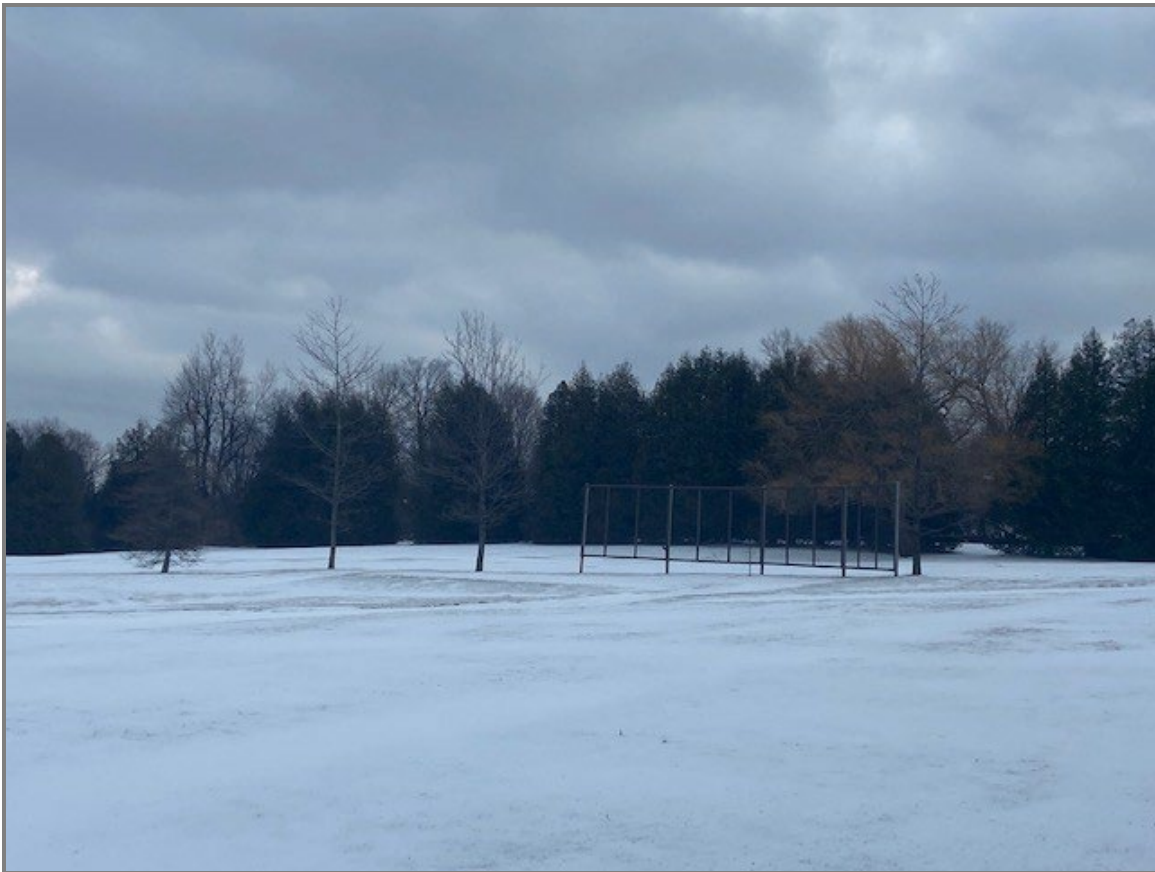
Photo #3: Trees no. 347-351 looking southeast.

344	White Spruce <i>Picea glauca</i> (3)	40- 49	F	1	- deadwood, in decline - in conflict with proposed grading	R	
345	Larch <i>Larix spp.</i>	24	G	1	- deadwood - in conflict with proposed grading	R	
346	Eastern White Cedar <i>Thuja occidentalis</i> (5)	44- 59	F	1	- in conflict with proposed grading	R	
347	White Spruce <i>Picea glauca</i>	51	F	1	- deadwood - in conflict with proposed grading	R	
348	Red Oak <i>Quercus rubra</i>	18	G	1	- in conflict with proposed grading	R	
349	Red Oak <i>Quercus rubra</i>	21	F	1	- deadwood, poor union - in conflict with proposed grading	R	
350	Red Oak <i>Quercus rubra</i>	18	G	1	- in conflict with proposed grading	R	
351	Larch <i>Larix spp.</i> (6)	11- 15	F	1	- deadwood - in conflict with proposed grading	R	
352	White Spruce <i>Picea glauca</i> (2)	19- 20	G	1	- in conflict with proposed grading	R	
353	Eastern White Cedar <i>Thuja occidentalis</i> (2)	42& 58	F	1	- in conflict with proposed grading	R

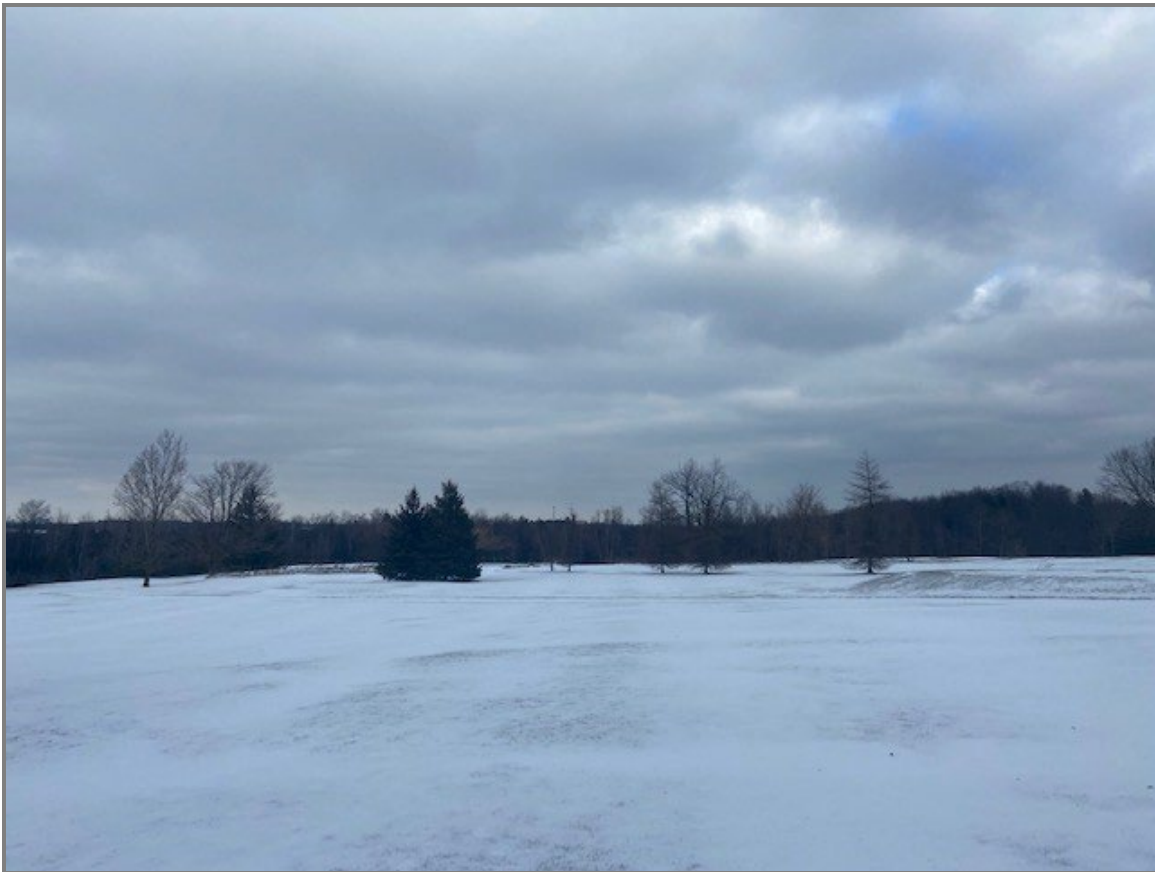
Photo #4: Trees no. 355-362 looking northeast.

Tree #	Species Common Name (Biological Name)	D B H (cm)	Condition	Category	Comments	Recommendation	M T P Z (M)
355	Sugar Maple <i>Acer saccharum</i>	74	F	1	- deadwood, storm break, poor union with included bark - in conflict with proposed grading	R	
356	Trembling Aspen <i>Populus tremuloides</i>	61	F	1	- deadwood, storm breaks - in conflict with proposed grading	R	
357	Norway Spruce <i>Picea abies</i>	69	G	1	- in conflict with proposed grading	R	
358	Willow <i>Salix spp.</i>	39	F	1	- poor union, deadwood, poor form - in conflict with proposed grading	R	
359	Willow <i>Salix spp.</i>	28	F	1	- poor union, deadwood, poor form - in conflict with proposed grading	R	
360	Black Cherry <i>Prunus serotina</i>	63	P	1	- multiple limb failures, large deadwood, in decline, split - in conflict with proposed grading	R	
361	Manitoba Maple <i>Acer negundo</i>	35	F	1	- deadwood, in decline, poor form, vines - in conflict with proposed grading	R

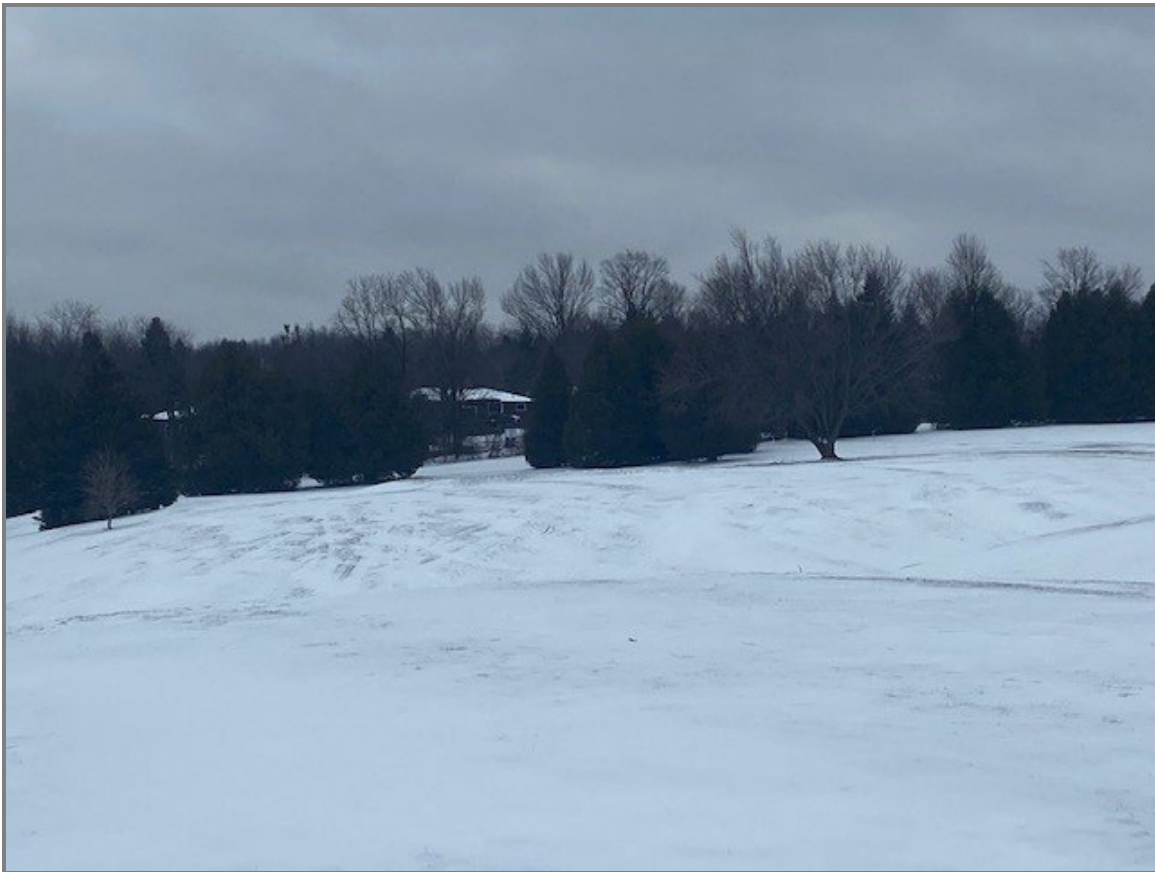
Photo #5: Trees no. 363-364 and 967 looking southeast.

362	Larch <i>Larix spp.</i>	12	F	1	- deadwood - in conflict with proposed grading	R	
363	Silver Maple <i>Acer saccharinum</i>	120	F	1	- deadwood, storm break, poor union with included bark - in conflict with proposed grading	R	
364	White Spruce <i>Picea glauca</i>	48	G	1	- in conflict with proposed grading	R	
365	Eastern White Cedar <i>Thuja occidentalis</i>	64	F	1	- poor union, deadwood, multi-stem - in conflict with proposed grading	R	
366	Scots Pine <i>Pinus sylvestris</i>	52	F	1	- deadwood, poor form - in conflict with proposed grading	R	
N1	Horse Chestnut <i>Aesculus hippocastanum</i>	11	F	2	- poor union - cannot maintain 100% of its prescribed TPZ	PI	1.8
N2	White Spruce <i>Picea glauca</i>	12	F	2	- clear of proposed construction - shall retain its prescribed TPZ	P	1.8
N3	Manitoba Maple <i>Acer negundo</i>	24	F	2	- deadwood, in decline, poor form, lean - cannot maintain 100% of its prescribed TPZ	PI	1.8
