**Reference Number: T20828-1**

**Subject: Test Pit Investigation on the North Parcel  
Proposed Residential Development  
Erin Property  
5520 8<sup>th</sup> Line, Erin, Ontario**

Test Pit Investigation-North Parcel

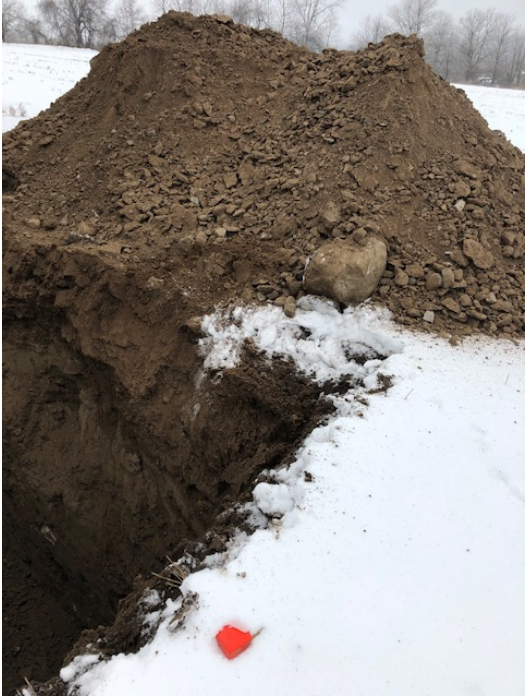
Photograph 1- View of excavated soils for TP 101. Test pit was dry upon completion and no water seepage observed.

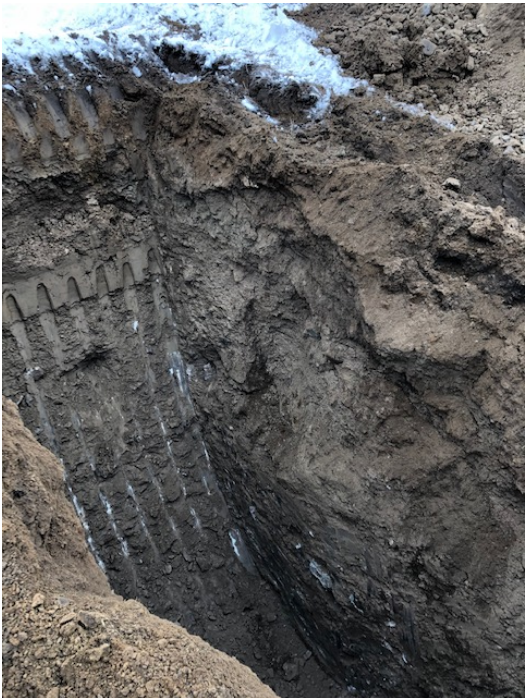
Photograph 2 – View of excavation for TP 102. Test pit was dry upon completion, however, after 4 hours, slow water seepage was observed at 2.5 m below existing grade.

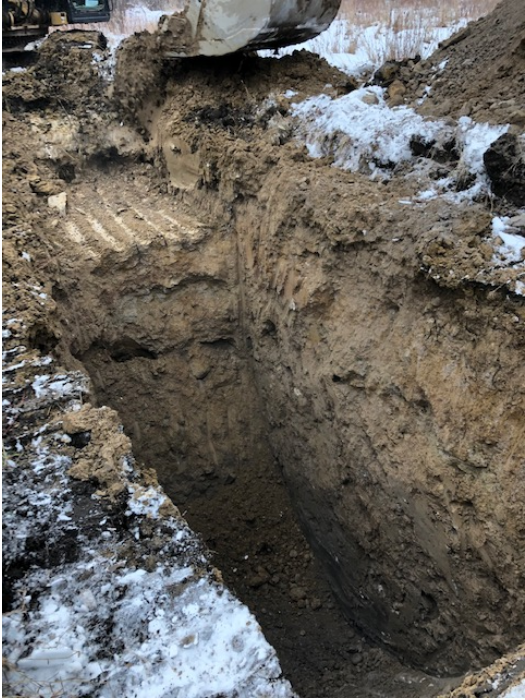
Photograph 3- View of excavation for TP 103. Sides caved in at about 3.8 m below existing grade.

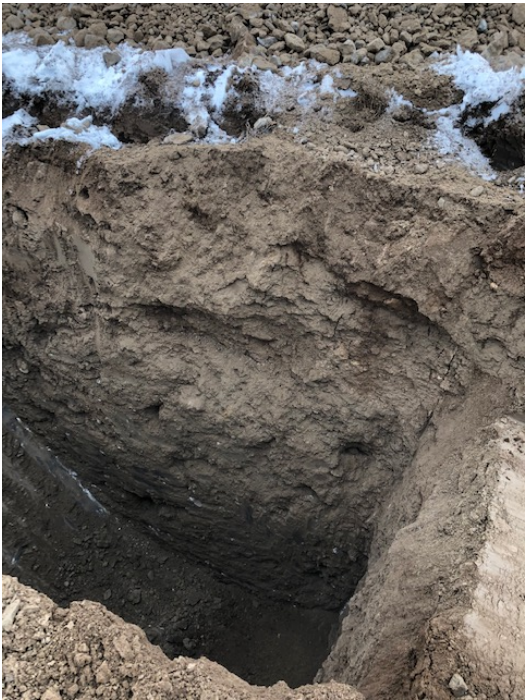
Photograph 4 – View of excavation for TP 104. Test pit was dry upon completion, however after 4.5 hours, slow water seepage was observed at 3.0 m below existing grade.

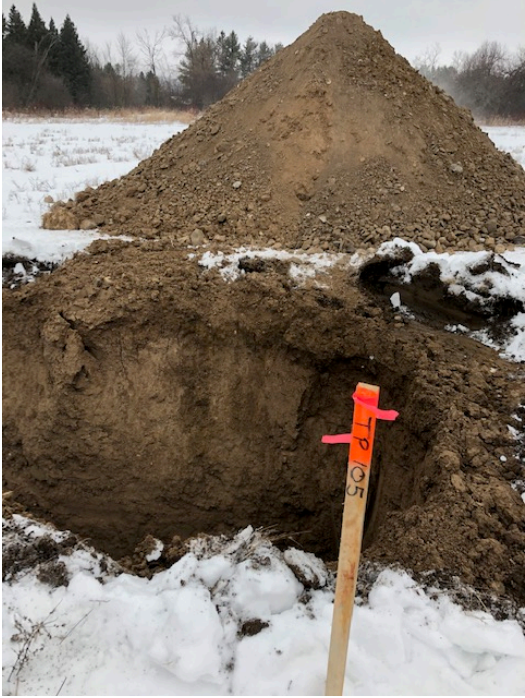
Photograph 5- Excavated soils from TP 105. After 4.0 hours, cave-in of sides and water level were observed at 3.0 m below existing grade.

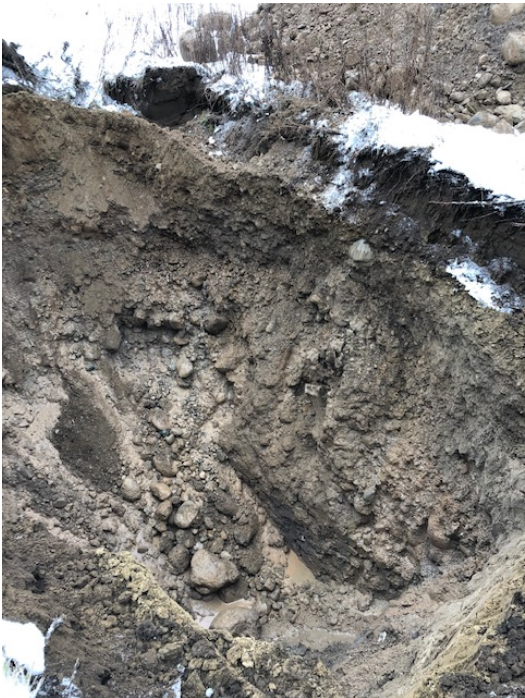
Photograph 6- View of excavation for TP 106. Note fast water seepage from sand and gravel seam at about 2.5 to 3.5 m below the existing grade.

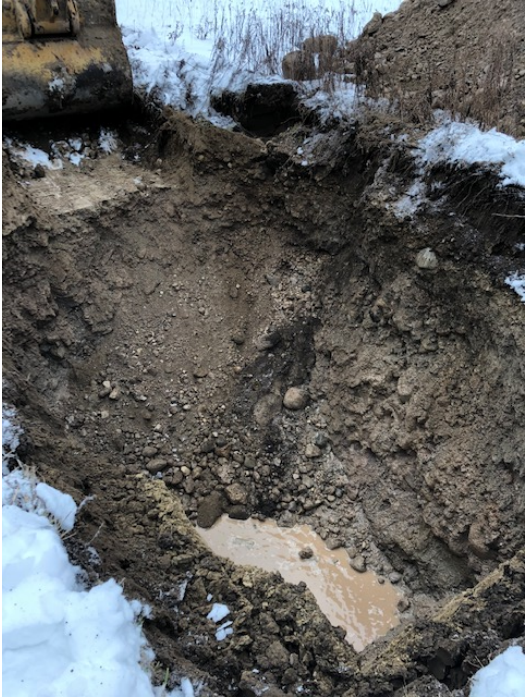
Photograph 7- View of TP 106, note cave-in and water level approximately 0.75 hours after excavation.

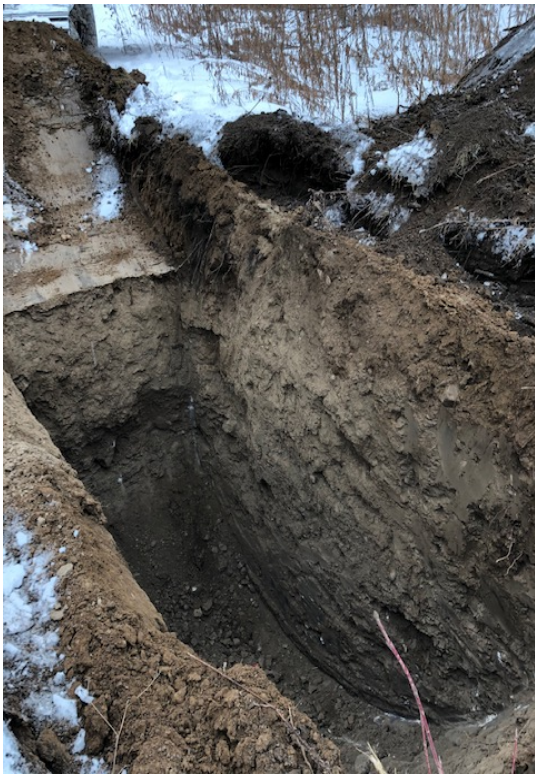
Photograph 8- View of excavation for TP 107. After 4.0 hours, test pit was dry and no cave-in observed.

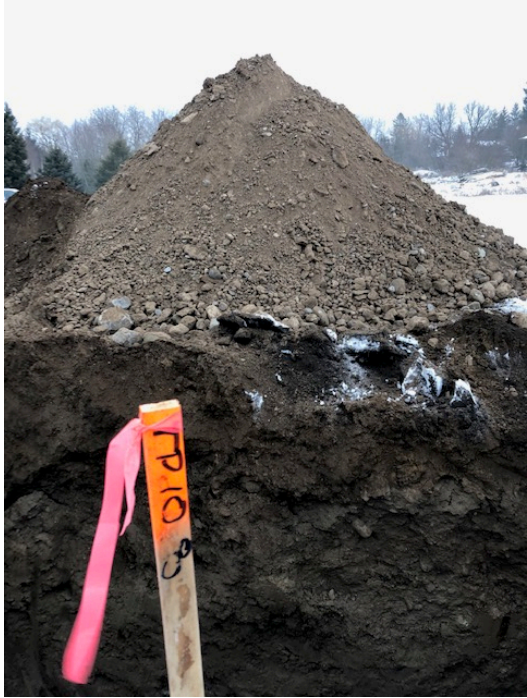
Photograph 9- View of excavated soils for TP108. Test pit was dry upon completion.

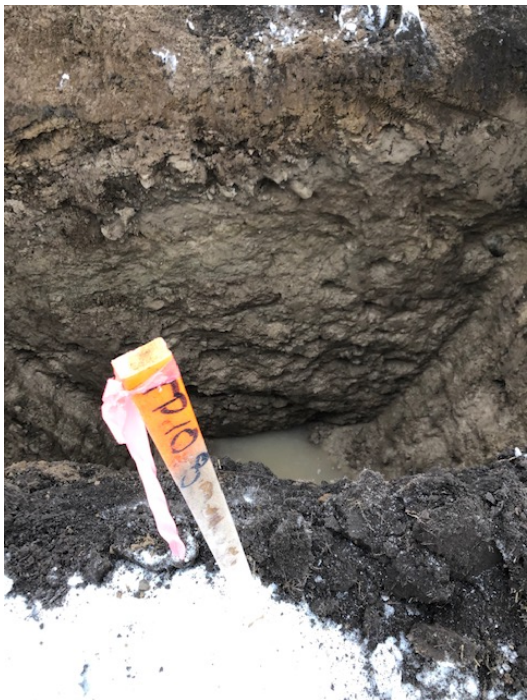
Photograph 10- View of TP 108, approximately 8 hours after completion. Slow water seepage was observed at 2.5 m below the existing grade.

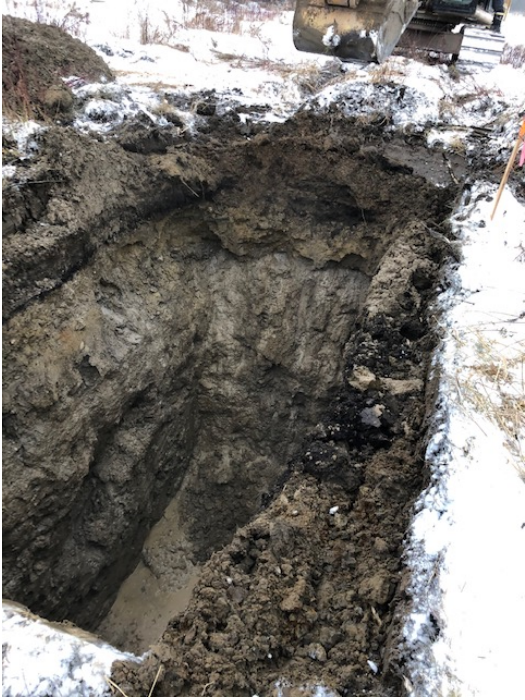
Photograph 11- View of excavation for TP 109. Water seepage was from sand and gravel seam at 2.0 to 2.5 m below existing grade.

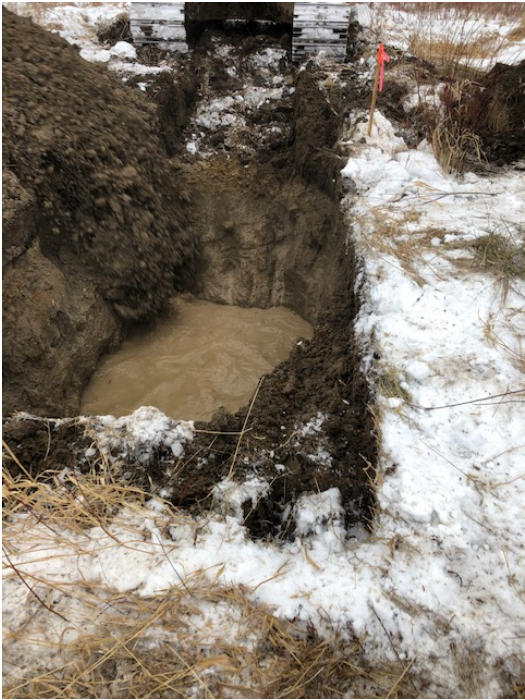
Photograph 12- View of TP 109 approximately 5 hours after completion.

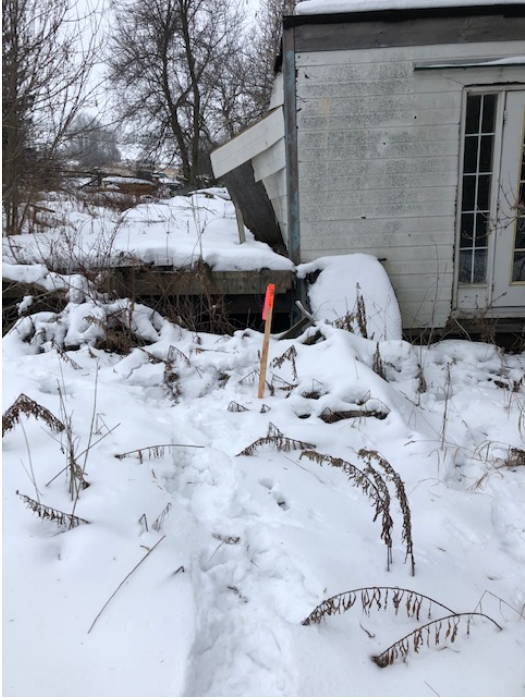
Photograph 13- Location of TP 110. Test pit was moved approximately 40 m south due to close proximity to wooden structure and construction material storage in area.

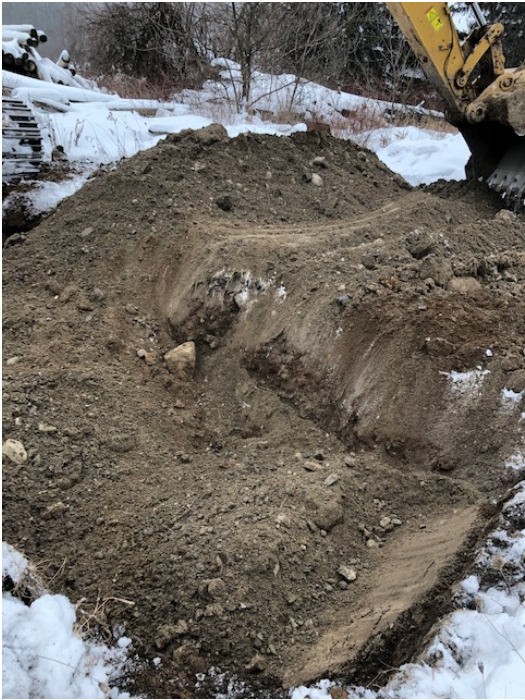
Photograph 14- View of excavated soil being used to backfill TP 110.

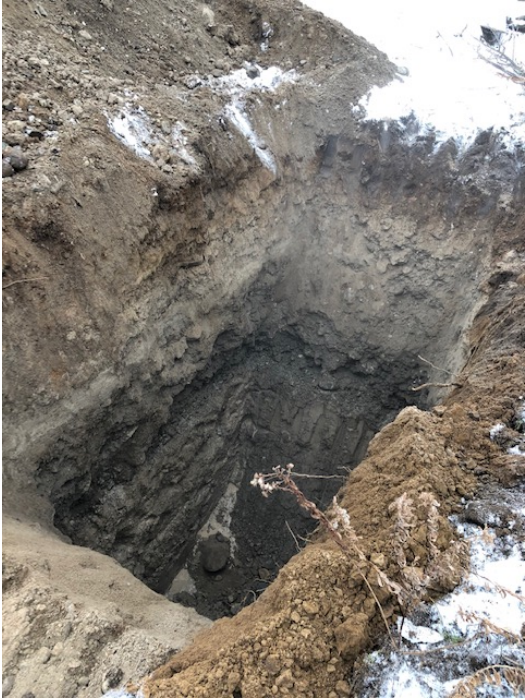
Photograph 15- View of BH 111-water at base was from slow water seepage from sand and gravel seam at 2.4 to 2.8 m below existing grade.

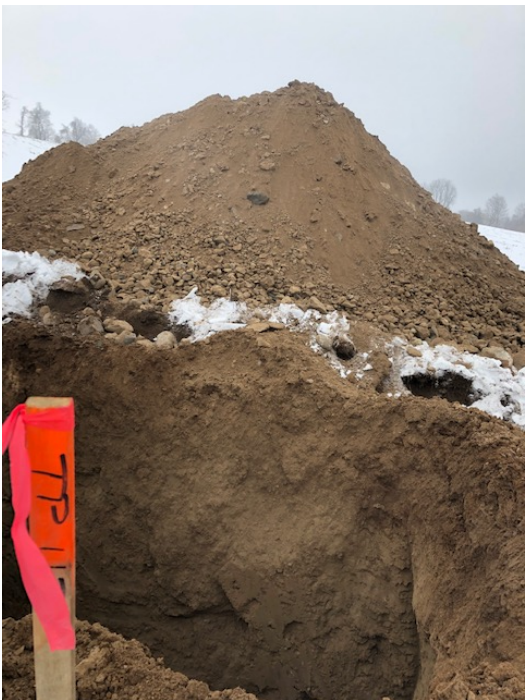
Photograph 16- View of excavated soils from TP 112. After 4.5 hours, test pit was dry and no cave-in observed.
