# Erosion Mitigation Assessment West Credit River (Erin Branch)

**Town of Erin, Wellington County**

June 8, 2022  
PN21060

Report Title: Erosion Mitigation Assessment  
Credit River Tributary  
Town of Erin, Wellington County

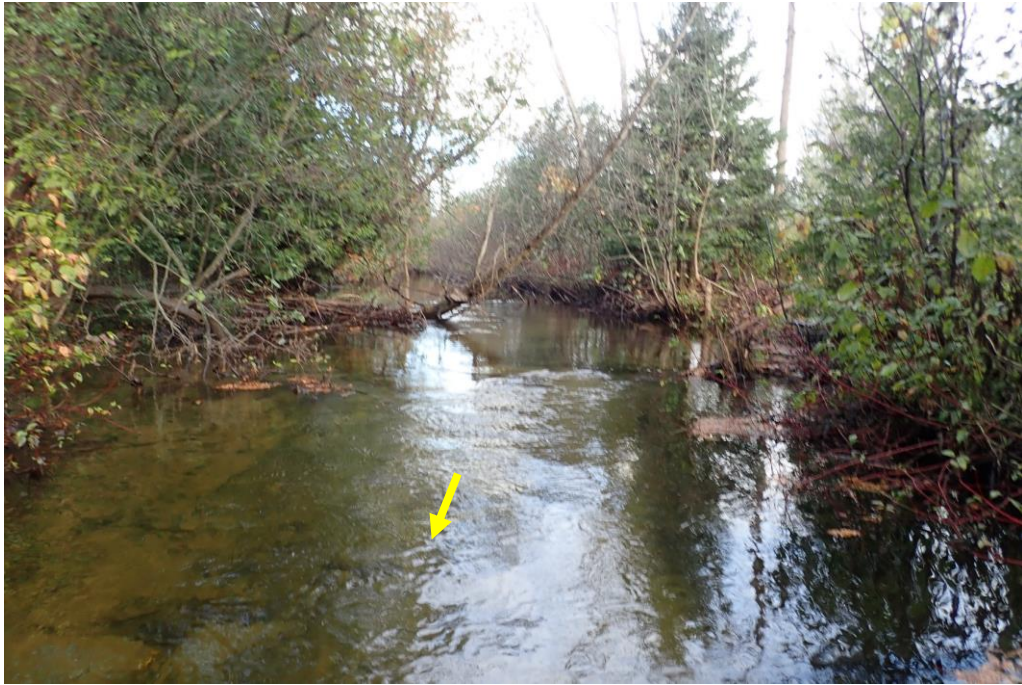
Photo 5  
Reach **TCR-1**

Shallow, run-type sections with rippled flow are intermittent throughout the reach.

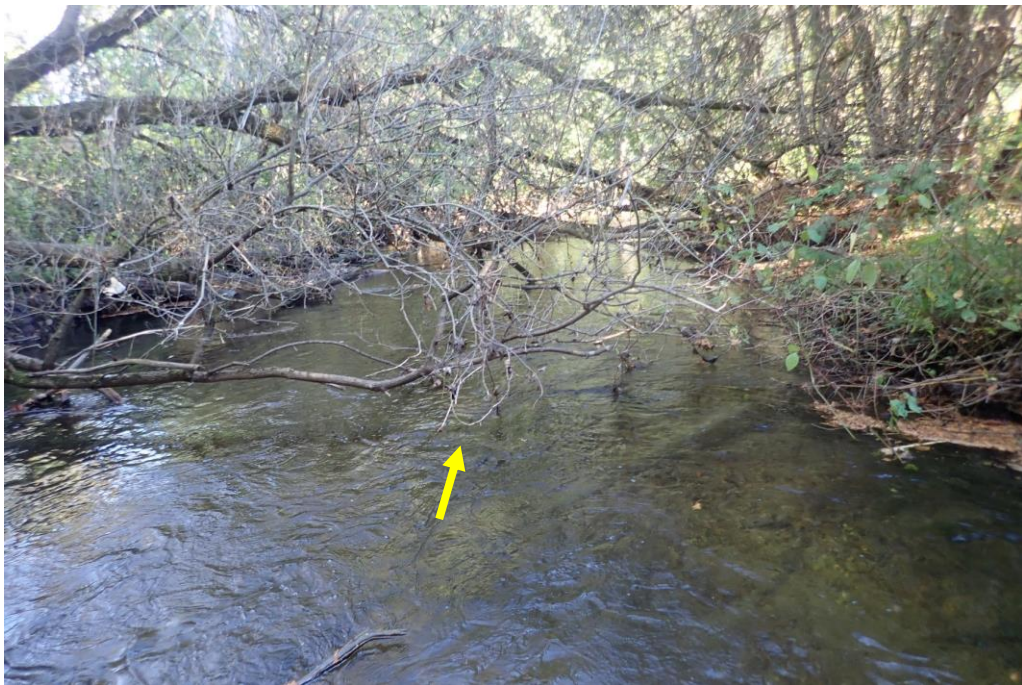
Photo 6  
Reach **TCR-1**

Overhanging mature trees, large woody debris, and exposed roots are common.

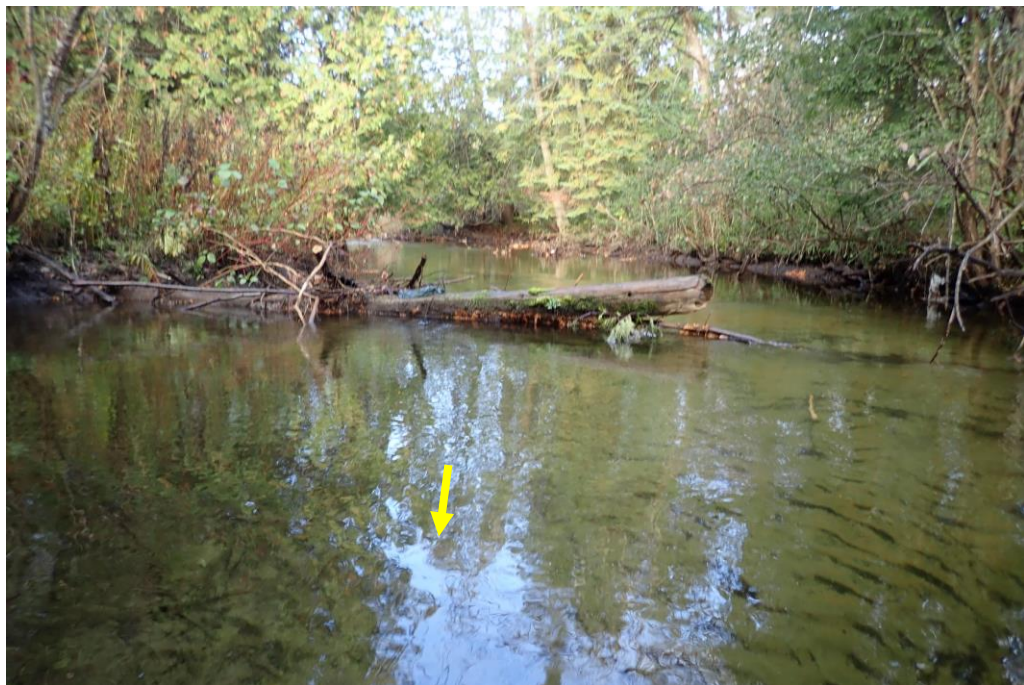
Photo 8  
Reach TCR-1

The channel substrate is predominantly sand and silt.

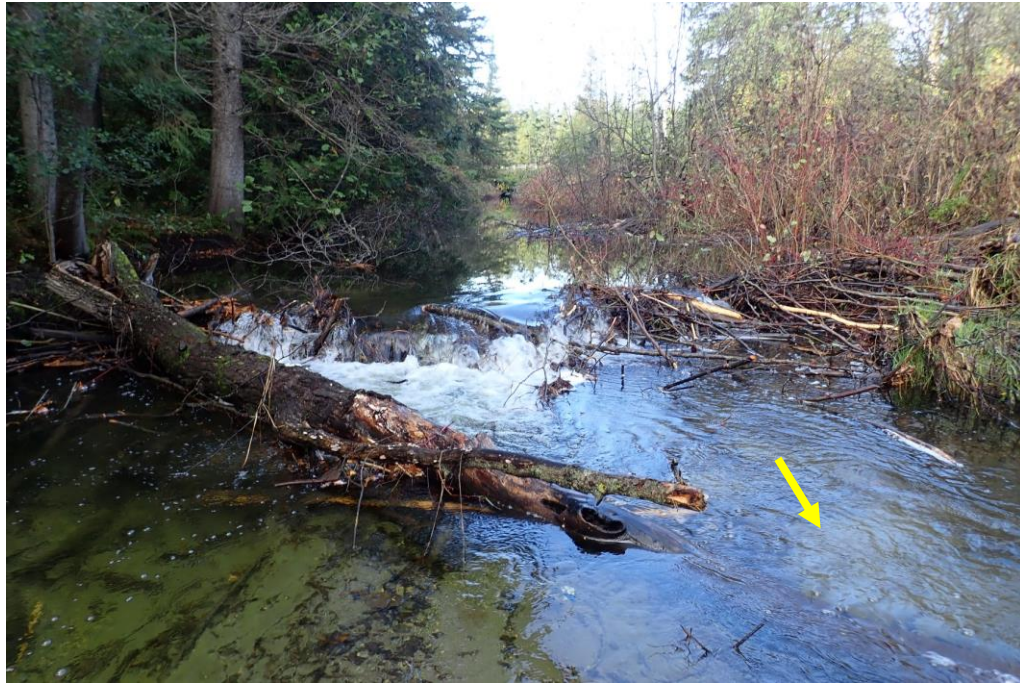
Photo 9  
Reach **TCR-1**

A small beaver dam was observed in the upstream portion of the reach.

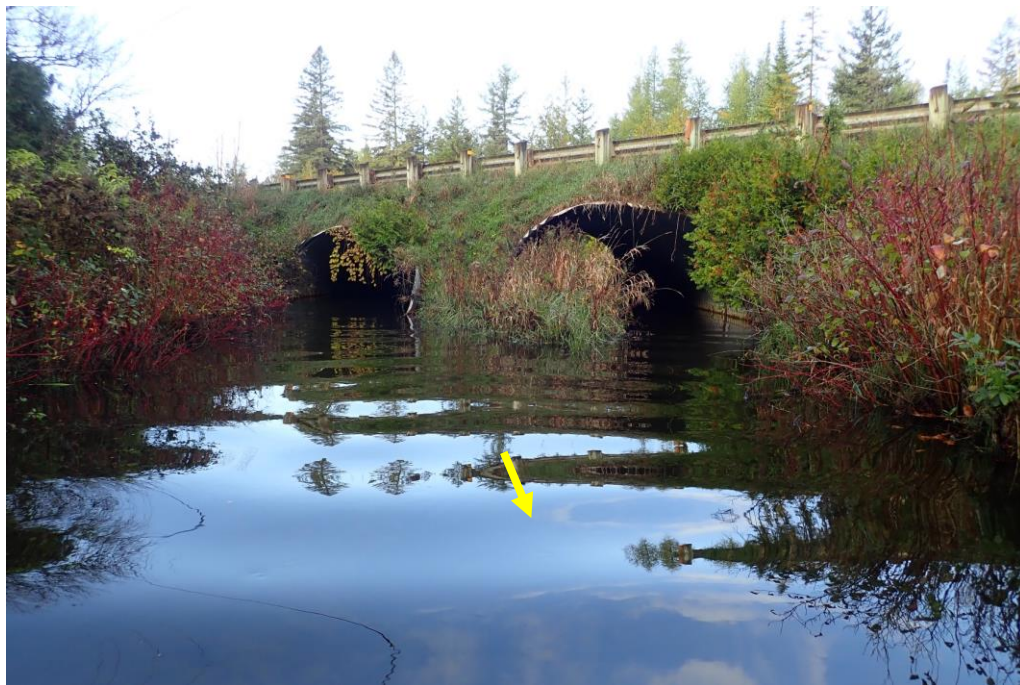
Photo 10  
Reach **TCR-1**

The 17<sup>th</sup> Sideroad crossing defines the upstream extent of Reach **TCR-1**.
