# Heritage Impact Assessment

*5916 Trafalgar Road North, Town of Erin, part of Lot 26, Concession 7, former Township of Erin, Wellington County, Ontario*

21481749-1000-R01

15 July 2022

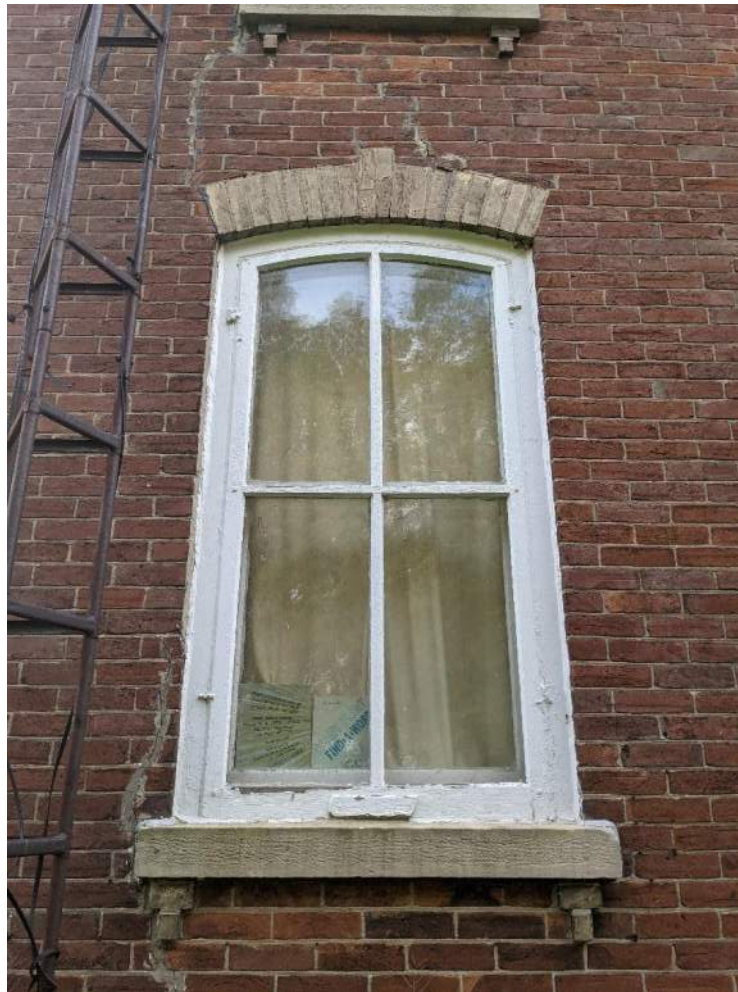
**Figure 87: Evidence of cracks radiating around the first and second level windows on the north facade.**
