PHASE ONE ENVIRONMENTAL SITE ASSESSMENT
5916 Trafalgar Road North,
Town of Erin, Ontario

Project No. 2100428EE

April 25, 2022

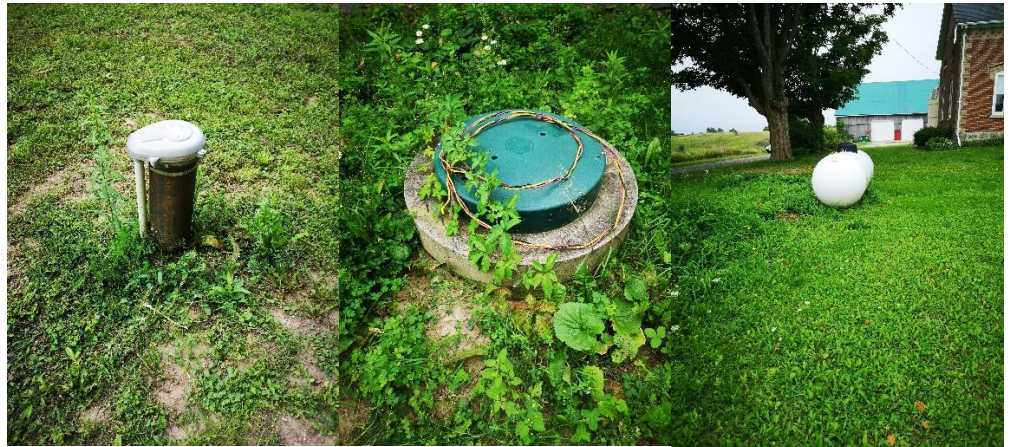
Photographs 5, 6 & 7

View of the wells and propane tank on the property.

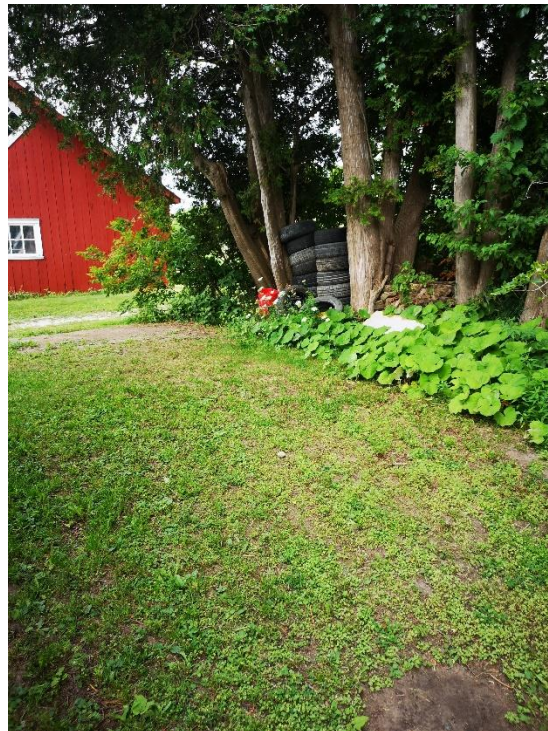
Photograph 8

View of tires stacked on site.

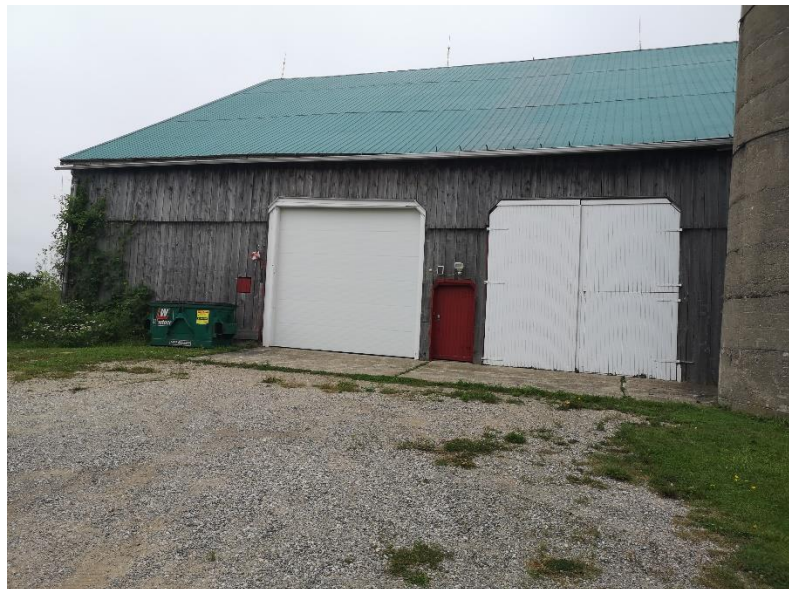
Photographs 14

View of the front of Barn 2 and garbage bin.

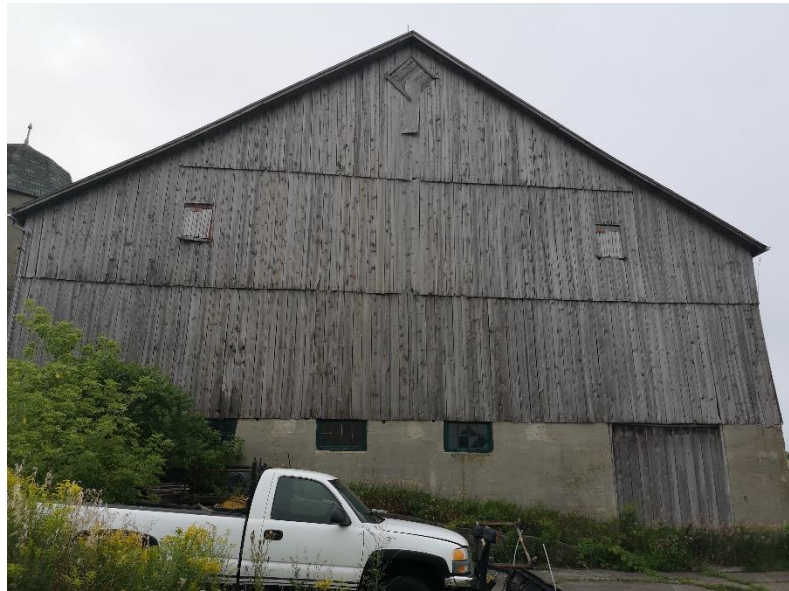
Photograph 15

View of the side of Barn 2 and truck parked on site.

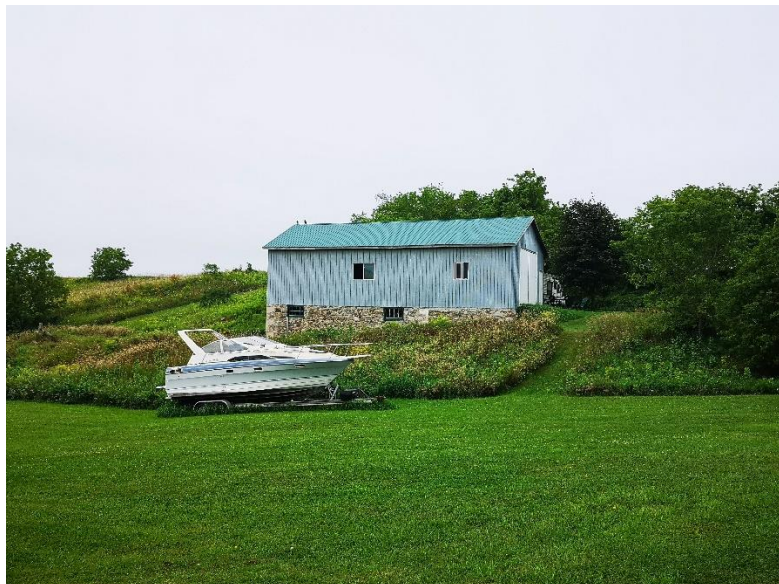
Photographs 16

View of front of Barn 3 and boat.

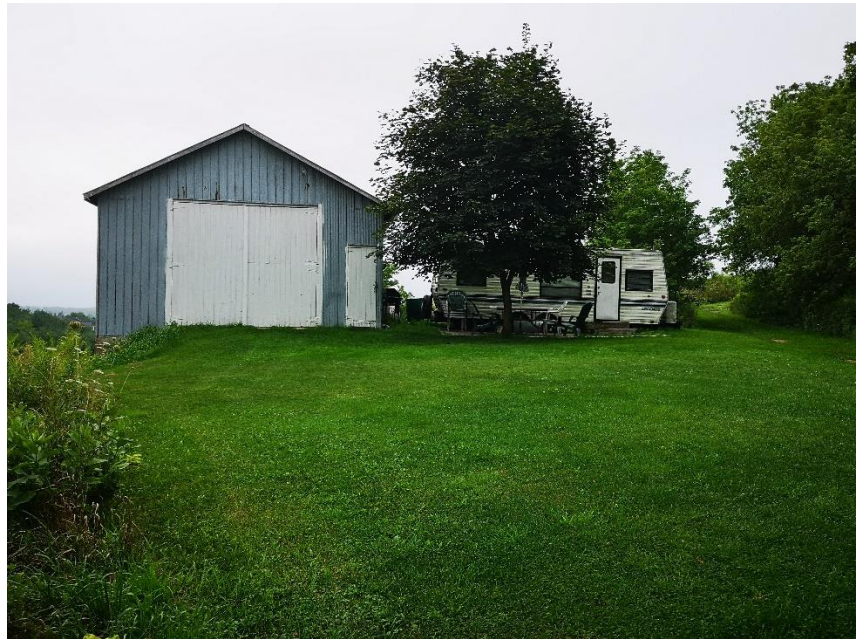
Photograph 17

View of the side of Barn 3 and trailer parking on site.

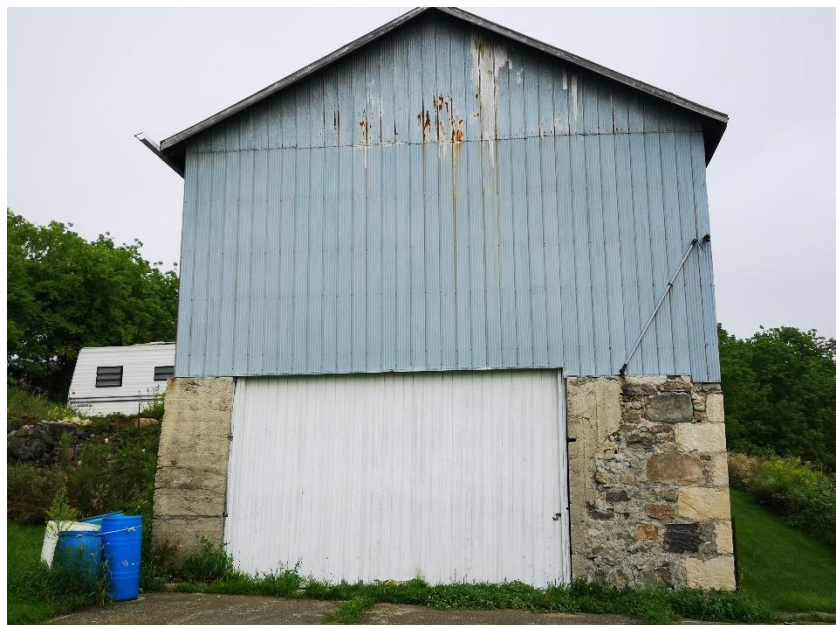
Photographs 18

View of the side of Barn 3 and water barrels.

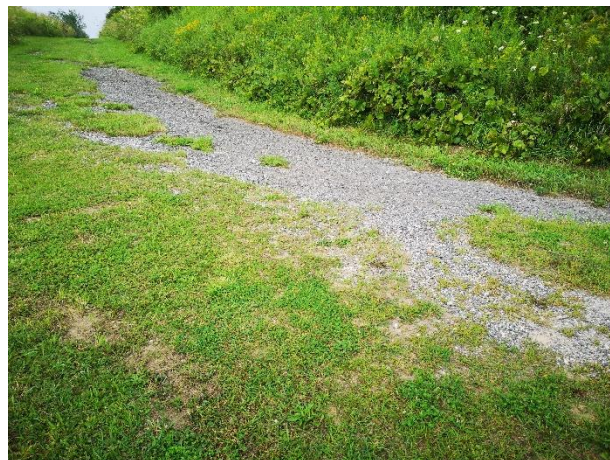
Photographs 20

Parameters	Information
Areas of Fill	Some areas of fill were observed at the time of the site visit. There are some areas of the property which have had fill material brought in for building the driveway.
Other Observations	N/A
Potentially Contaminating Activities (PCAs)	There were onsite PCAs. These include: <ul style="list-style-type: none"> • PCA #40: Pesticides (including Herbicides, Fungicides, and Anti-Fouling Agents) Manufacturing, Processing, Bulk Storage, and Large-Scale Applications. • PCA #30: Importation of Fill Material of Unknown Quality • PCA #28: Gasoline and Associated Products Storage in Fixed Tanks
Unidentified Substances	None observed

View of the trail to the back of the property with fill material on it.

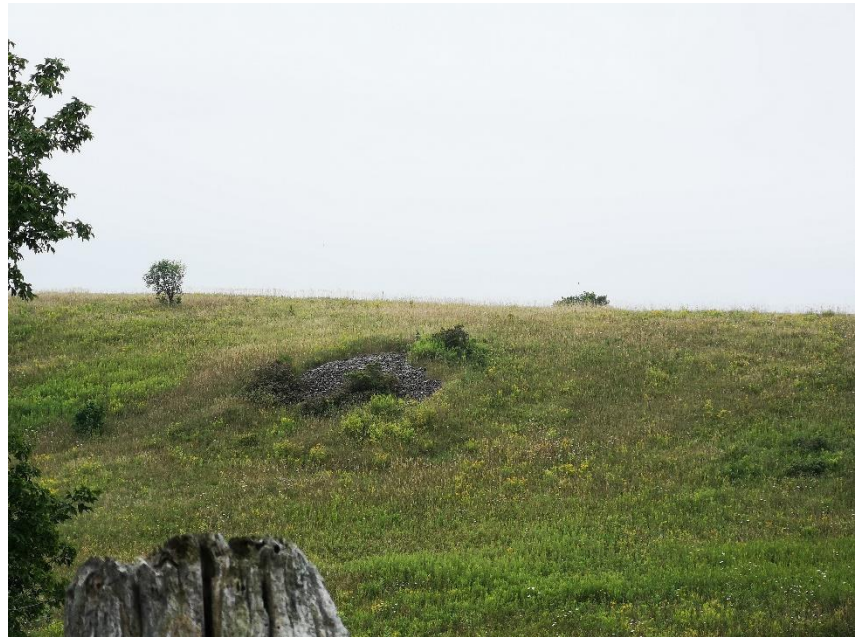
Photograph 21

View of fill material on site.

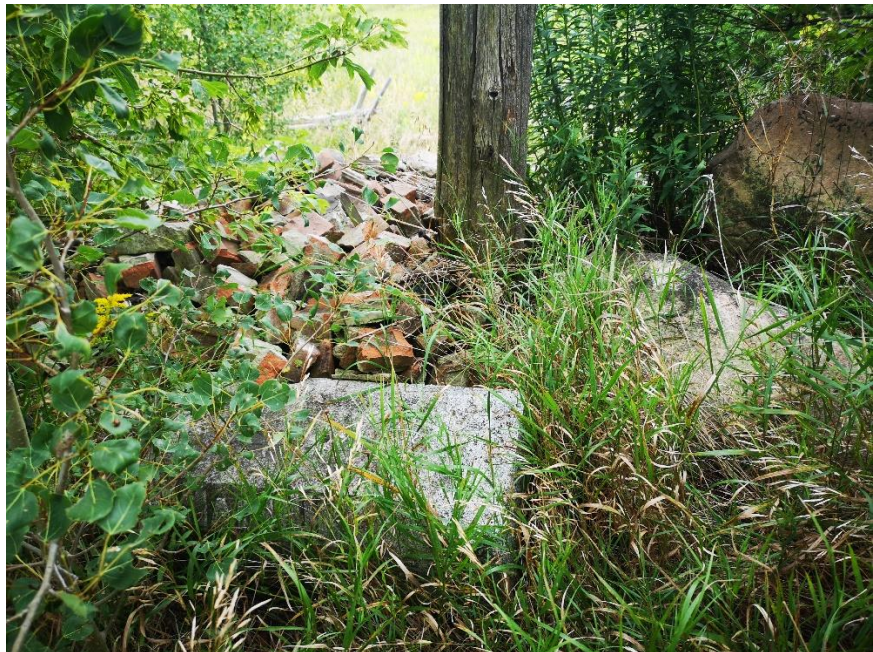
Photographs 22

View of brick pile on site.
