TECHNICAL MEMORANDUM

DATE 22 March 2022

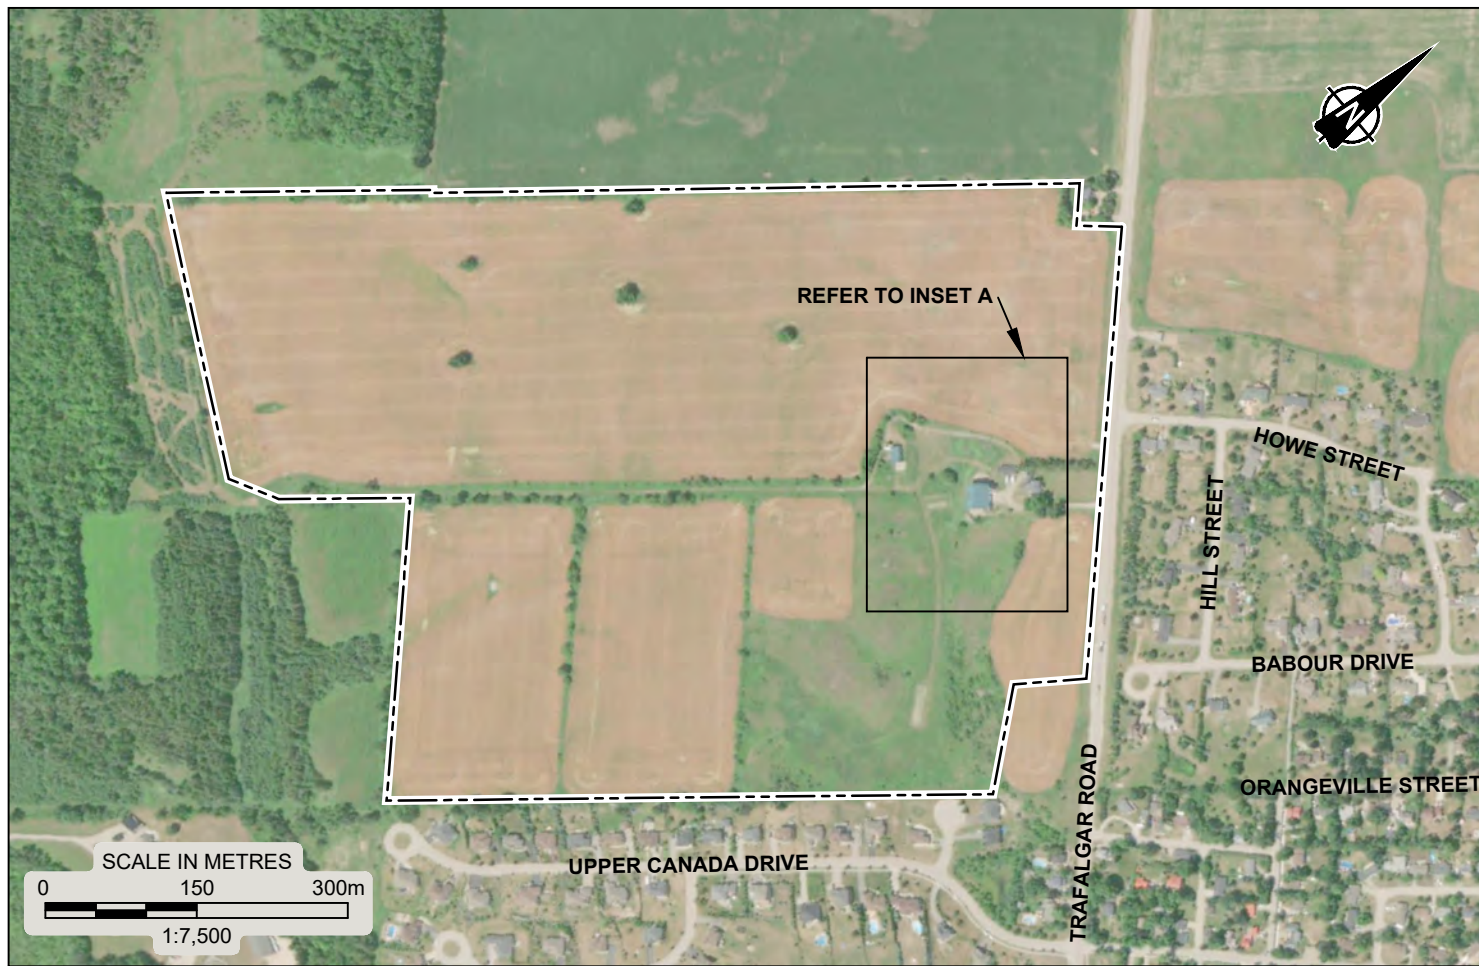
AERIAL IMAGERY (BING IMAGERY)

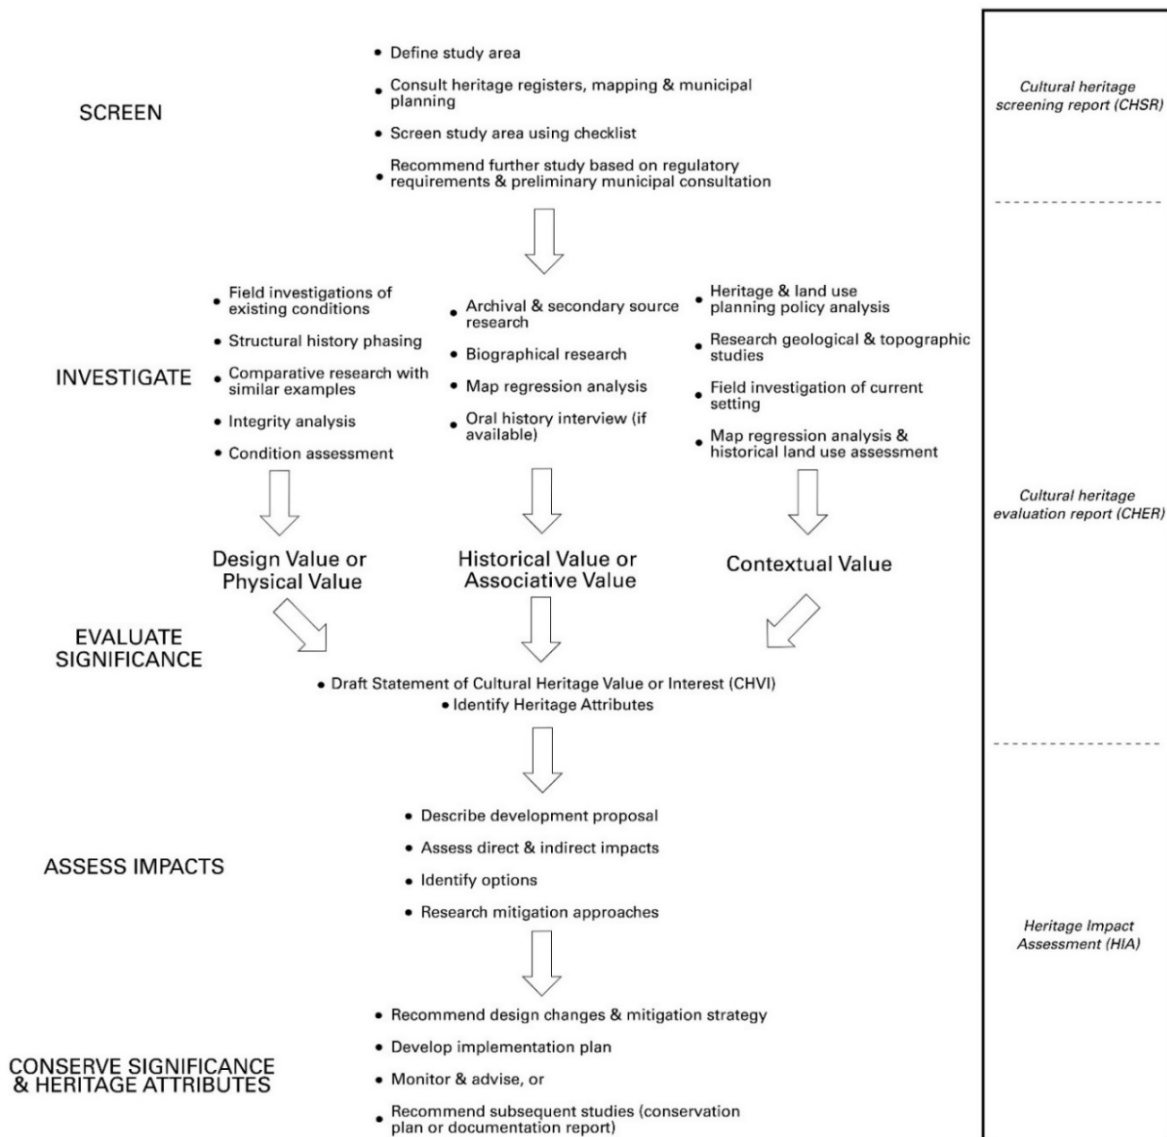
Figure 2: Typical process to investigate a property, evaluate its significance, assess impacts to its CHVI and heritage attributes, and mitigate any adverse effects.

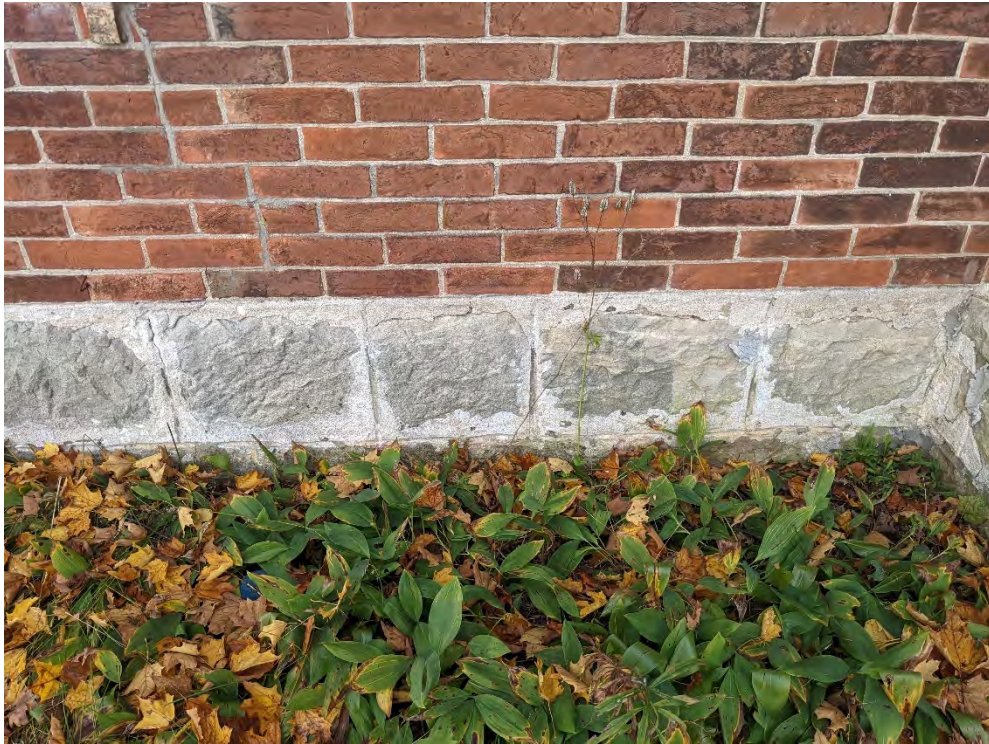
Figure 18: Tooled stone foundation and running bond brick on the east façade

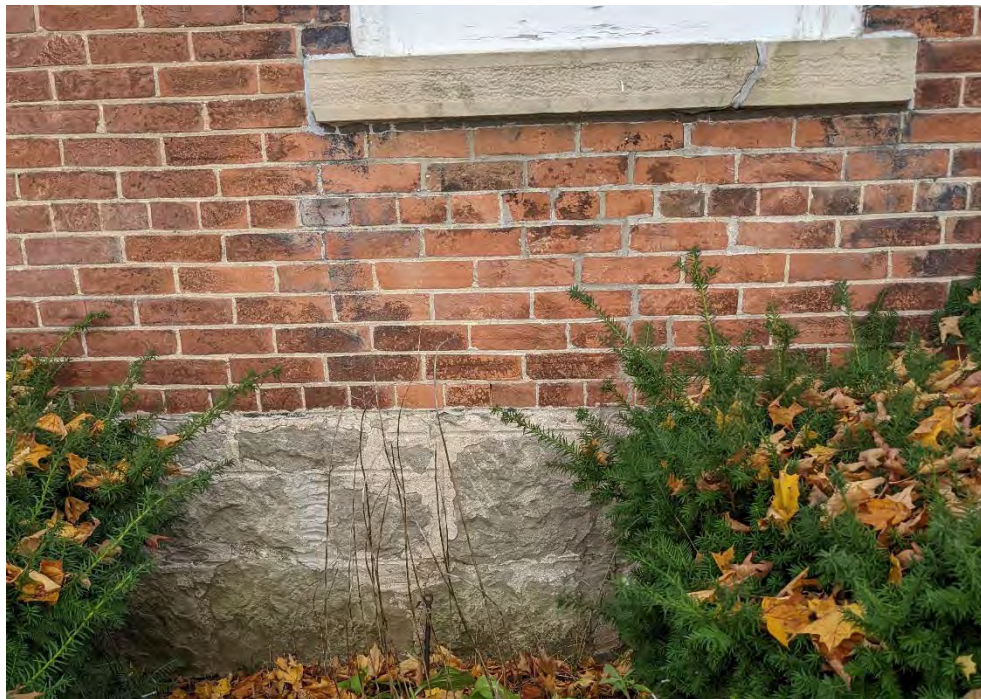
Figure 19: Stone foundation and common bond brick on south elevation.

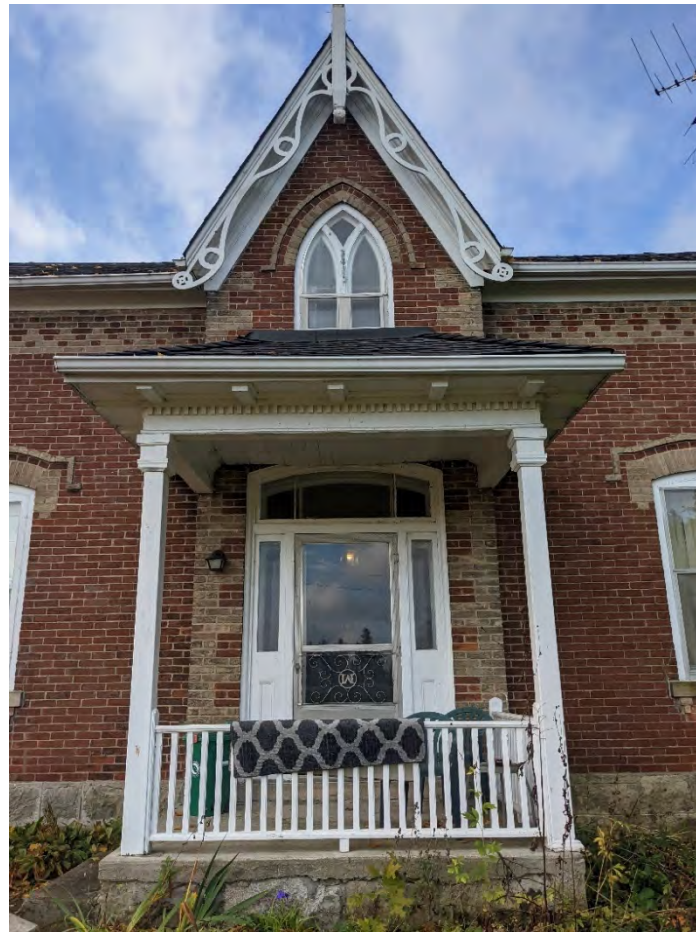
Figure 20: Front entrance with covered front porch

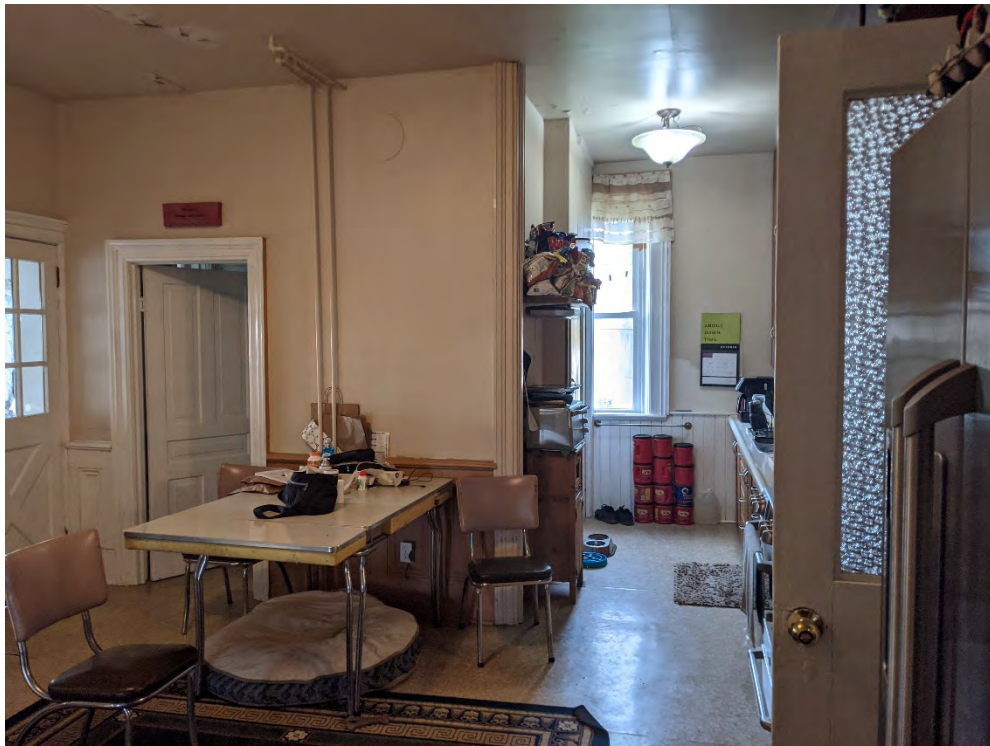
Figure 34: Kitchen in the rear wing, towards west

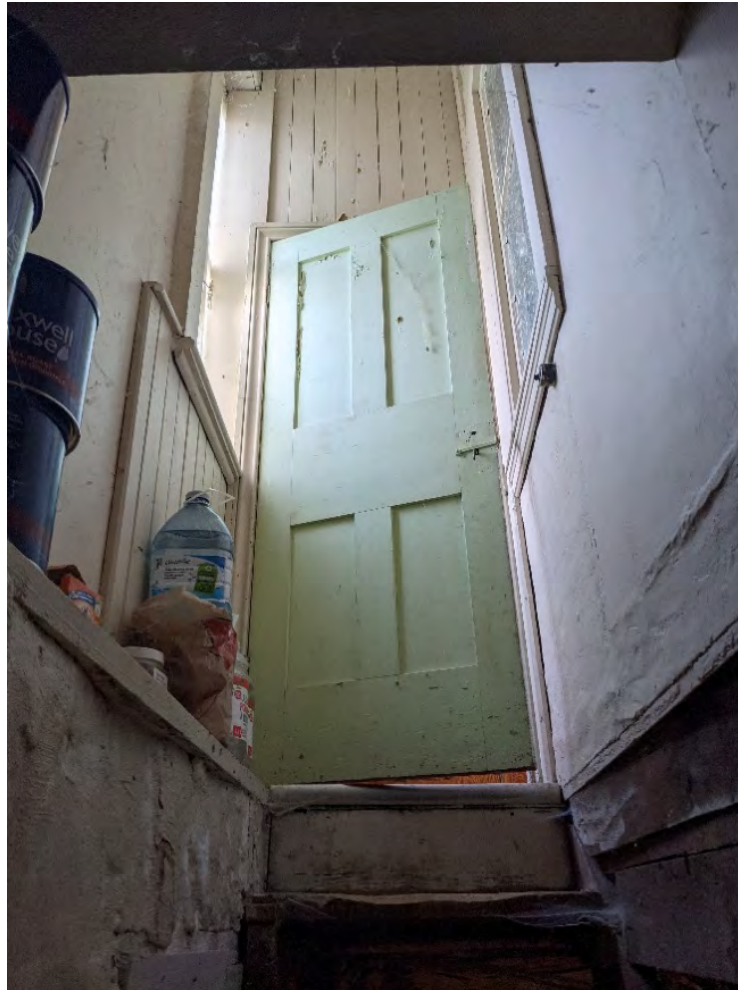
Figure 51: The door from the kitchen, view from the basement stairs

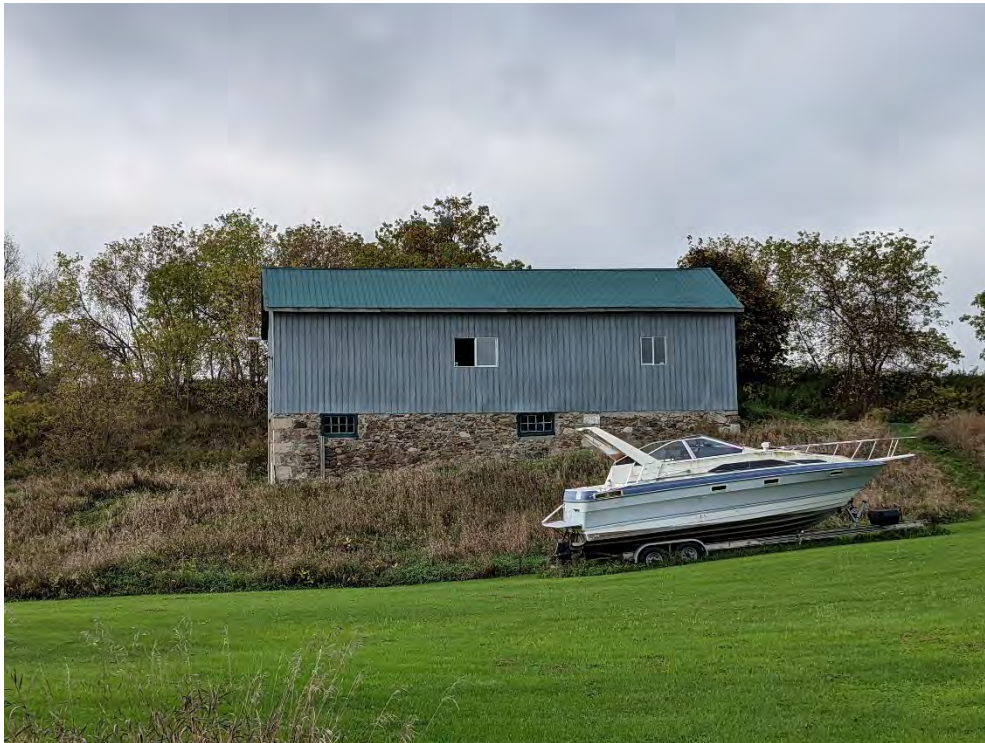
Figure 86: Small Barn

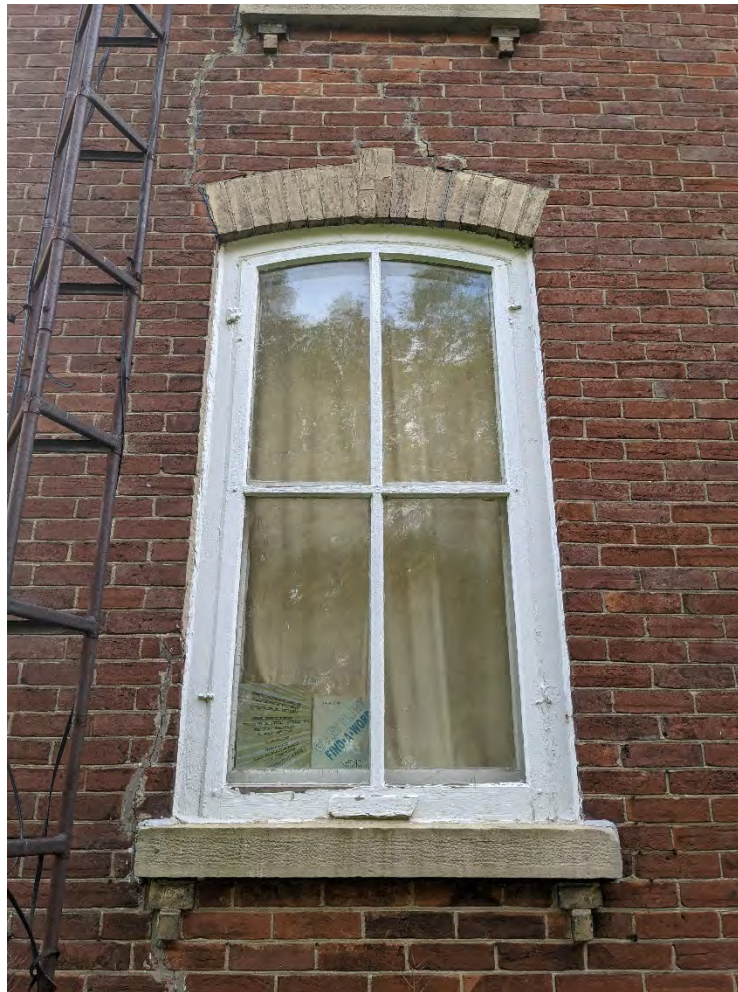
Figure 87: Evidence of cracks radiating around the first and second level windows on the north facade.

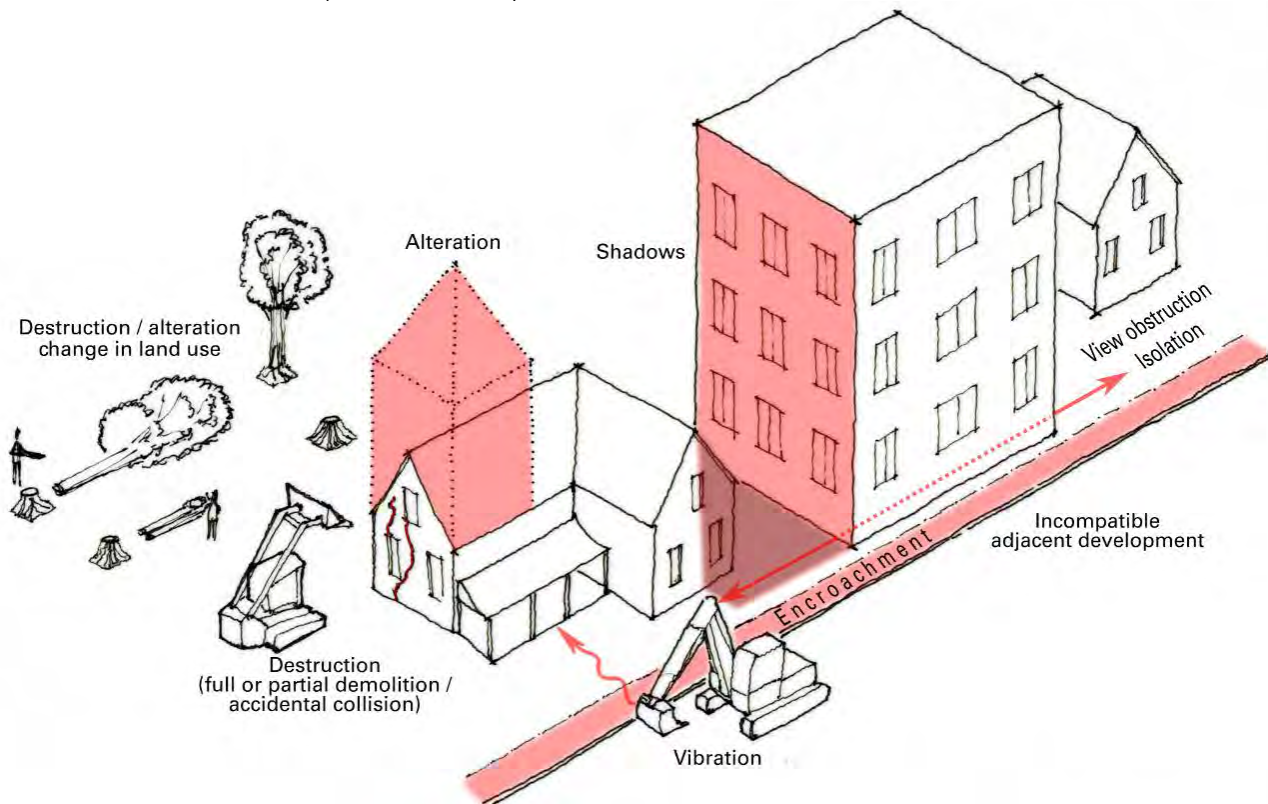
Figure 88: Examples of negative impacts.
