Re: Erin Heights Golf Course - Erin - Arborist Report and TPP

Arborist Report
&
Tree Protection Plan

Erin Heights Golf Course
Erin, ON

Appendix I: Tree Protection Plan – TPP-1 & Grading Plan

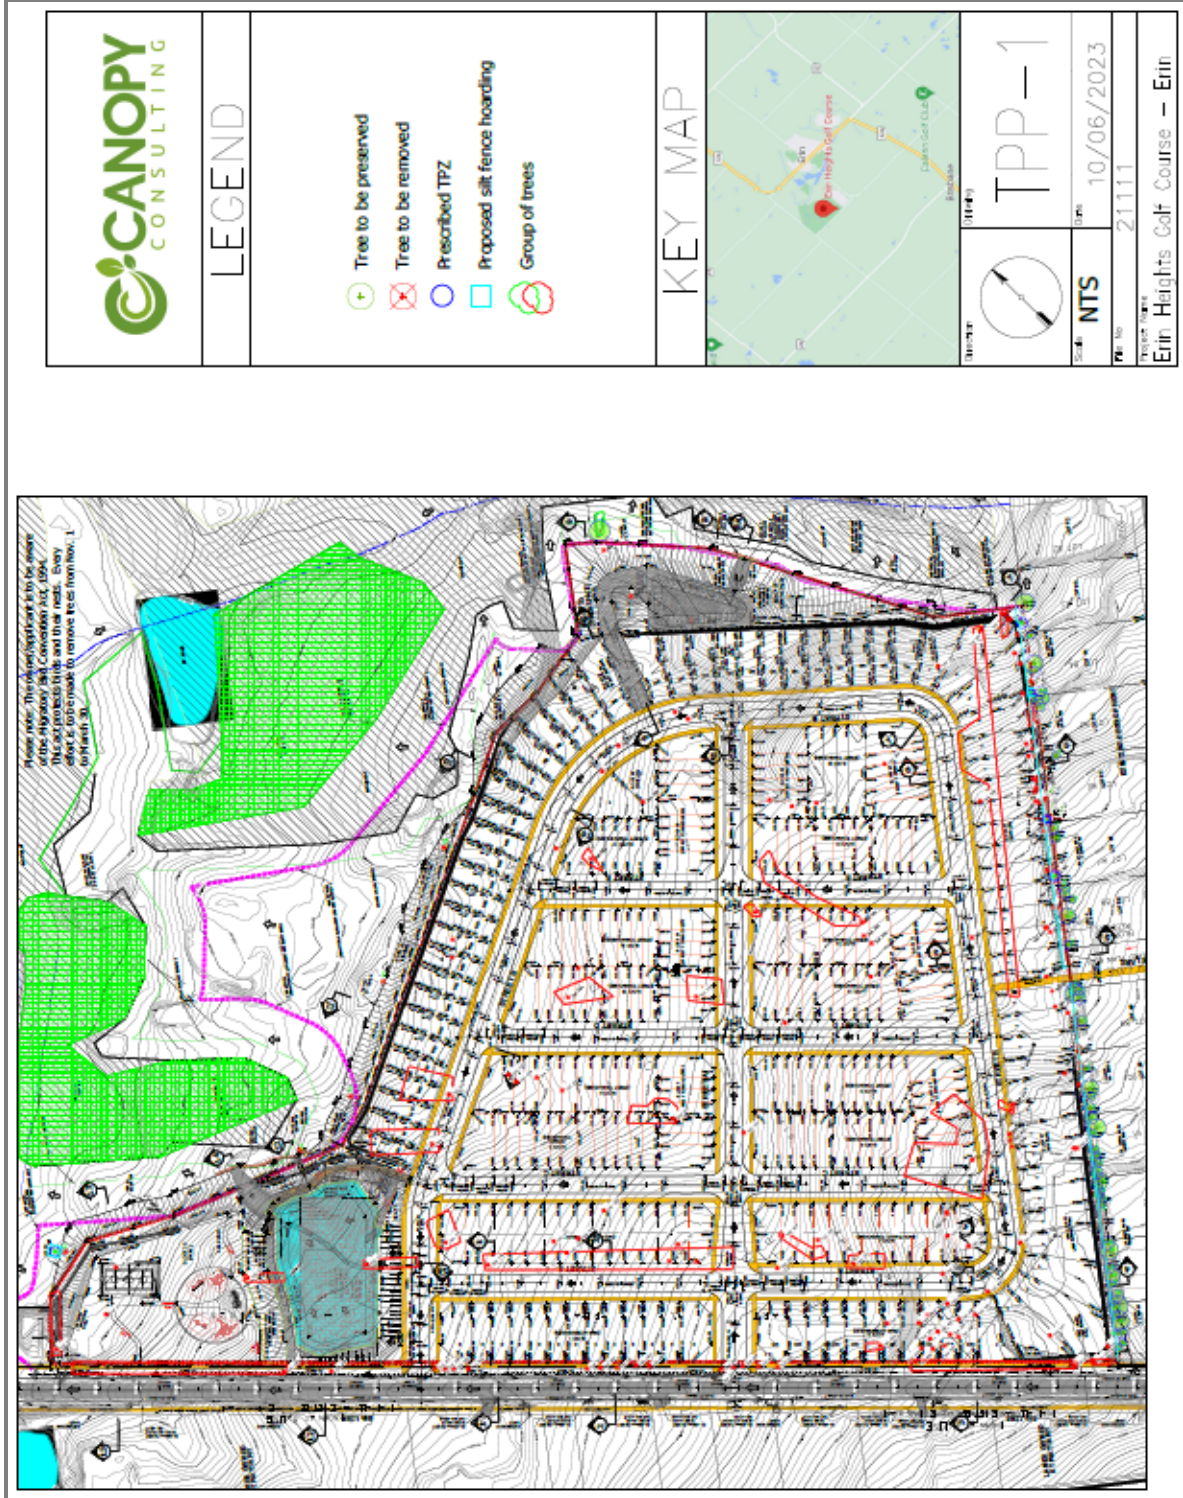
3. Trees no. N1, N3, N5-N9, N11-N15, N18-N23, N25, N27-N30, N33 and N39. are encroached upon by the proposed grading and retaining wall. Such an encroachment is located outside the critical root zone on the outer edge of the TPZ. Roots disturbed in this area are likely to be 2-5cm in diameter. It is recommended a qualified arborist be on site to supervise excavation/grading within the TPZ, root prune as required and to provide any other remedial actions deemed necessary. This disturbance is minor and should have a minimal effect on the trees current conditions. Authorization from the Town and the corresponding neighbor is required prior to the injury of twenty-five trees.

- 1.1 Install hoarding as per attached Tree Protection Plan in Appendix I.
- 1.2 Hoarding shall consist of single heavy duty silt fence, which will be maintained for the duration of the project.

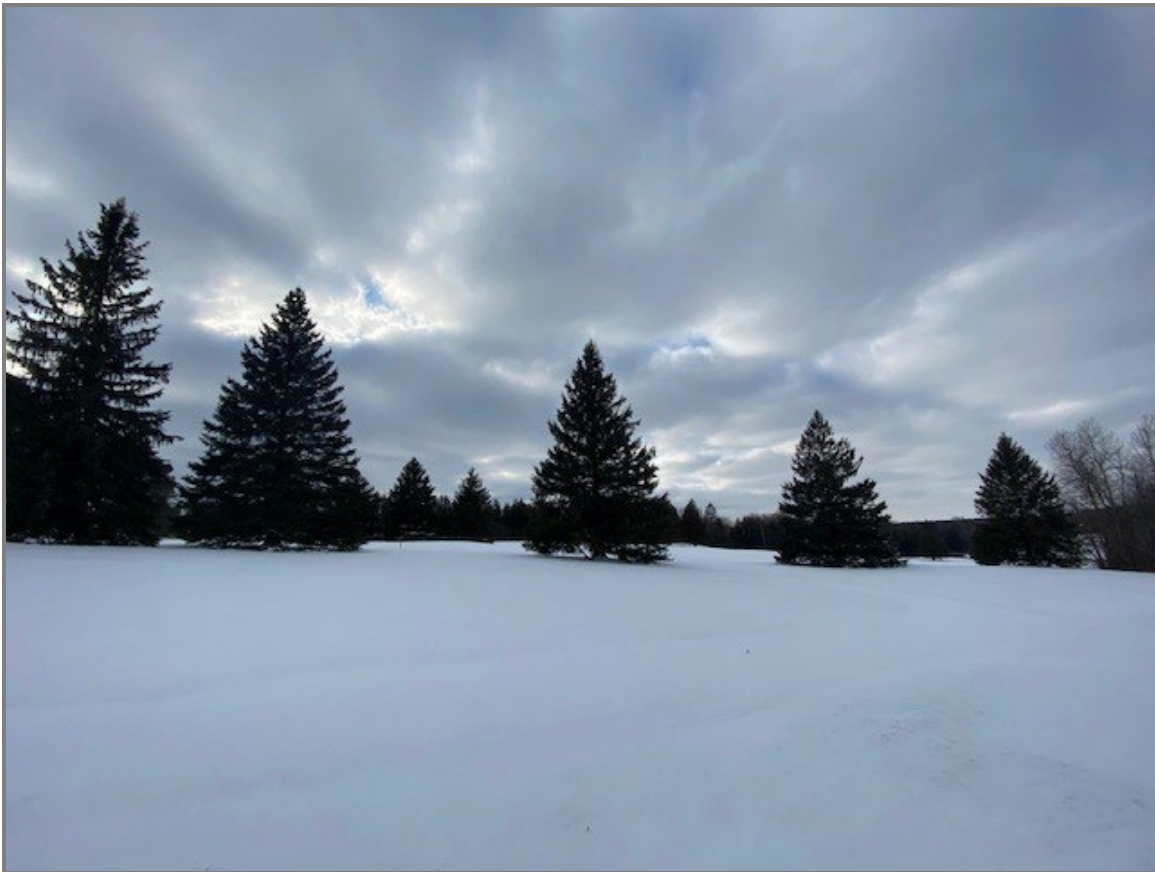
Photo #2: Trees no. 335 looking west.

335	Eastern White Cedar <i>Thuja occidentalis</i> (5)	32-45	F	1	- in decline, discoloured - in conflict with proposed grading	R	
336	Willow <i>Salix spp.</i> (stump)		F	1	- trunk failure - in conflict with proposed grading	R
