**Updated Hydrogeological Assessment,
Water Balance Assessment and Source
Water Protection Analysis, Erin Fairways
Subdivision, 5525 Eighth
Line, Town of Erin,
Ontario**

EC (Erin) GP Inc., 125 Villarboit Crescent Vaughan, ON L4K 4K2

**Terra-Dynamics Consulting Inc.
432 Niagara Street, Unit 2
St. Catharines, ON L2M 4W3
(905) 646-7931**

September 19, 2023

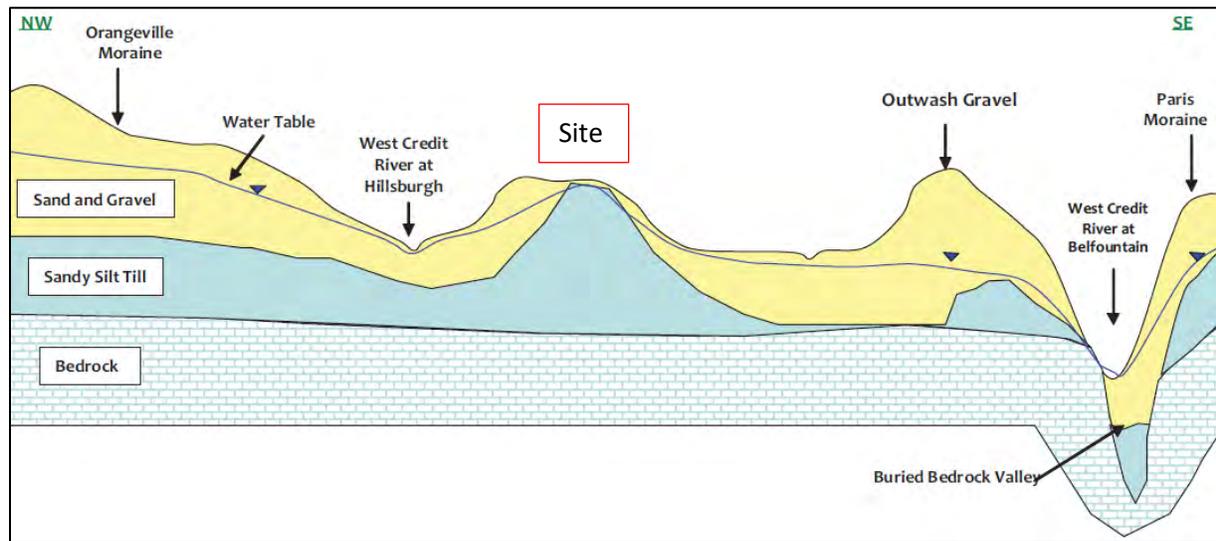
Figure 4 – Hillsburgh and Erin Schematic Cross-Section (Credit Valley et al, 2011)

A local hydrogeologic cross-section summarizes the Site setting, with the overburden thickness above bedrock decreasing from 40 m to less than 10 m towards the northwest and the West Credit River (Figure 3). This cross-section for the Site matches the general conceptual model in the area of (i) sand and gravel, underlain by (ii) sandy silt (*to silty sand*) till, underlain by (iii) the bedrock aquifer as shown below in Figure 4 (Credit Valley et al, 2011).

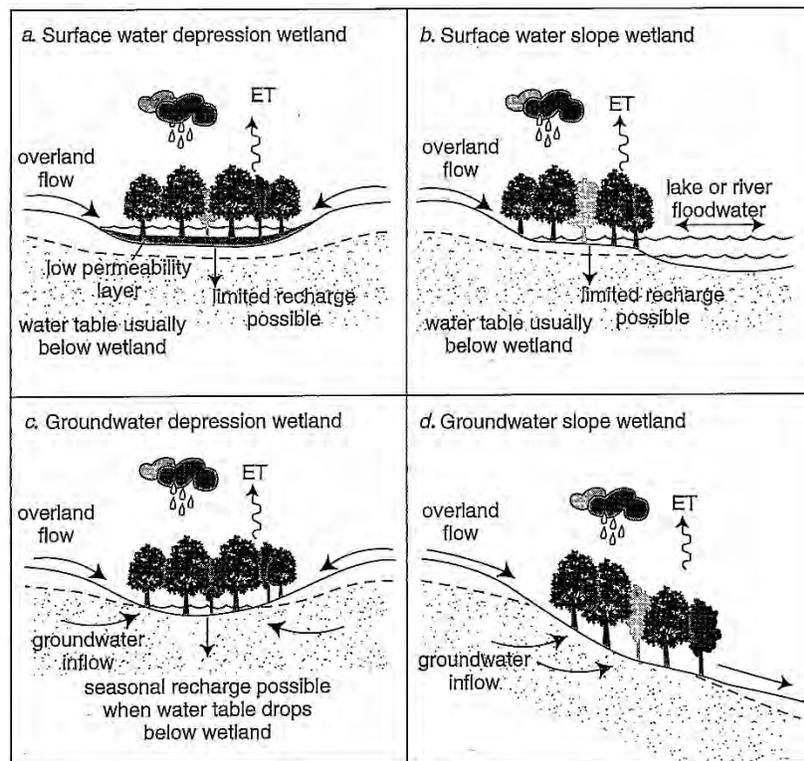
Figure 6 – Groundwater flow patterns for wetlands (Mitsch and Gosselink, 2007)

The wetlands are a combination of three types, as visualized below in Figure 6: (ID (a)) surface water depression, (ID (c)) groundwater depression and (ID (d)) groundwater slope wetlands as reported by Mitsch and Gosselink (2007). The relevant portions of the definitions of these groundwater flow schematics are also presented below. This combination model is proposed as (i) the wetlands are underlain by a low permeability layer allowing some perched to mounded conditions, (ii) the ground surface gently slopes, (iii) at the SWM4-1 cedar swamp the water table is below ground surface under recharge conditions and at the SWM3-2 poplar swamp the water table is usually below ground surface but groundwater discharge can occur and (iv) a shallow depth to groundwater allows for root uptake of groundwater (McBean, Rovers and Farquhar, 1995).

Groundwater depression wetlands (ID (c)): “...groundwater discharge wetlands...in a depression low enough to intercept the local groundwater table... can occur in coarse-textured glaciofluvial deposits...Water-level fluctuations...less dramatic than... surface flow....because of the relative stability of the groundwater levels”

Groundwater slope wetlands (ID (d)): “Wetlands often develop on slopes ...Groundwater flow into these wetlands can be ...seasonal...”

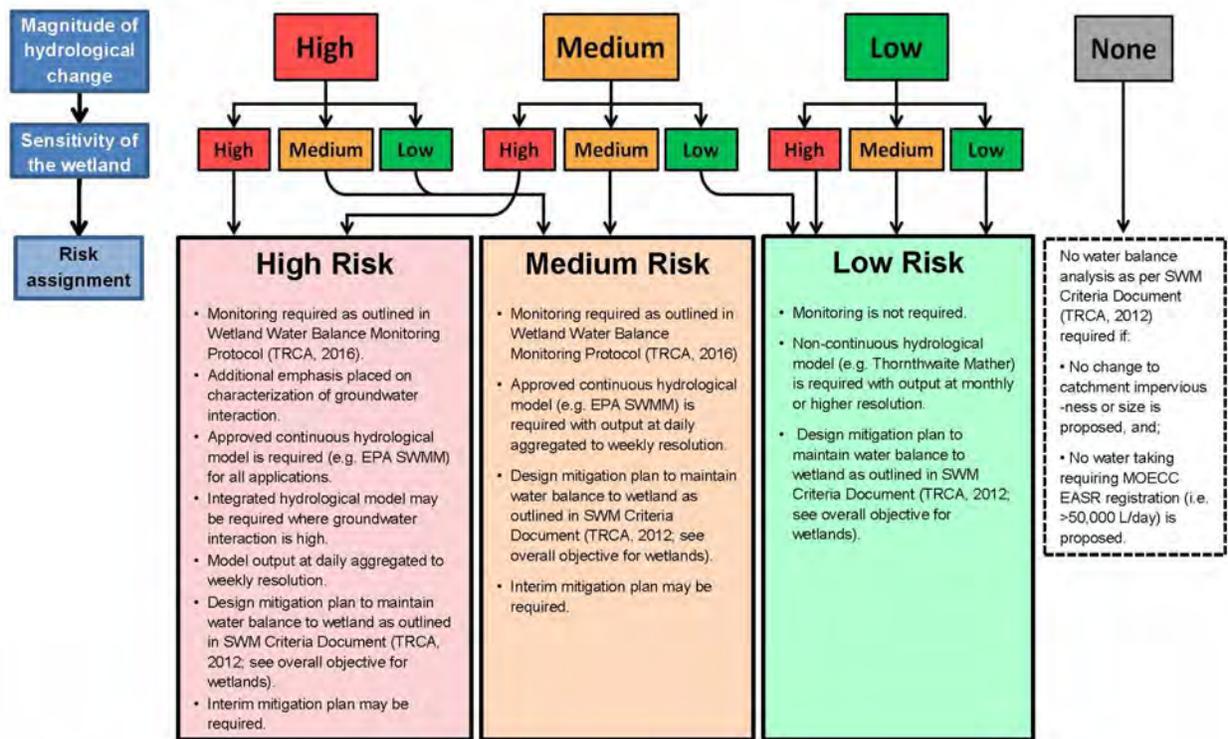
Figure 6 - Wetland Risk Evaluation Decision Tree

- (iv) Additional emphasis placed on characterization of groundwater interaction [High Risk only, i.e. Wetland 4a]
 - Additional monitoring was implemented adding water level dataloggers to monitoring wells located up- and down-gradient of the wetland confirming an overall downwards vertical gradient at the Cedar wetland, with no groundwater discharge observed at the wetland monitoring stations Wet-2/GW-2.

- (v) Integrated hydrological model may be required where groundwater interaction is high [High Risk only, i.e. Wetland 4a]
 - Groundwater interaction is not considered high at the Cedar wetland and was under recharge conditions during the two years of monitoring which included both dry and wet precipitation periods. However, it is acknowledged that shallow groundwater levels were measured within a metre of surface. The existing CVC FEFlow model (AquaResource Inc., 2009) could be used if required, however it is unclear of the benefit of doing so as the conceptual model appears well understood and appropriate mitigation have been designed.

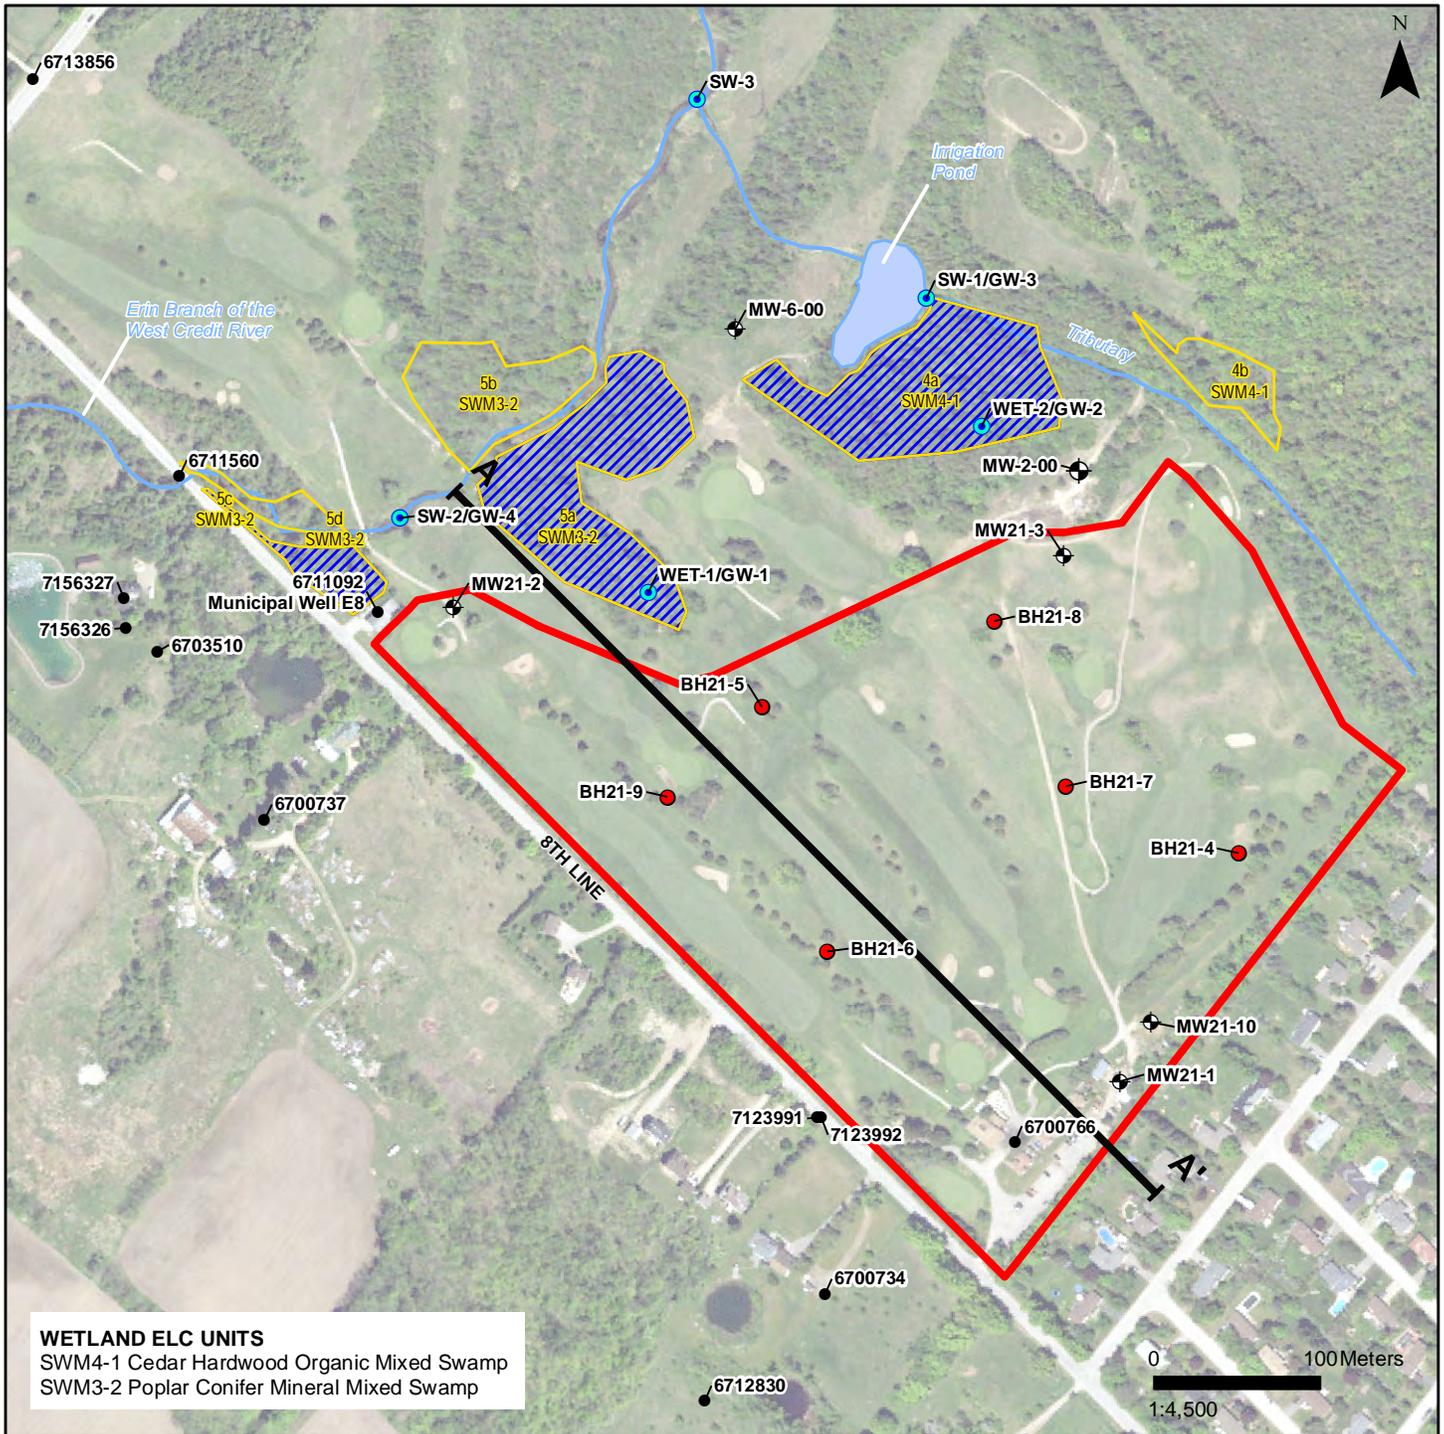
Figure 2

WETLAND ELC UNITS
 SWM4-1 Cedar Hardwood Organic Mixed Swamp
 SWM3-2 Poplar Conifer Mineral Mixed Swamp

All calculated potential infiltration rates were greater than 7.6 mm/hour as expected for hydrologic soil group A (USDA, 1986), and none were less than 15 mm/hour, i.e. all suitable for recharge measures, with the highest rates in the central portion of the Site at boreholes BH21-3, BH21-6, BH21-7 and BH21-8 (Table 1, Figure 2) which consists of silty sand fill, sand or sand and gravel at surface.

It is also noted that there is an existing Irrigation Pond adjacent/downgradient of the cedar hardwood organic mixed swamp SWM4-1 (Figure 2). This pond may not be in operation following residential development of the Site. Consequently, this would benefit wetland hydrology, as the Irrigation Pond would not be drawn down for irrigation purposes during the growing season.

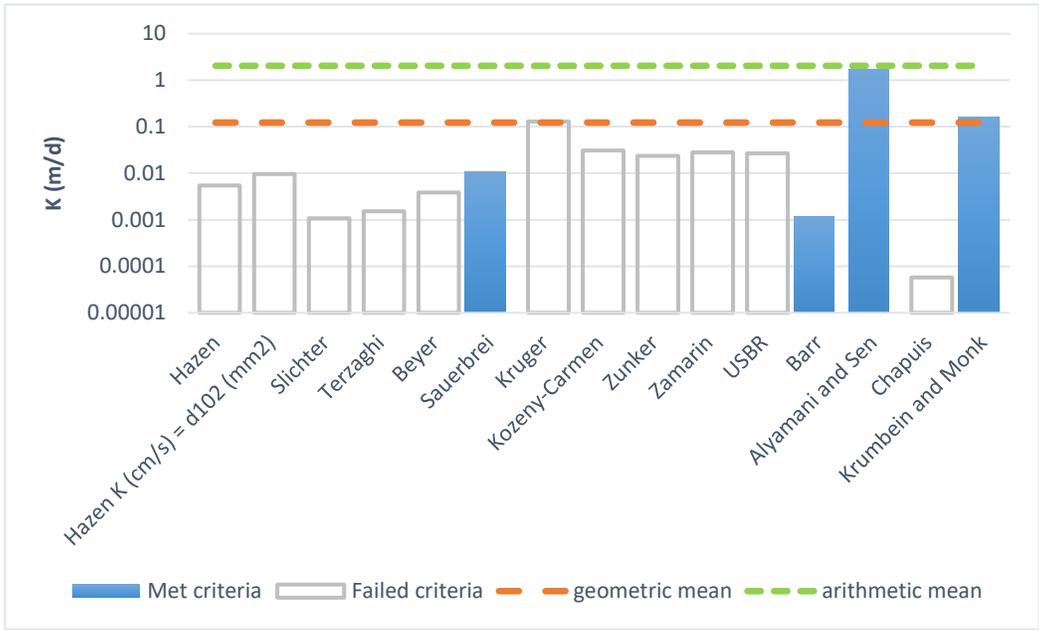
Poorly sorted gravelly sand with fines

Estimation of Hydraulic Conductivity	cm/s	m/s	m/d	de
Hazen	.631E-05	.631E-07	0.01	
Hazen K (cm/s) = d ₁₀ (mm)	.111E-04	.111E-06	0.01	
Slichter	.124E-05	.124E-07	0.00	
Terzaghi	.177E-05	.177E-07	0.00	
Beyer	.444E-05	.444E-07	0.00	
Sauerbrei	.123E-04	.123E-06	0.01	
Kruger	.150E-03	.150E-05	0.13	
Kozeny-Carmen	.356E-04	.356E-06	0.03	
Zunker	.273E-04	.273E-06	0.02	
Zamarin	.324E-04	.324E-06	0.03	
USBR	.311E-04	.311E-06	0.03	
Barr	.133E-05	.133E-07	0.00	
Alyamani and Sen	.196E-02	.196E-04	1.70	
Chapuis	.661E-07	.661E-09	0.00	
Krumbein and Monk	.187E-03	.187E-05	0.16	
Shepherd	.965E-02	.965E-04	8.33	
geometric mean meeting criteria	5.E-05	5.E-07	4.E-02	
arithmetic mean meeting criteria	5.E-04	5.E-06	5.E-01

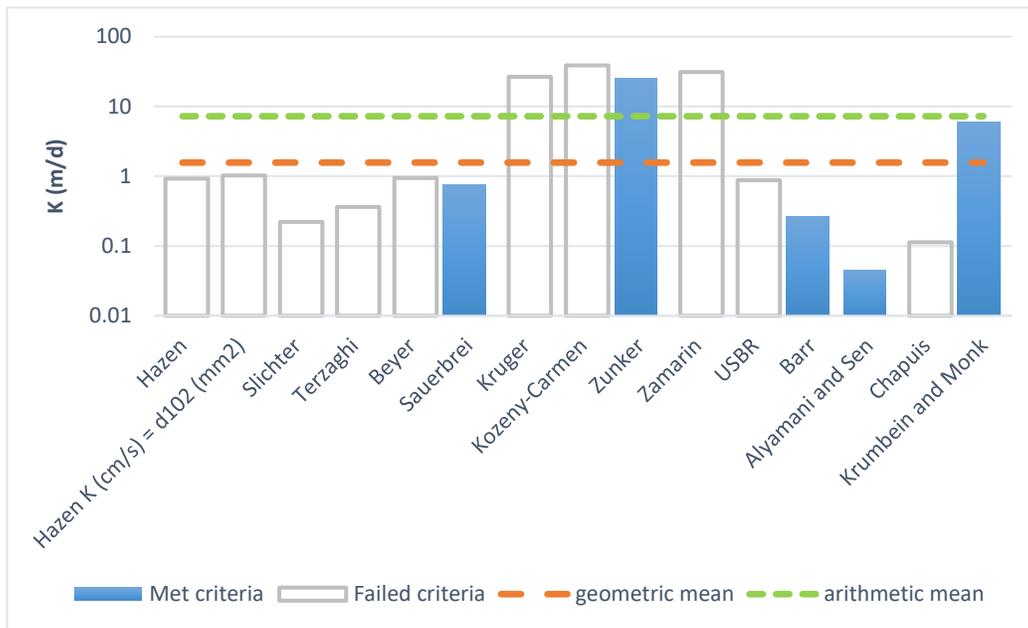
Poorly sorted gravelly sand low in fines

Estimation of Hydraulic Conductivity	cm/s	m/s	m/d	de
Hazen	.107E-02	.107E-04	0.93	
Hazen K (cm/s) = d ₁₀ (mm)	.118E-02	.118E-04	1.02	
Slichter	.256E-03	.256E-05	0.22	
Terzaghi	.420E-03	.420E-05	0.36	
Beyer	.110E-02	.110E-04	0.95	
Sauerbrei	.862E-03	.862E-05	0.75	
Kruger	.308E-01	.308E-03	26.58	
Kozeny-Carmen	.452E-01	.452E-03	39.06	
Zunker	.292E-01	.292E-03	25.26	
Zamarin	.359E-01	.359E-03	31.01	
USBR	.101E-02	.101E-04	0.87	
Barr	.304E-03	.304E-05	0.26	
Alyamani and Sen	.518E-04	.518E-06	0.04	
Chapuis	.131E-03	.131E-05	0.11	
Krumbein and Monk	.701E-02	.701E-04	6.06	
Shepherd	.129E-01	.129E-03	11.17	
geometric mean meeting criteria	1.E-03	1.E-05	1.E+00	
arithmetic mean meeting criteria	7.E-03	7.E-05	6.E+00

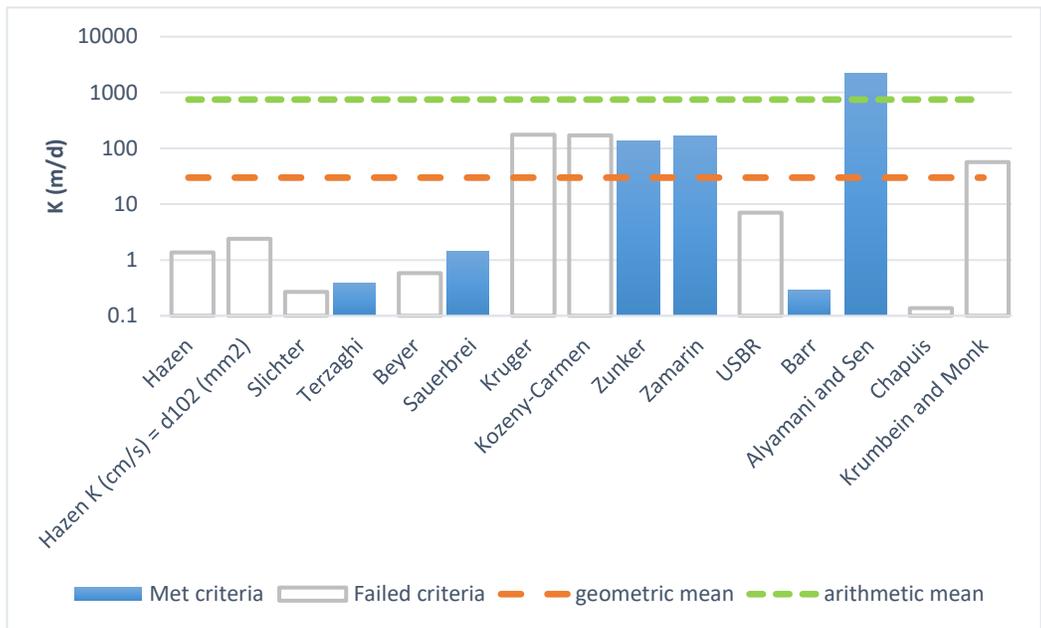
Poorly sorted sandy gravel low in fines

Estimation of Hydraulic Conductivity	cm/s	m/s	m/d	de
Hazen	.158E-02	.158E-04	1.36	
Hazen K (cm/s) = d ₁₀ (mm)	.279E-02	.279E-04	2.41	
Slichter	.310E-03	.310E-05	0.27	
Terzaghi	.443E-03	.443E-05	0.38	
Beyer	.668E-03	.668E-05	0.58	
Sauerbrei	.165E-02	.165E-04	1.43	
Kruger	.202E+00	.202E-02	174.39	
Kozeny-Carmen	.199E+00	.199E-02	171.65	
Zunker	.157E+00	.157E-02	135.72	
Zamarin	.193E+00	.193E-02	166.38	
USBR	.819E-02	.819E-04	7.08	
Barr	.333E-03	.333E-05	0.29	
Alyamani and Sen	.251E+01	.251E-01	2169.34	
Chapuis	.158E-03	.158E-05	0.14	
Krumbein and Monk	.652E-01	.652E-03	56.36	
Shepherd	.320E+01	.320E-01	2767.67	
geometric mean meeting criteria	2.E-02	2.E-04	1.E+01	
arithmetic mean meeting criteria	5.E-01	5.E-03	4.E+02
