**Hydrogeological Assessment - Langen
Property**

**Mattamy (Erin) Limited and
2779181 Ontario Inc.
Erin, Ontario**

**R.J. Burnside & Associates Limited
292 Speedvale Avenue West Unit 20
Guelph ON N1H 1C4 CANADA**

**June 2022
300052075.0002**

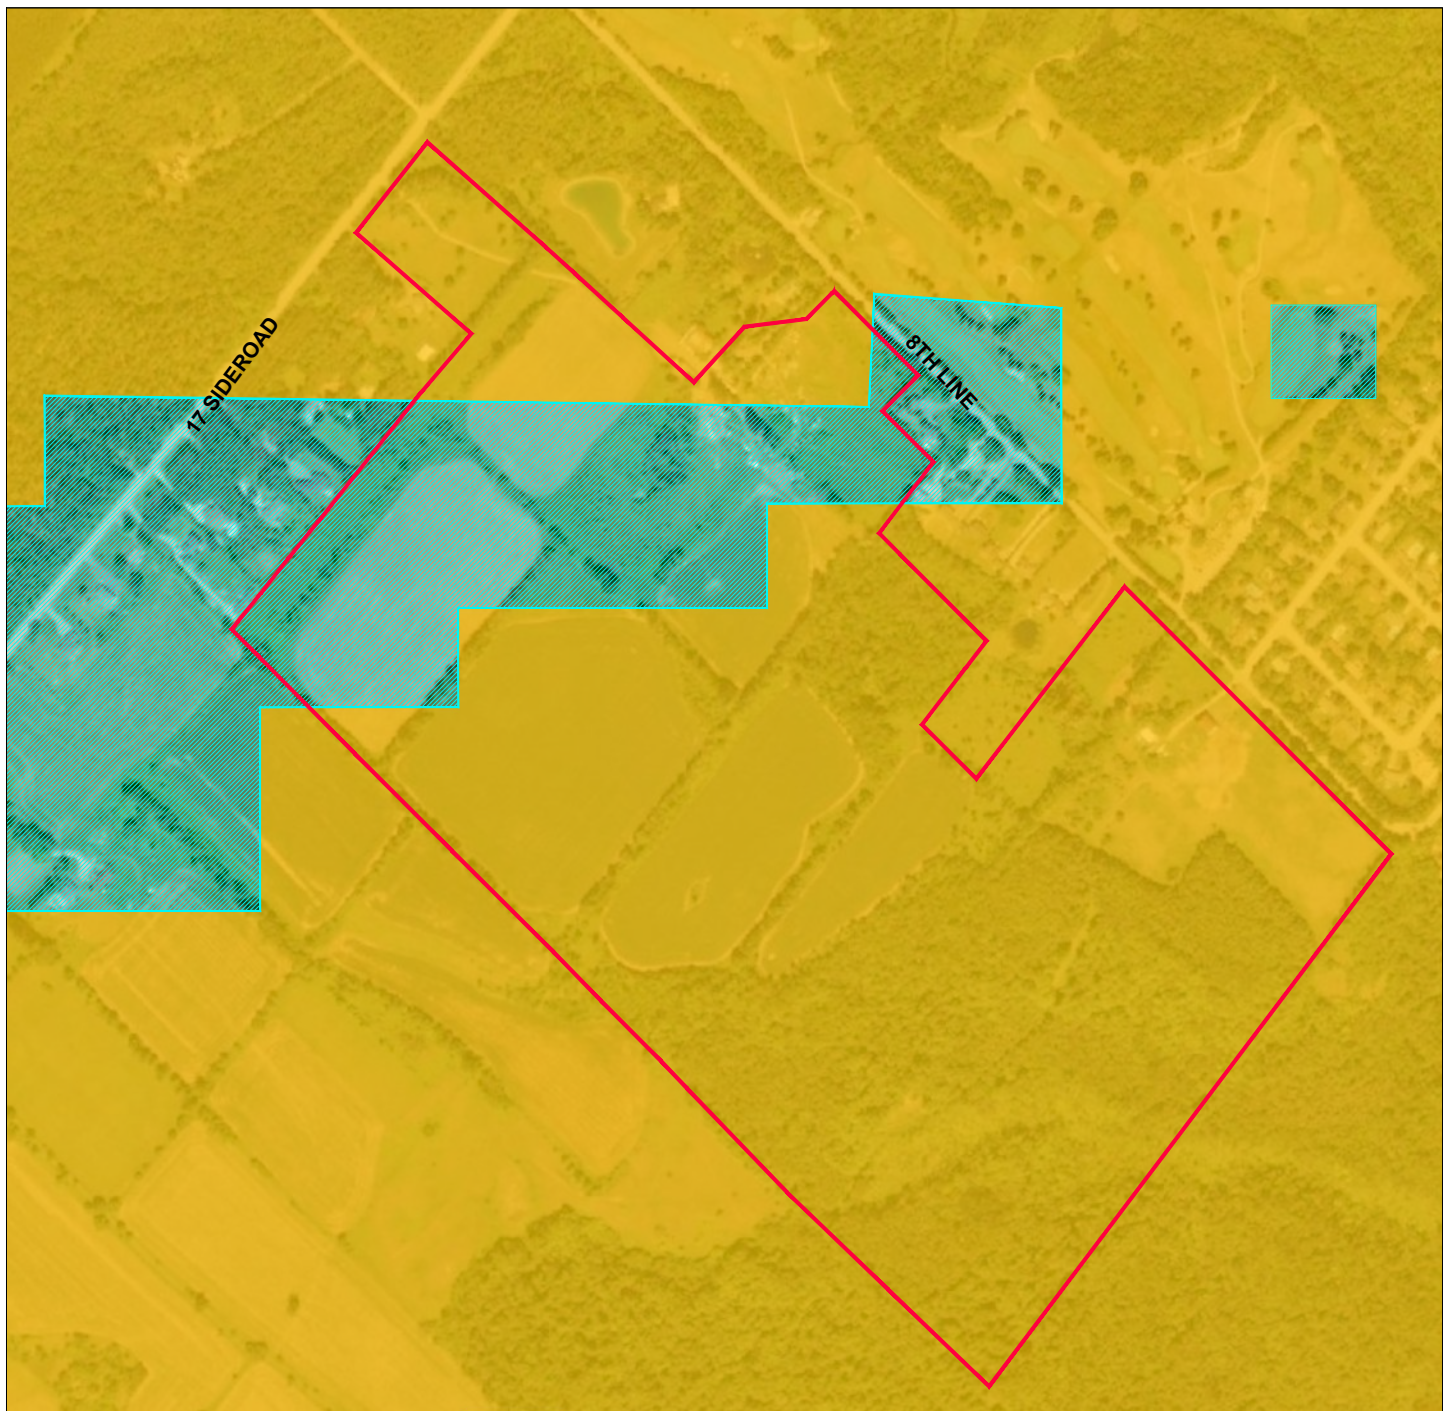
Drawn SK	Checked SC	Date OCTOBER 2023	Figure No.
Scale 1:6,000	Project No. 300052075	13

Figure Title **WELL HEAD PROTECTION AREAS**

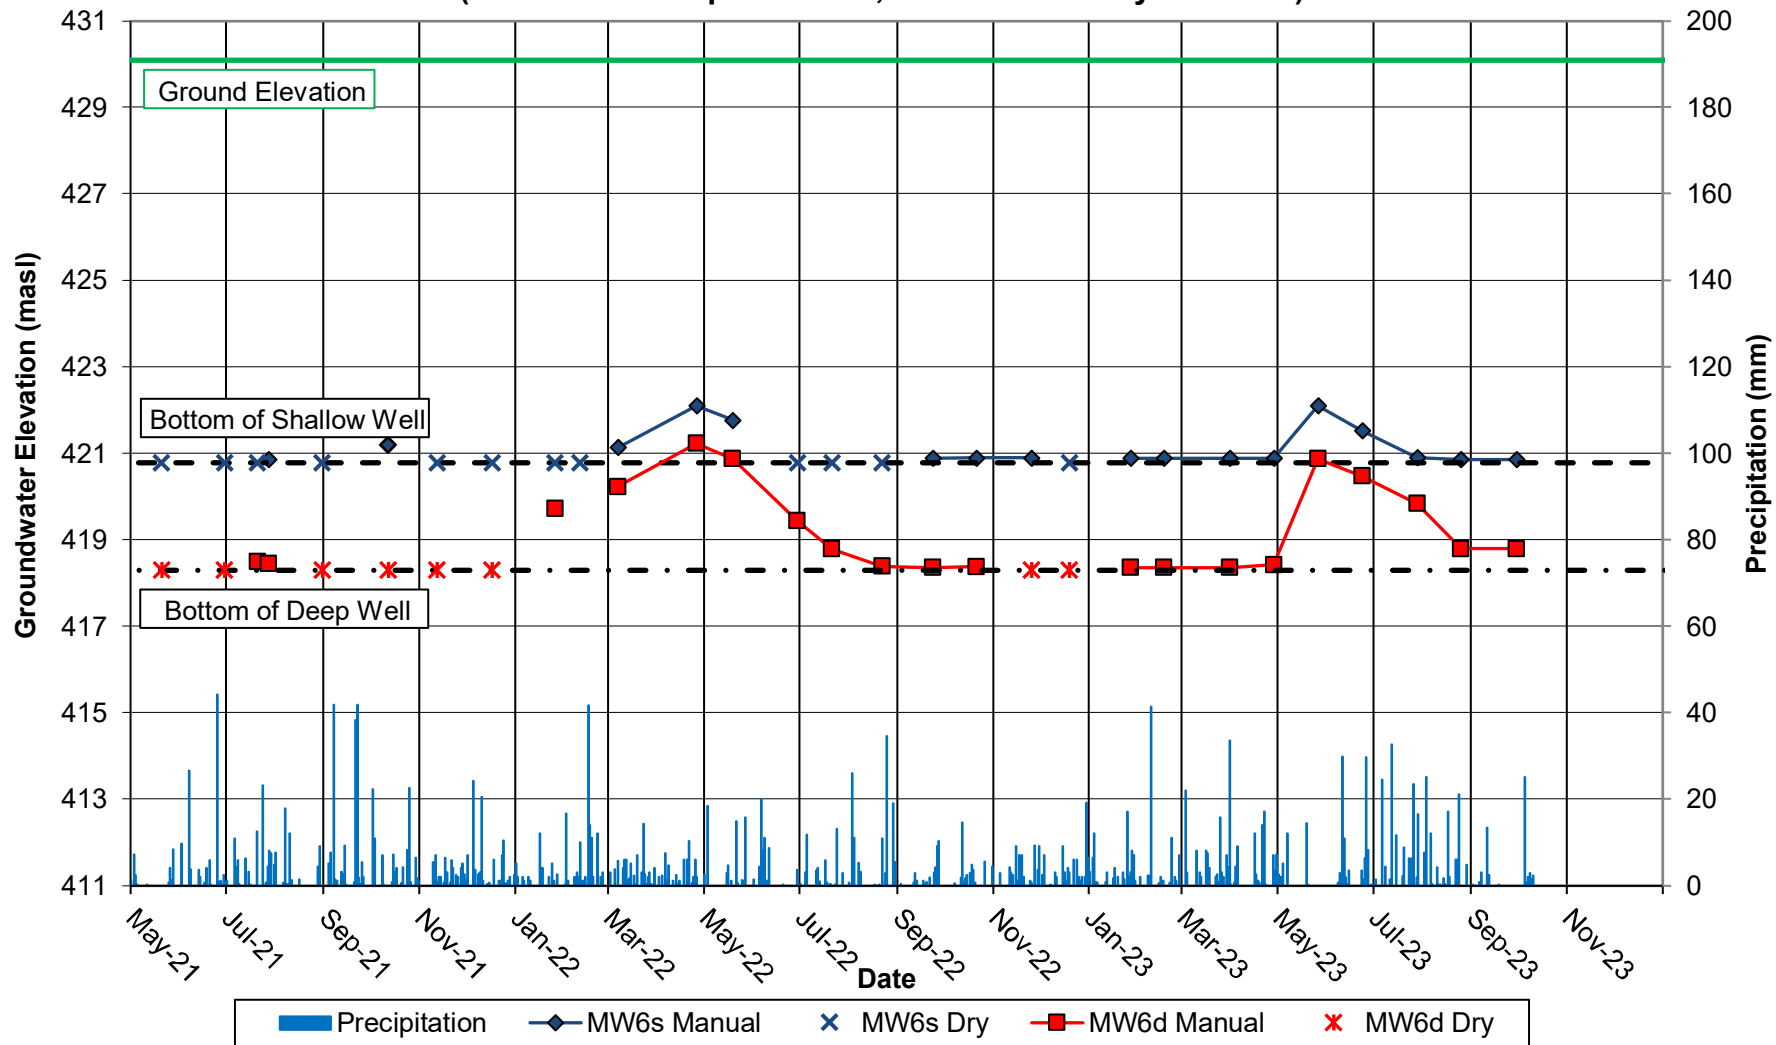
MW6s/d
Groundwater Elevations
(MW6s - Well Depth: 9.3 m, Screened in Silty Sand Till)
(MW6d - Well Depth: 12.0 m, Screened in Silty Sand Till)

- Nested monitoring wells MW1s/d and MW6s/d were installed to determine vertical hydraulic gradients and evaluate the recharge or discharge conditions on the subject lands. There was small upward gradient observed at monitoring well nest MW1s/d with water levels in the deep well being slightly higher than the shallow well MW1s, however the difference is too small to be considered significant (Figure D-1, Appendix D). At MW6s/d water levels in the deep well were lower than the shallow well when the wells were not dry indicating recharge conditions (Figure D-6).

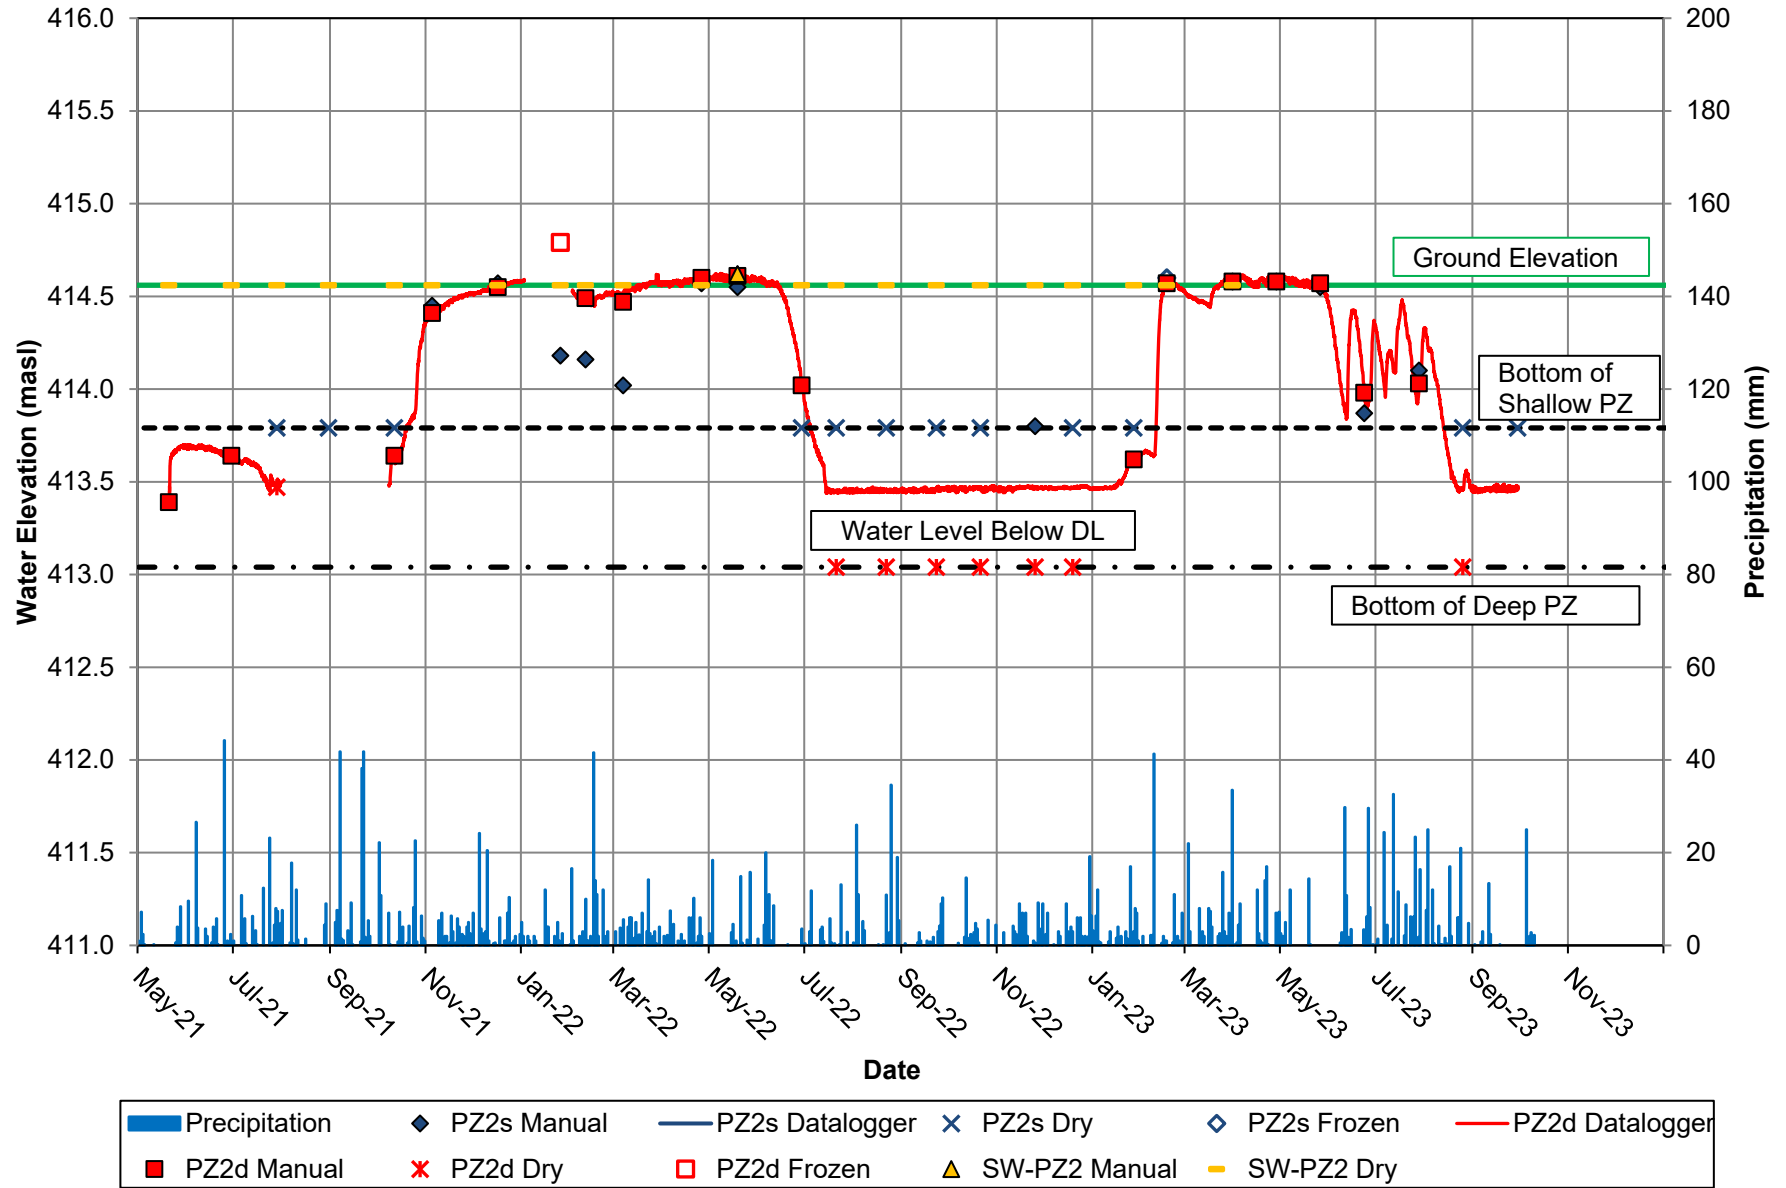
PZ2s/d Groundwater and Surface Water Elevations

- PZ2s/d is located within the West Credit River wetland complex on the east side of the subject lands just north of a woodlot. Water levels at PZ2s were dry from July to October 2021 then ranged from ground surface to 0.54 m below ground between November 2021 and September 2023 (Figure D-11, Appendix D). Water levels at PZ2d ranged from 1.2 mbgs up to 0.01 m above grade. The gradients at PZ2sd appear to change seasonally with a downward gradient during the summer months and upward gradient in the winter and spring. Due to the established elevations compared to regional conditions it is interpreted that perched groundwater conditions exist in this area and support a local groundwater system around the wetland. Surface water was observed at PZ2s/d on only two occasions, April and May 2022. The wetland was dry at PZ2 the rest of the monitoring rounds (Table E-2, Appendix E).

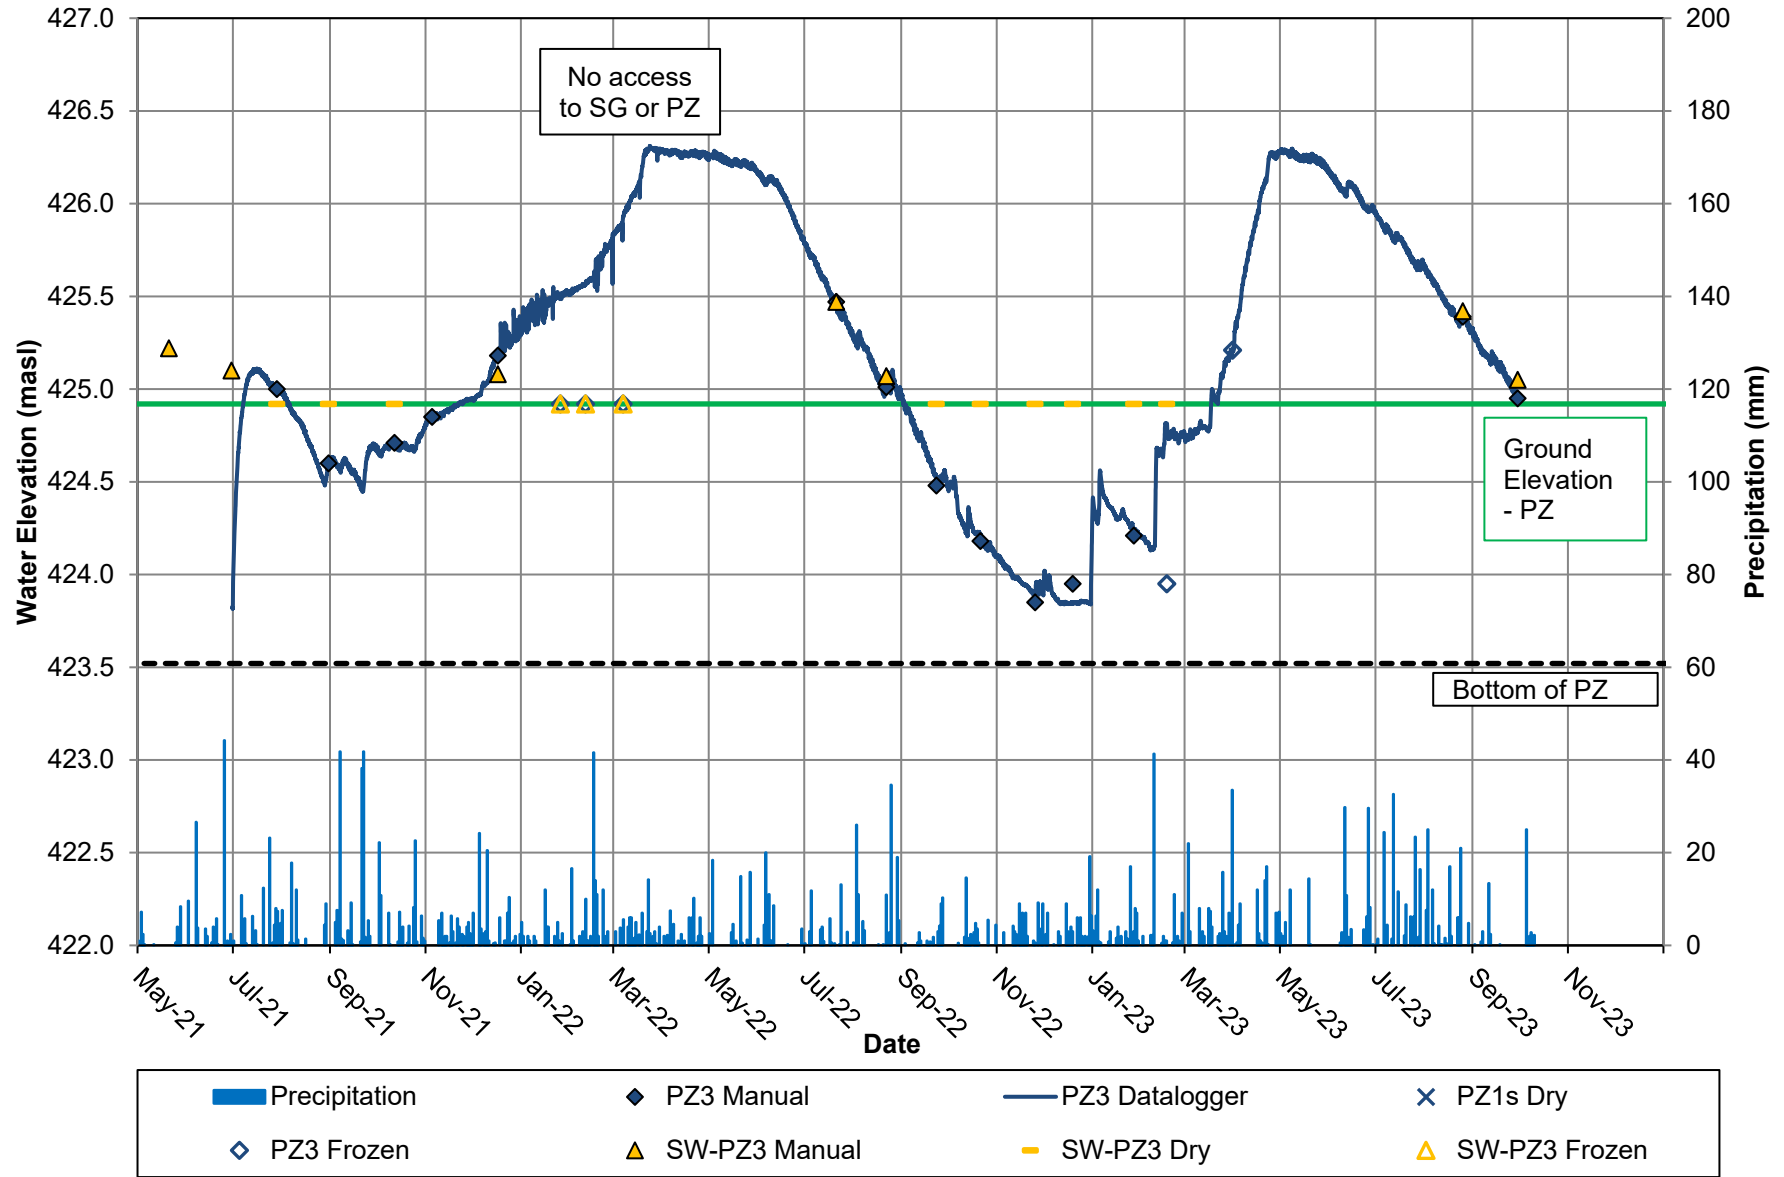
PZ3 Groundwater and Surface Water Elevations
