**STAGE 1 ARCHAEOLOGICAL ASSESSMENT  
ERIN WASTEWATER SERVICING  
PART OF LOTS 22- 25, CONCESSION 7,  
PART OF LOTS 23-26, CONCESSION 8,  
PART OF LOTS 11-18, CONCESSION 9,  
AND PART OF LOTS 12-17, CONCESSION 10  
(FORMER TOWNSHIP OF ERIN)  
TOWN OF ERIN  
COUNTY OF WELLINGTON, ONTARIO**

**ORIGINAL REPORT**

Archaeological Licence #P094 (Merritt)  
Ministry of Tourism, Culture and Sport PIF# P094-0233-2017  
ASI File: 16EA-007

15 December 2017

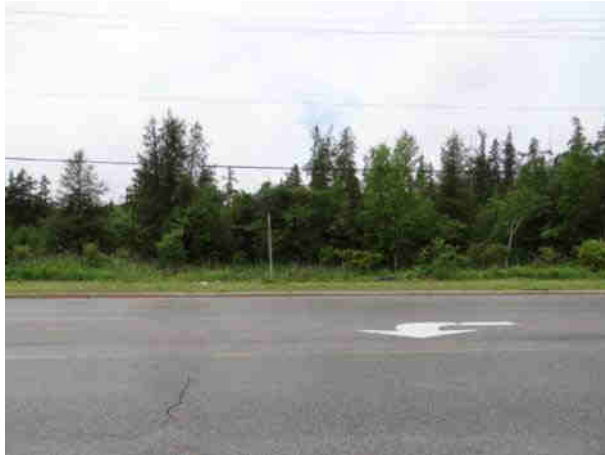
Plate 1: Southwest view of Hillsburgh SPS site; Area beyond disturbed road exhibits potential, requires Stage 2 test pit survey

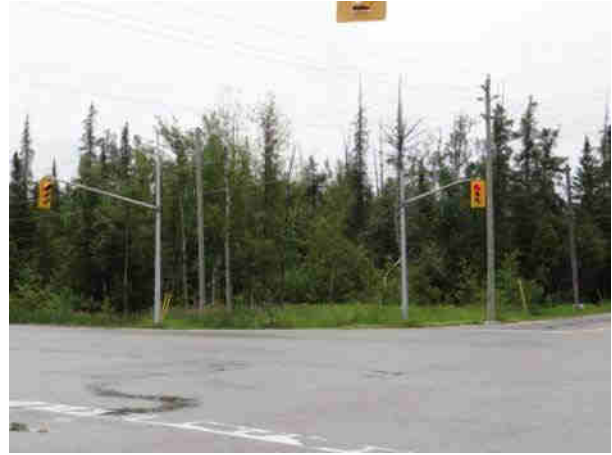
Plate 2: South view of Hillsburgh SPS site; Area beyond disturbed road exhibits potential, requires Stage 2 test pit survey

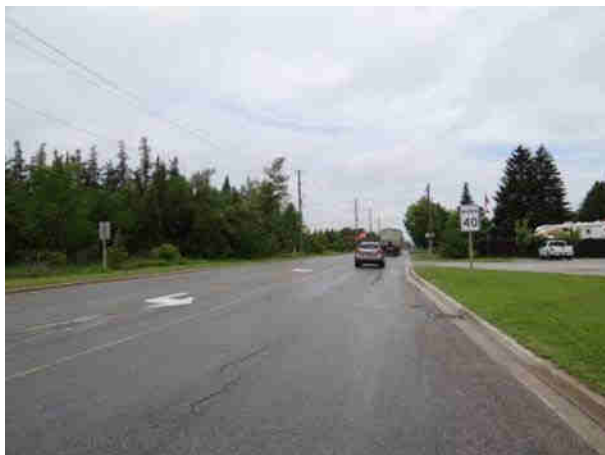
Plate 3: Northwest view of Main St, Hillsburgh; Proposed sewer route is within the disturbed ROW, no Stage 2 required

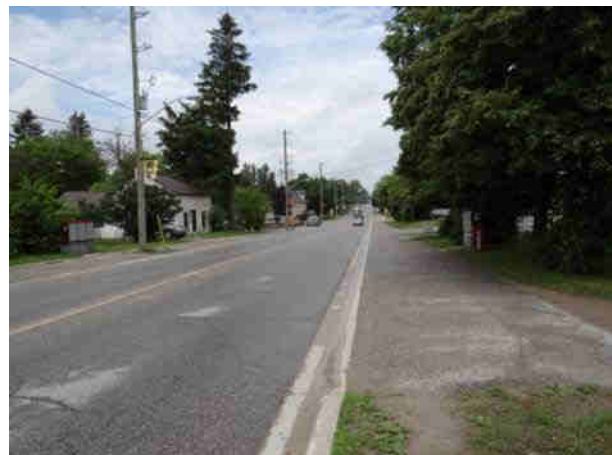
Plate 4: Northwest view of Main St, Hillsburgh; Proposed sewer route is within the disturbed ROW, no Stage 2 required

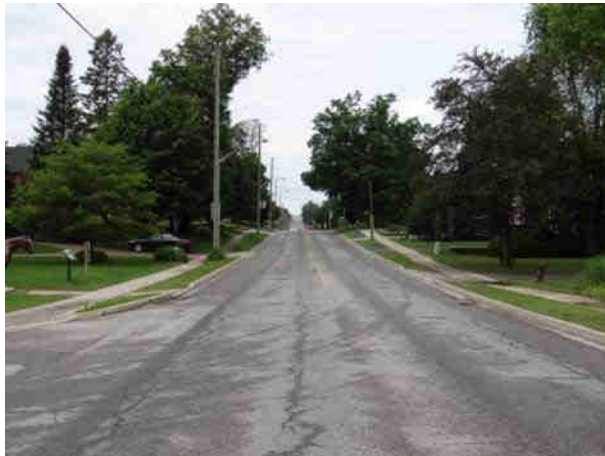
Plate 5: Northwest view of Main St, Hillsburgh; Proposed sewer route is within the disturbed ROW, no Stage 2 required

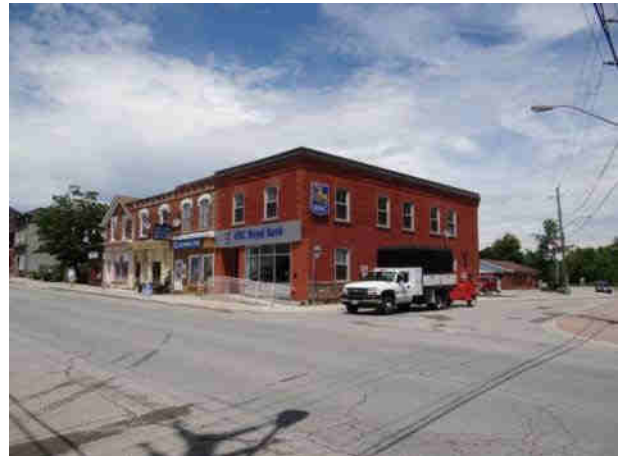
Plate 6: North view of Main St and Mill St, Hillsburgh; Proposed sewer route and forcemain are within the disturbed ROW, no Stage 2 required

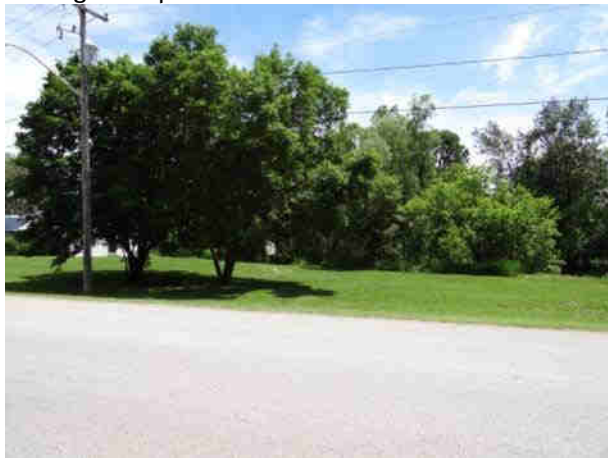
Plate 7: East view of Hillsburgh SPS site; Area beyond disturbed road exhibits potential, requires Stage 2 test pit survey

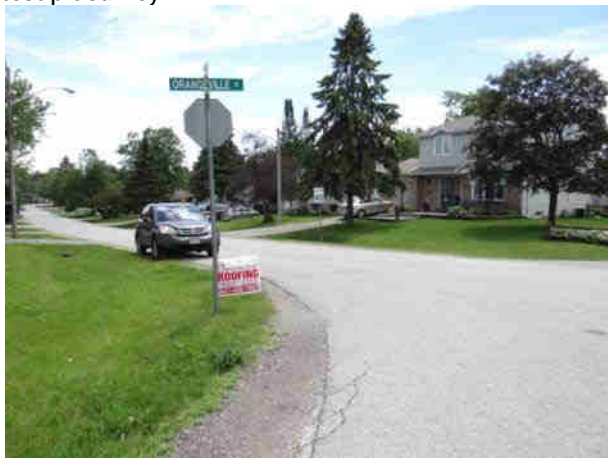
Plate 10: Southwest view of Orangeville St, Hillsburgh; Proposed sewer route is within the disturbed ROW, no Stage 2 required

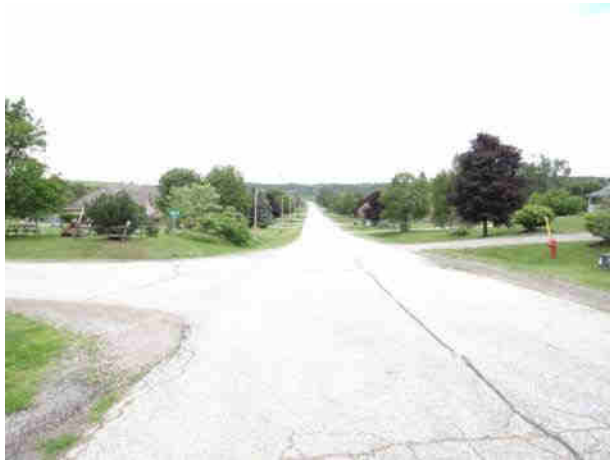
Plate 12: Northwest view of Main St, Hillsburgh; Proposed sewer route is within the disturbed ROW, no Stage 2 required

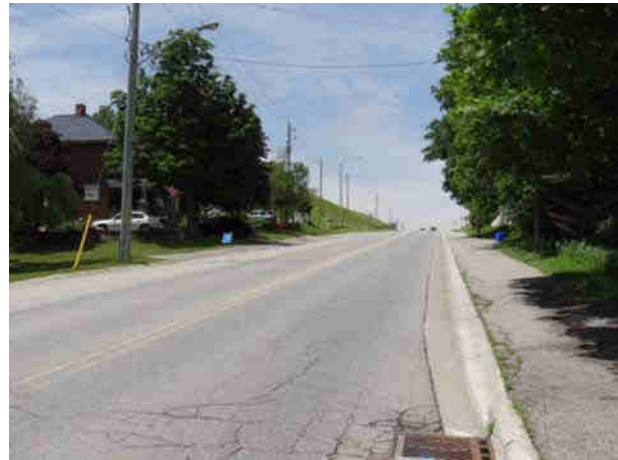
Plate 13: Southeast view of Erin Park Dr, Erin; Proposed sewer route is within the disturbed ROW, no Stage 2 required

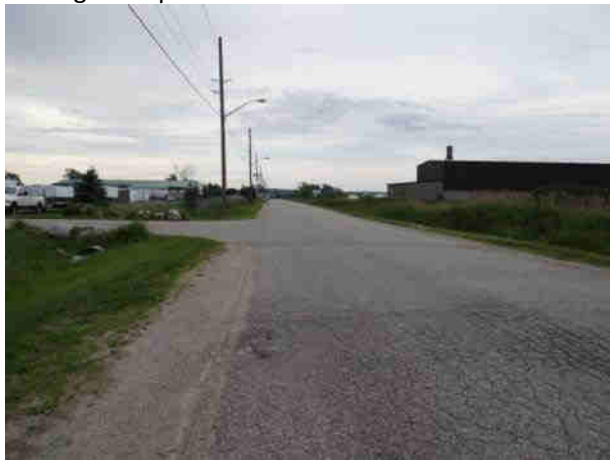
Plate 14: Northeast view of Erinville Dr, Erin; Proposed sewer route is within the disturbed ROW, no Stage 2 required

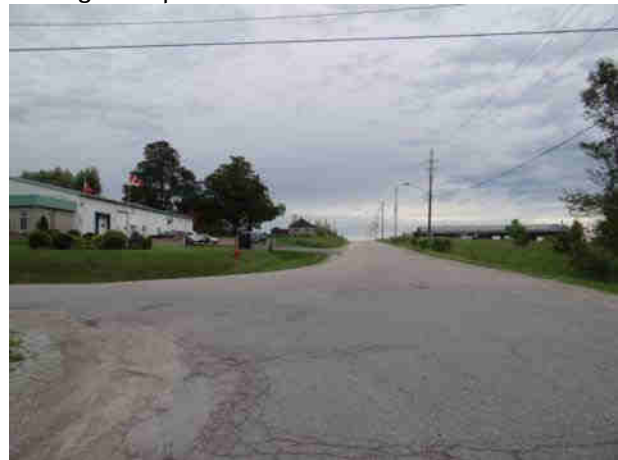
Plate 15: South view of Wellington 23 Rd, Erin; Proposed sewer route is within the disturbed ROW, no Stage 2 required

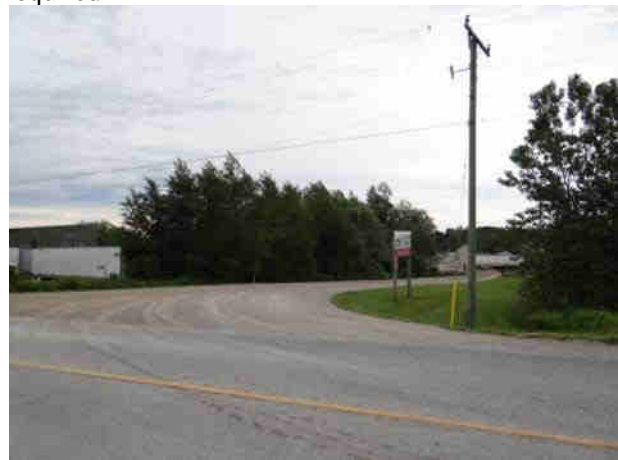
Plate 16: East view of SPS site #4, Erin; Area beyond the disturbed road exhibits potential, requires Stage 2 test pit survey

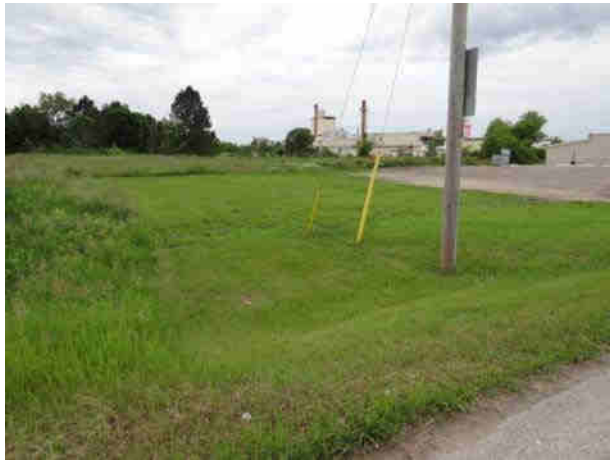
Plate 17: South view of SPS site #2, Erin; Area beyond the disturbed road exhibits potential, requires Stage test pit 2 survey

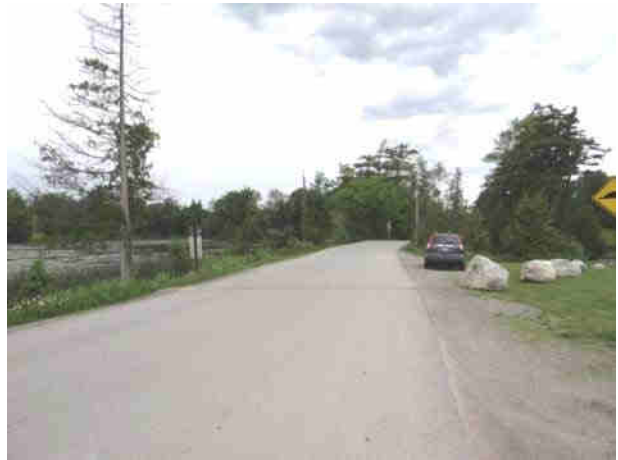
Plate 18: Northeast view of Overland Dr, Erin; Proposed sewer route is within the disturbed road, no Stage 2 required

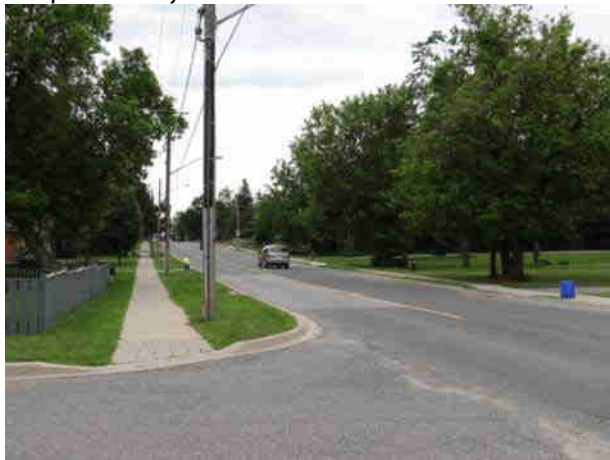
Plate 19: Southeast view of Main St, Erin; Proposed sewer route and forcemain are within the disturbed road, no Stage 2 required

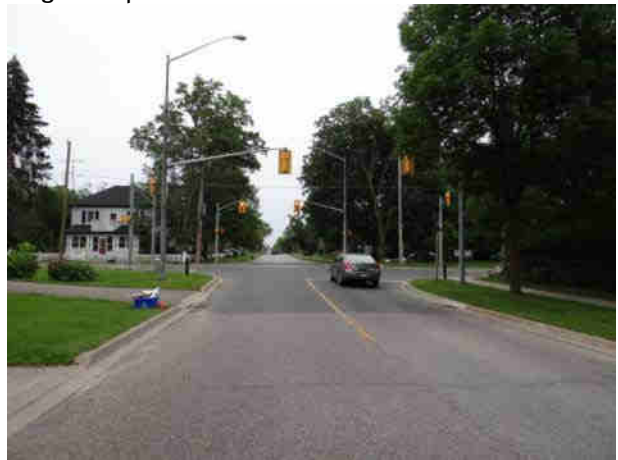
Plate 20: Northeast view of Dundas St W at Main St, Erin; Proposed sewer route and forcemain are within the disturbed road, no Stage 2 required

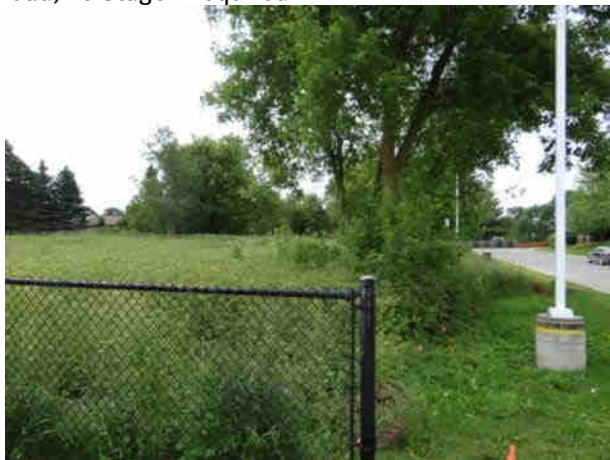
Plate 21: Southeast view of SPS site #5, northeast side of Boland Dr, Erin; Area exhibits potential, requires Stage 2 test pit survey

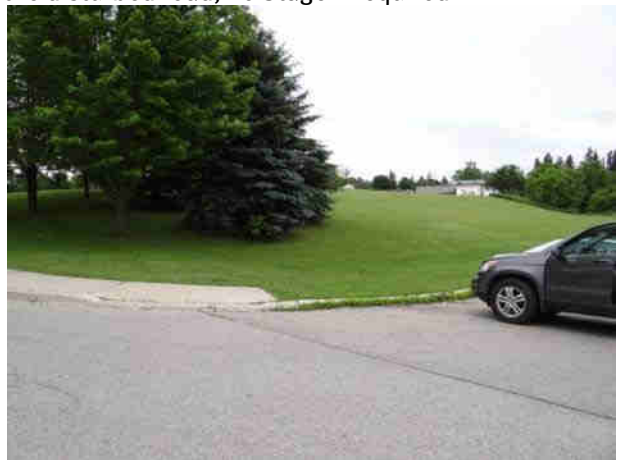
Plate 22: South view of SPS site #5, southwest side of Boland Dr, Erin; Area beyond disturbed parking lot exhibits potential, requires Stage 2 test pit survey

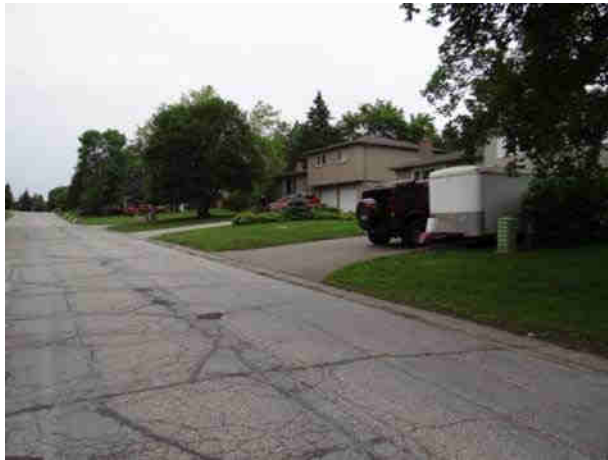
Plate 23: North view of SPS site #7, Erin; sewer route, and forcemain are within the disturbed road, if proposed SPS site #7 will impact the lawn, Stage 2 test pit survey is required

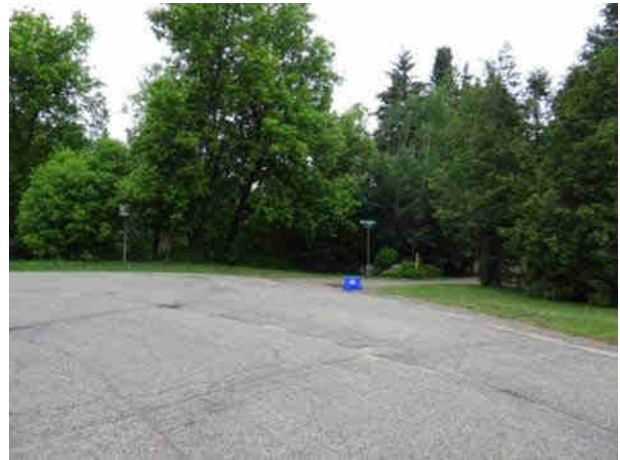
Plate 24: North view of SPS site #8, Erin; Area north of disturbed road exhibits potential, requires Stage 2 test pit survey

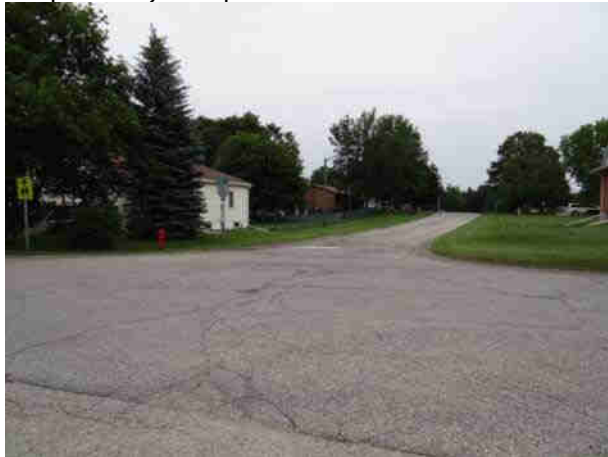
Plate 25: Northeast view of Scotch St at Daniel St, Erin; Proposed sewer route and forcemain are within the disturbed road, no Stage 2 required

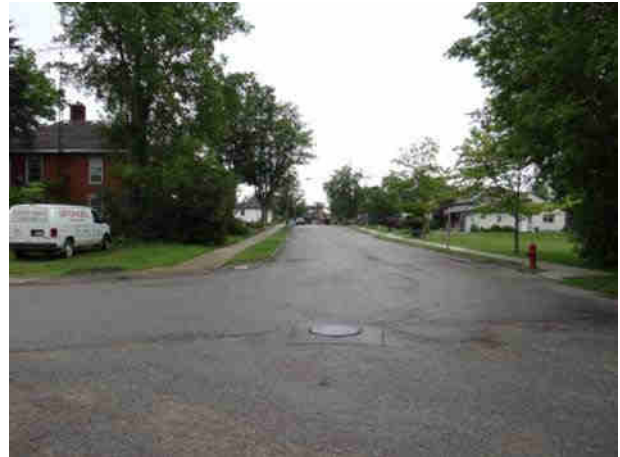
Plate 26: Northeast view of Church St and Church Blvd, Erin; Proposed sewer route is within the disturbed road, no Stage 2 required

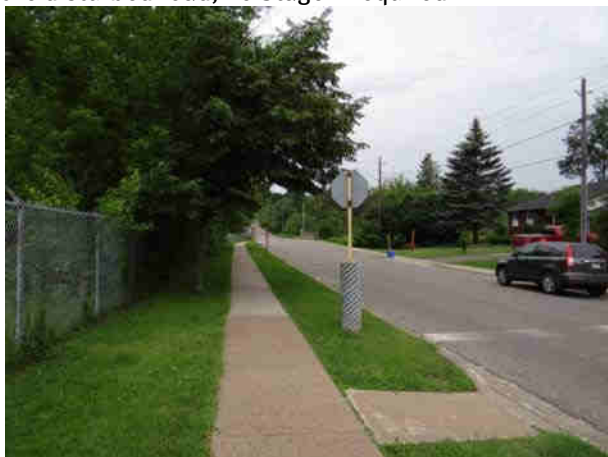
Plate 27: Southwest view of Dundas St W, Erin; Proposed sewer route is within the disturbed road, no

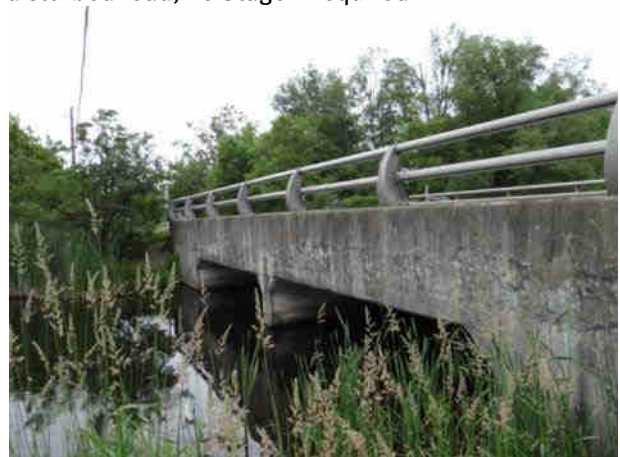
Plate 28: East view of Dundas St W bridge and West Credit River, Erin; Lands adjacent to disturbed bridge

footings are sloped, low and wet, no Stage 2 required

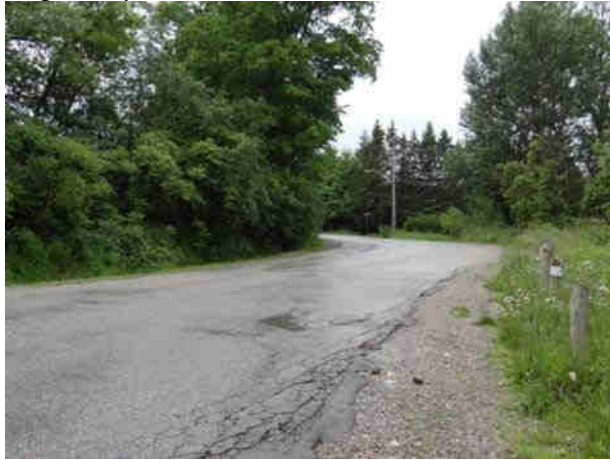
Plate 29: Southwest view of Dundas St W, Erin; Proposed forcemain is within the disturbed road, no Stage 2 required. Any impacts beyond the gravel shoulder require Stage 2 survey.

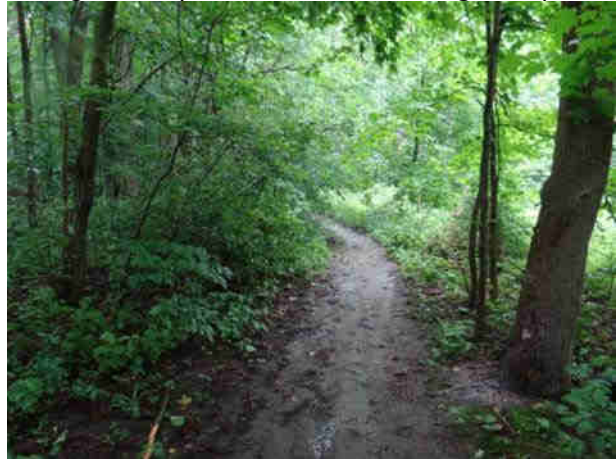
Plate 30: Southeast view of proposed forcemain along existing trail north of Erin Height Blvd, Erin; Area exhibits potential, requires Stage 2 test pit survey

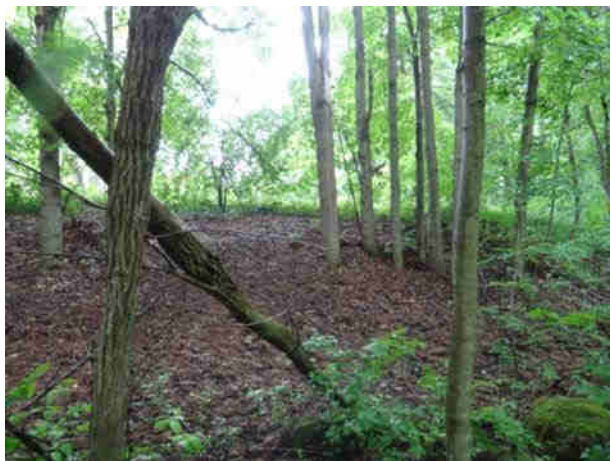
Plate 31: Southwest view of SPS site 3, Erin; Area exhibits potential, requires Stage 2 test pit survey

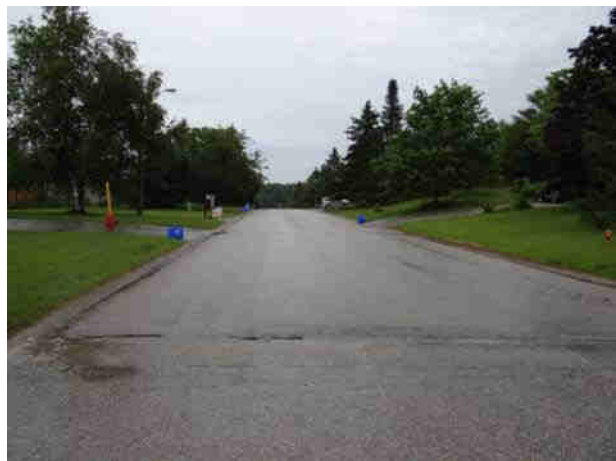
Plate 32: Northeast view of Erin Height Blvd, Erin; Proposed sewer route is within the disturbed road, no Stage 2 required.

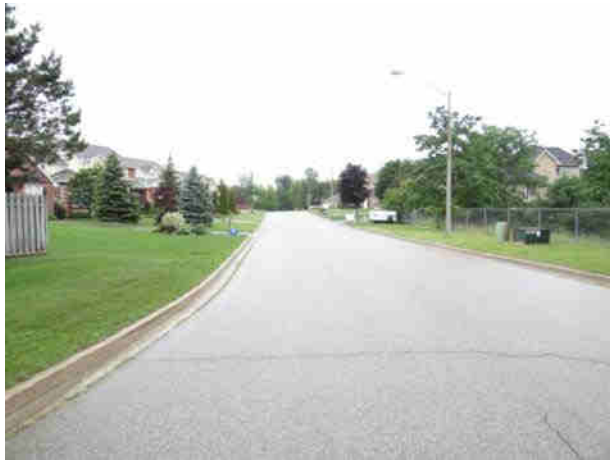
Plate 33: West view of Waterford Dr, Erin; sewer route is within the disturbed road, SPS site #6 to the north requires Stage 2 test pit survey

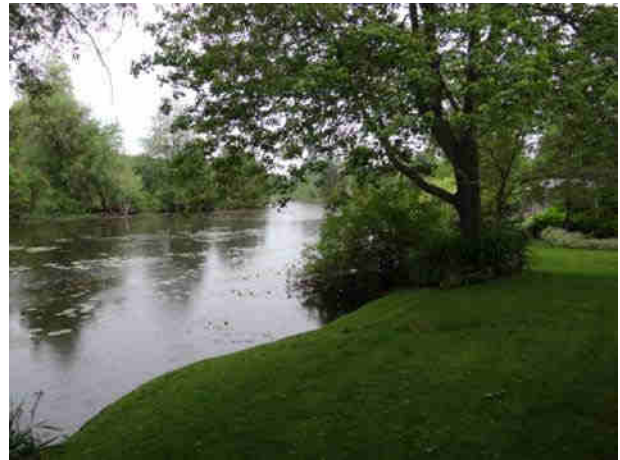
Plate 34: West view of West Credit River behind storefronts on Main St near Church Blvd; Area requires Stage 2 test pit survey

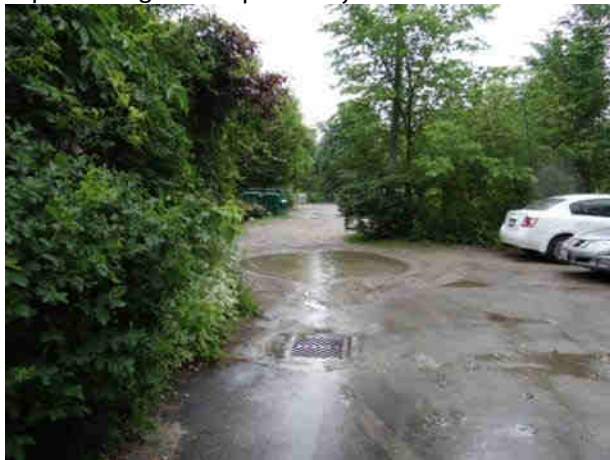
Plate 35: Southeast view between Charles St and Church Blvd, Erin; Proposed sewer route is within the disturbed road and parking lot, no Stage 2 required.

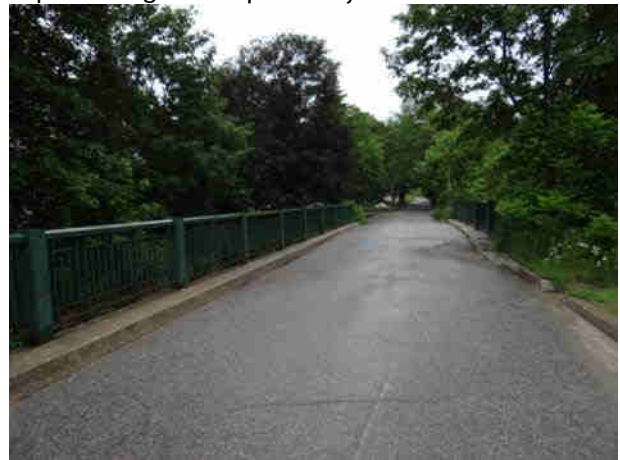
Plate 36: South view of Charles St and bridge, Erin; Proposed sewer route is within the disturbed road, no Stage 2 required.

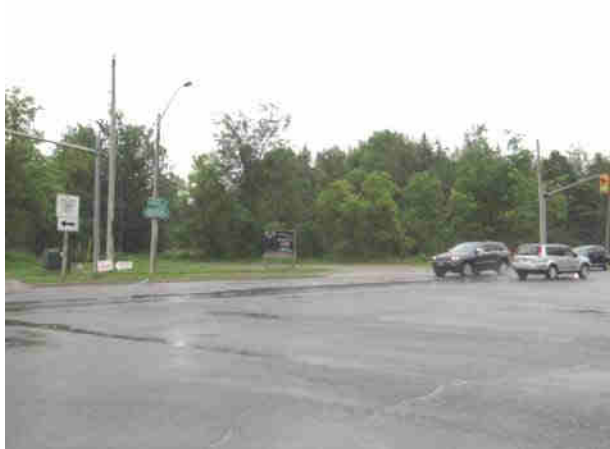
Plate 37: East view of SPS site #1A; Area surrounding the disturbed parking lot retains potential, requires Stage 2 test pit survey

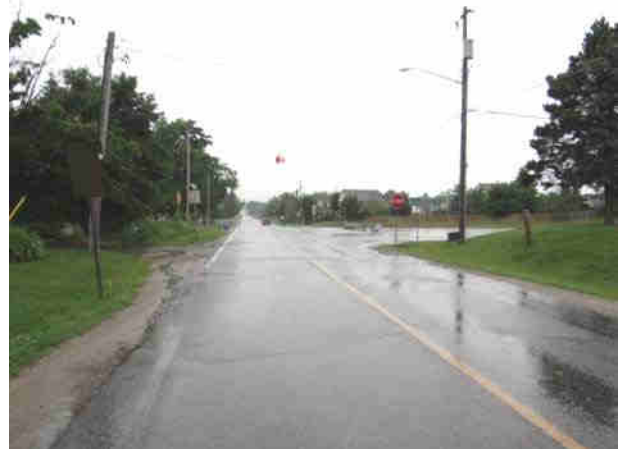
Plate 38: Northwest view of 9<sup>th</sup> Line and Wellington Rd 52, Erin; Proposed sewer route and forcemain are within the disturbed road, no Stage 2 required.

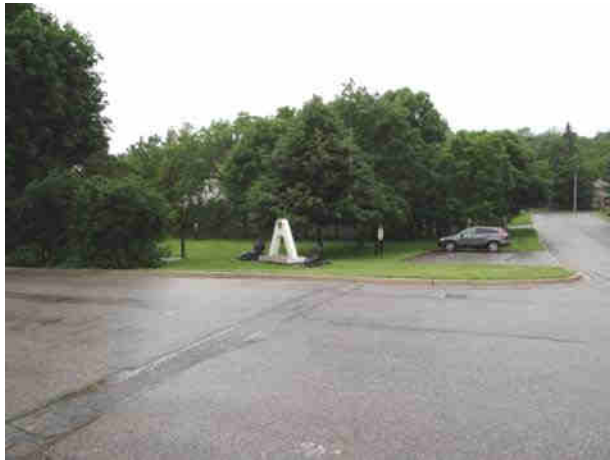
Plate 39: South view of SPS site #1B; Area beyond disturbed road retains potential, requires Stage 2 test pit survey

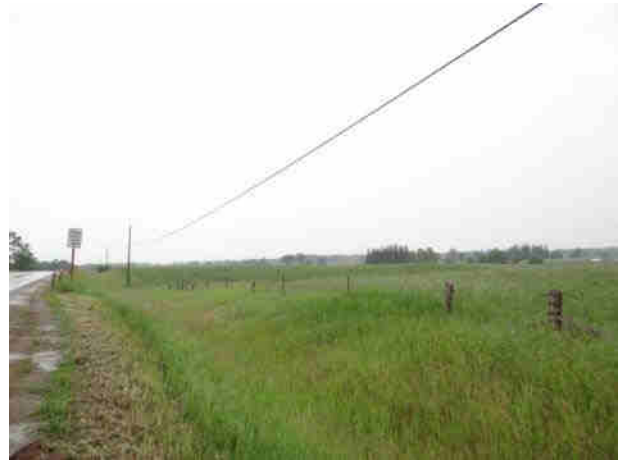
Plate 40: Northeast view of WWTP site; Area southwest of the disturbed road retains potential, requires Stage 2 pedestrian survey

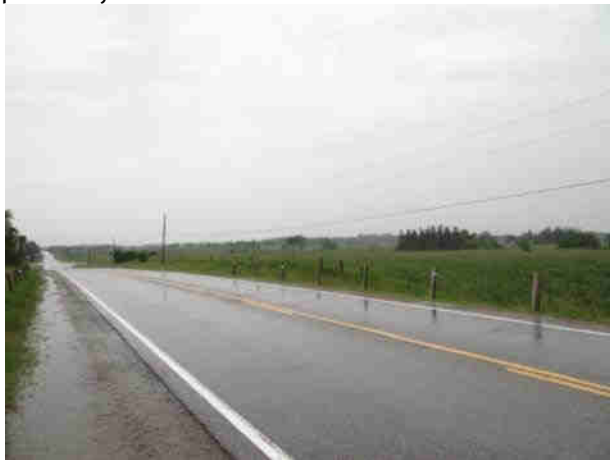
Plate 41: Northeast view of proposed WWTP site on Wellington Road 52; Area beyond disturbed road retains potential, requires Stage 2 pedestrian survey

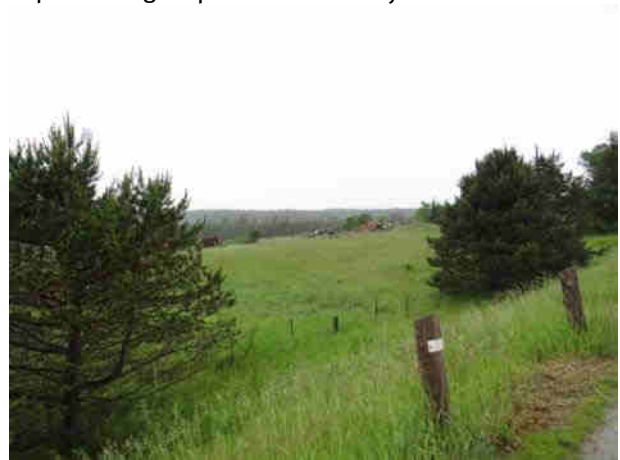
Plate 42: North view of proposed WWTP site; Area retains potential, requires Stage 2 pedestrian survey

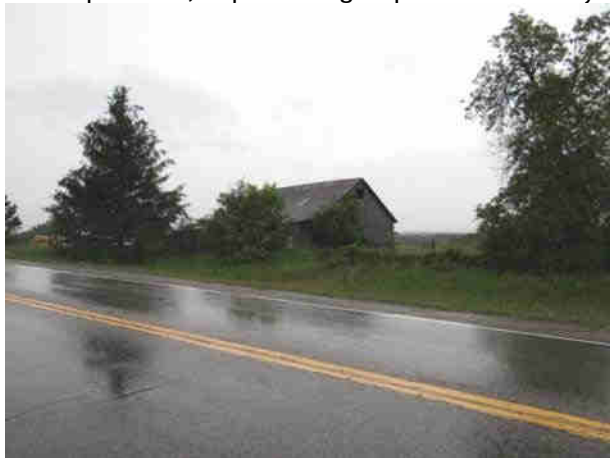
Plate 43: West view of proposed WWTP site; Area beyond disturbed road retains potential, requires Stage 2 pedestrian and test pit survey

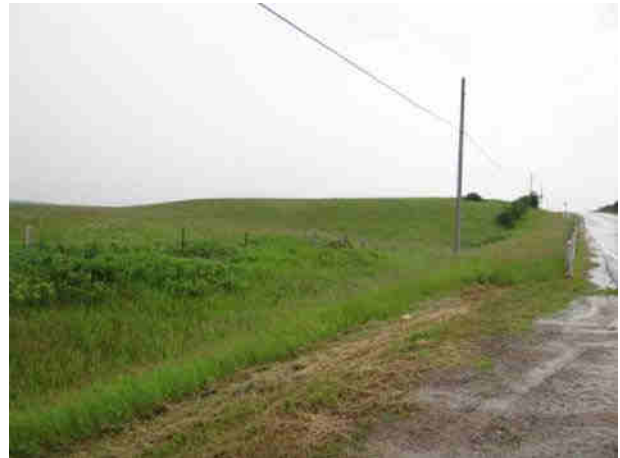
Plate 44: South view of proposed WWTP site; Area southwest of the disturbed road retains potential, requires Stage 2 pedestrian survey
