2.5.4 Benthic Macroinvertebrates Characterization

Phase 1 - Environmental Component - Existing Conditions Report

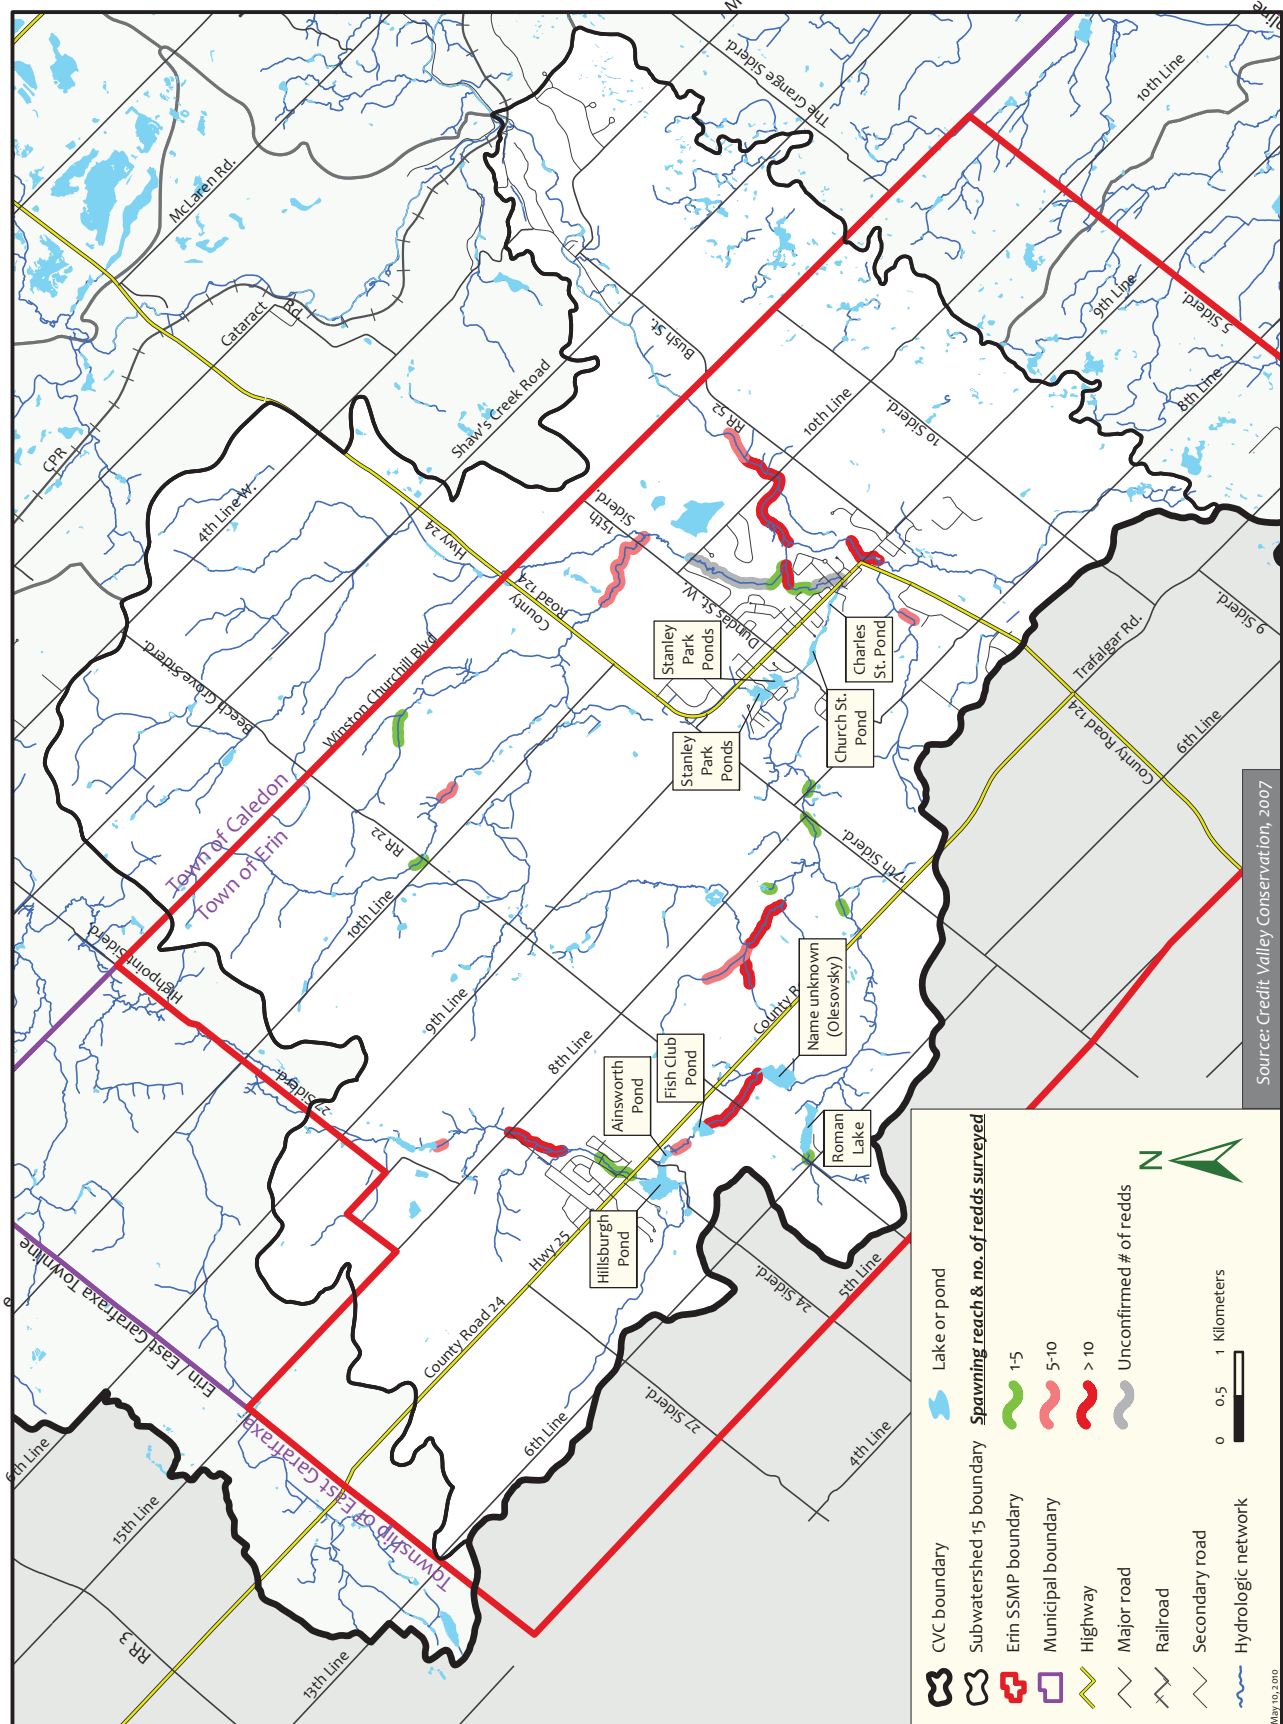
Figure 2.6.6 Fish Spawning Survey and Fish Barriers

Figure 2.6.6 summarizes spawning redds surveyed in the West Credit River subwatershed study area. The most productive spawning reach is on the main channel at the downstream end of the study area. This length of river extends unimpeded by dams for 6.5 km downstream to Belfountain and as such many trout throughout these lower reaches could migrate up into the study area. A self-sustaining population can not exist between barriers without “critical” spawning habitat conditions provided by strong upwelling groundwater.

spawning area is provided around the confluence of tributaries along the rail trail (between County Road 24 and 8th Line north of 17th Sideroad).

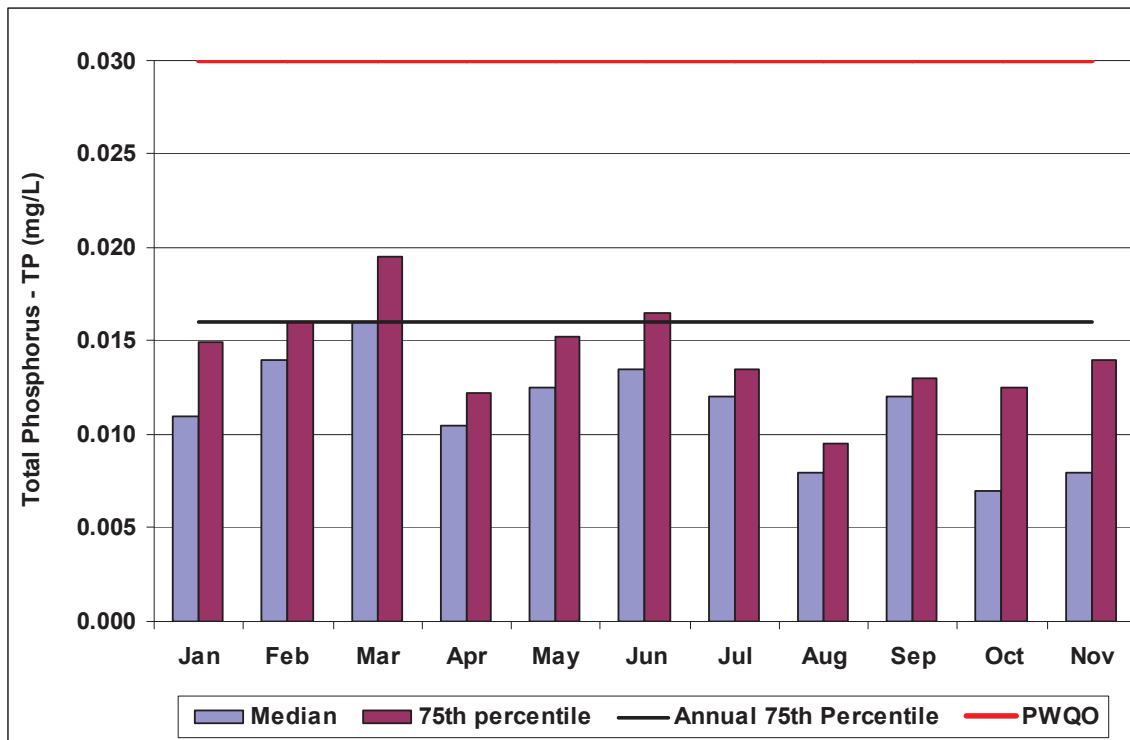
Figure 2.7.3 Summary Statistics of Total Phosphorus Concentrations for the West Credit River at Winston Churchill Blvd. from 1996-2008

Analysis of total phosphorus long-term data for the West Credit River at Winston Churchill Blvd. indicates that this reach of the West Credit River is not a Policy 2 watercourse with respect to Total Phosphorus. At this station the overall 75th percentile and monthly 75th percentile concentrations fell below the PWQO set by MOE (**Figure 2.7.3**) and the percent violation of the PWQO is 4%. Trend analysis demonstrates a slight decrease in phosphorus concentrations during period 1996-2008.

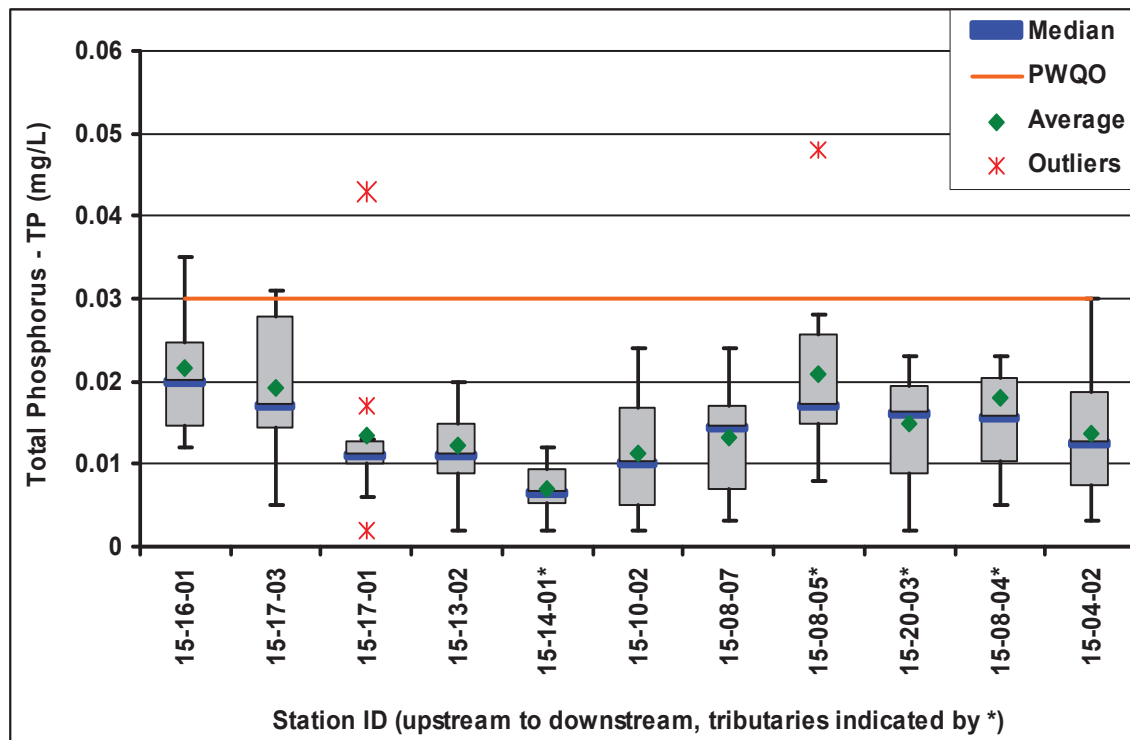
Figure 2.7.4 Box Plot of Total Phosphorus Concentrations for the SSMP Study Stations from 2007-2008 (PWQO = 0.03 mg/L)

Hillsburgh and Erin stations indicating that phosphorus contributions are likely coming from urban storm water runoff (**Figure 2.7.4**).

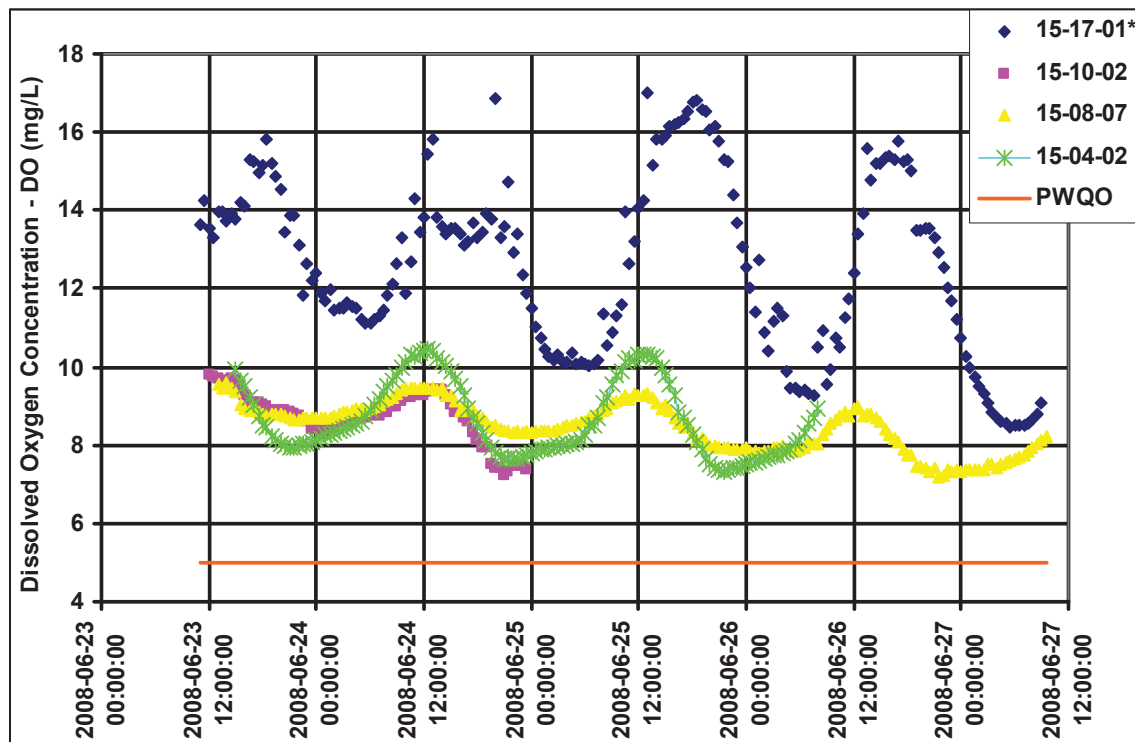
Figure 2.7.11 Diurnal Survey Dissolved Oxygen Results for West Credit River Stations in June 2008

Two sets of diurnal monitoring tests for dissolved oxygen, pH, conductivity, and water temperature were completed at 4 stations across the study area, one in late June, and one in late August. **Figure 2.7.11** illustrates DO concentrations over the five days of Hydrolab deployment in June 2008. All concentrations surpassed the minimum DO objective of 5 mg/L. The large variation seen in the West Credit River downstream of the Head Pond (also known as the Hillsburgh Dam) station in Hillsburgh (15-17-01) illustrates the influence of plant growth and respiration in the upstream pond in conjunction with re-aeration from the waterfall. Some mechanical difficulty was experienced with the Hydrolab probe at the 8th Line Gauge Station (15-10-02) which resulted in a shortened DO measurement period.

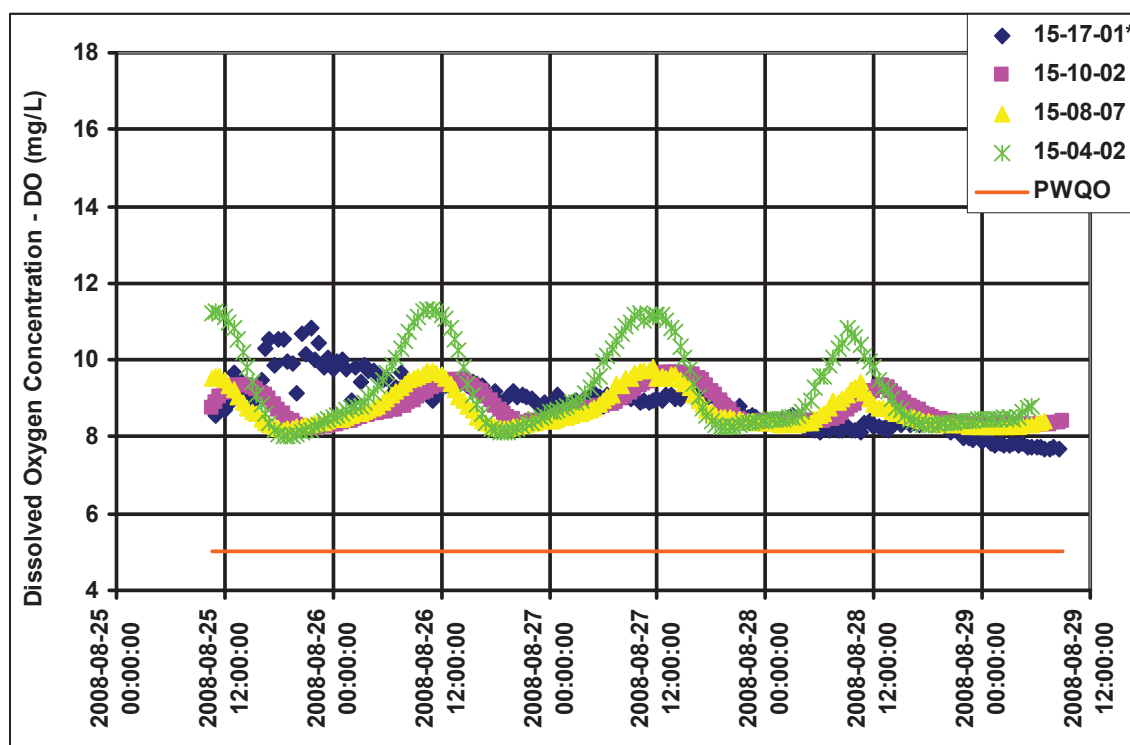
Figure 2.7.12 Diurnal Survey Dissolved Oxygen Results for West Credit River Stations in August 2008

(also known as the Hillsburgh Dam) in Hillsburgh and the large variations in DO found at this station are an artifact of the aquatic macrophyte growth within the pond upstream. These macrophytes produce dissolved oxygen during the day through photosynthesis and consume oxygen during the night through respiration. The air and water temperatures were below normal in the summer of 2008 which likely had a positive influence on dissolved oxygen concentration as the water has the capacity to hold more oxygen in colder water temperatures.

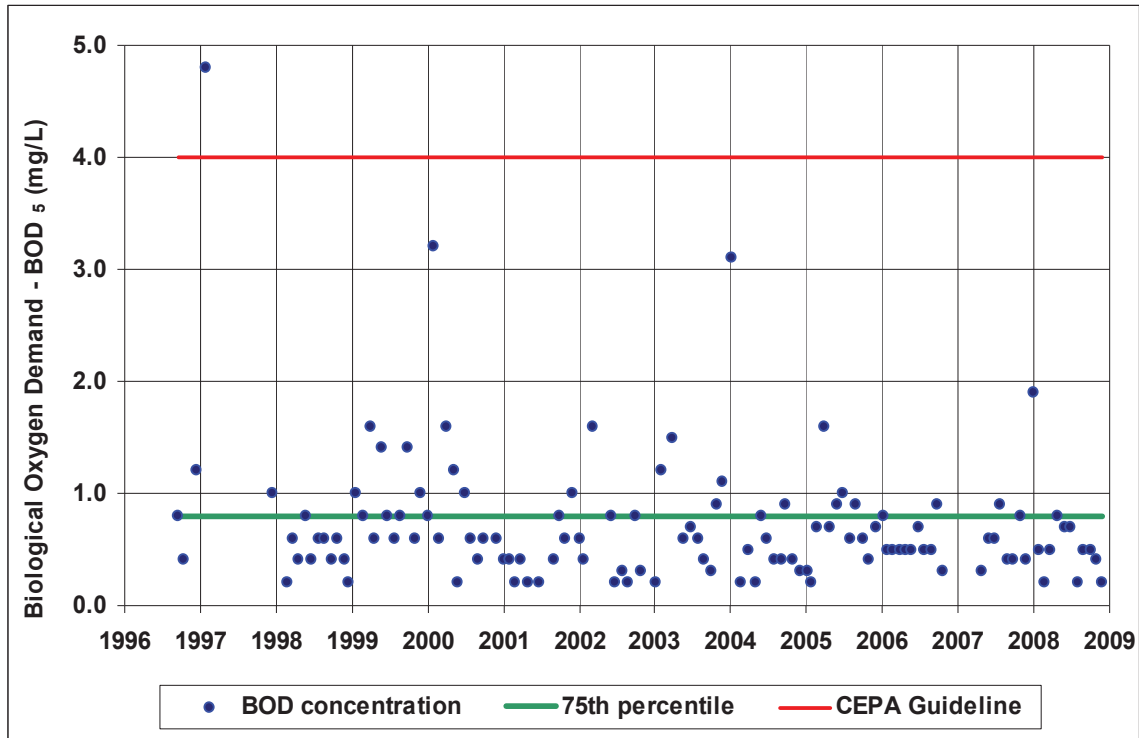
Figure 2.7.13 BOD₅ Concentrations for the West Credit River at Winston Churchill Blvd. from 1996-2008

Figure 2.7.13 depicts the long term time series of BOD₅ concentration in the West Credit River at Winston Churchill Blvd. There were no major variations in seasonal / monthly 75th percentile values. However, fall and winter appeared to have slightly higher BOD concentrations (refer to the Water Quality and Sediment Chemistry Appendix). BOD₅ data collected through the SSMP fieldwork in 2007-2008 measured no values above the detection limit of 2 mg/L. This is supported by the low levels of algal and aquatic macrophytes biomass observed in the study area.

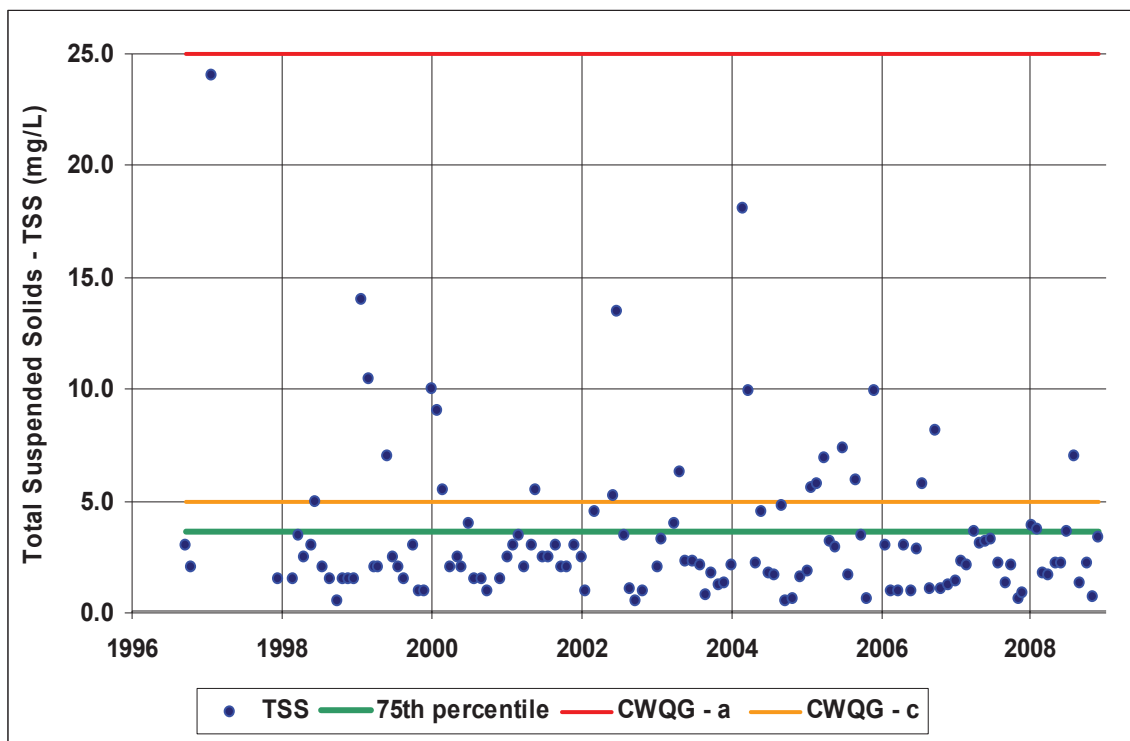
Figure 2.7.14 TSS Concentrations for the West Credit River at Winston Churchill Blvd. from 1996-2008

Suspended solids measurements are spot measurements similar to water temperature and can vary widely from wet to dry conditions (**Figure 2.7.14**). The data suggests that the West Credit River at Winston Churchill Blvd. station may occasionally receive large sediment loads through erosion, agricultural runoff, and stormwater flows but overall has a low suspended sediment loading as the 75th percentile is 3.6 mg/L, below the chronic toxicity CWQG. The seasonal distribution of the data demonstrated a slight increase in concentrations in the later winter and spring indicating that higher loading is likely associated with spring melt and runoff. Also, trend analysis did not demonstrate a significant trend in the long term TSS data.

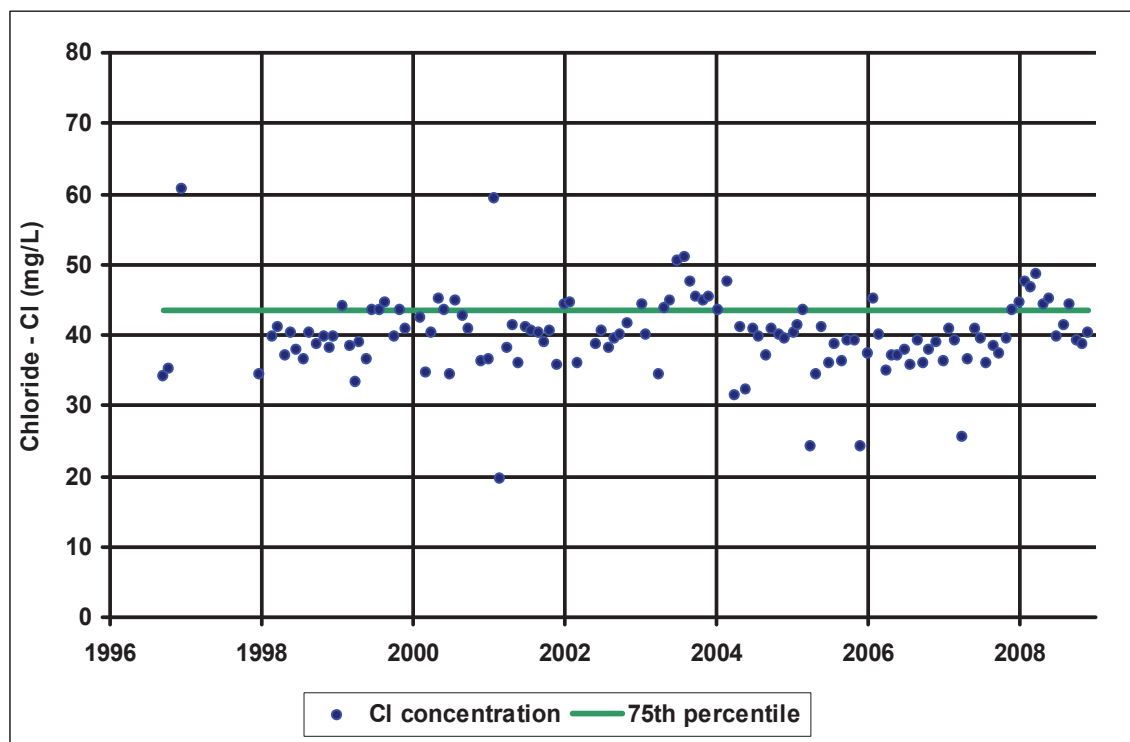
Figure 2.7.15 Chloride Concentrations for the West Credit River at Winston Churchill Blvd. from 1996-2008 (Lowest Observed Effect Concentration = 252 mg/L)

Figure 2.7.15 depicts the statistical characteristics and historical time series of chloride concentration in the West Credit River at the Winston Churchill Blvd. station. The chloride concentrations measured well below the CVC Objective (250 mg/L) and had a long term annual 75th percentile at 43 mg/L with no recorded exceedances of the objective. The time series graph demonstrates a slight seasonal distribution to chloride concentrations indicating influences from road salting contributions. Trend analyses did not find a significant trend in chloride levels during the study period.

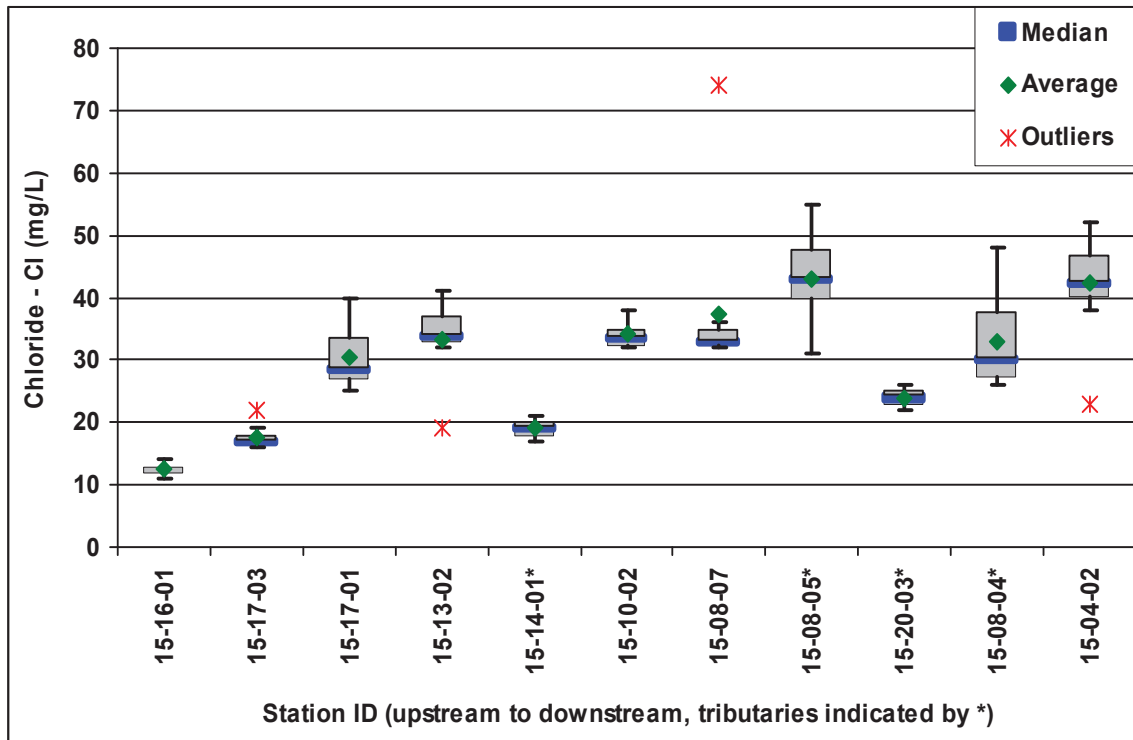
Figure 2.7.16 Chloride Concentrations for the SSMP Study Stations from 2007-2008 (Environment Canada's no effect concentration = 252 mg/L)

smaller urban tributaries with less ability to dilute road salting impacts as compared to the West Credit River main branch.

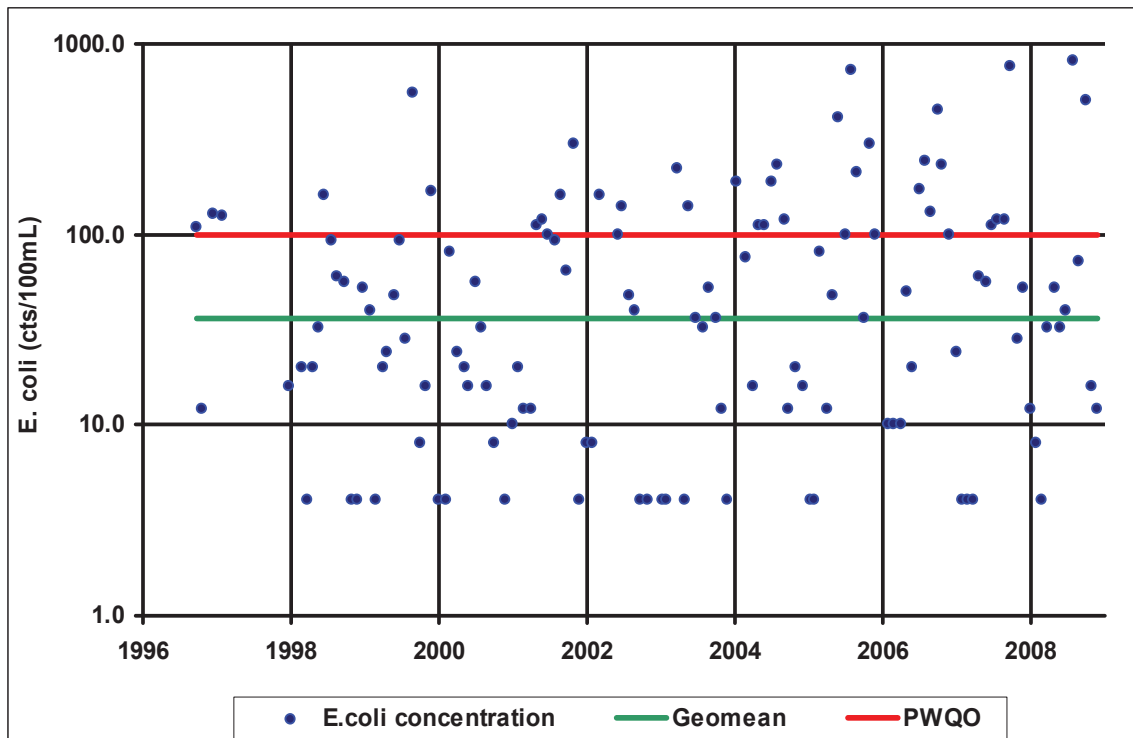
Figure 2.7.17 *E. coli* Concentrations (logarithmic scale) for the West Credit River at Winston Churchill Blvd. from 1996-2008 (PWQO = 100 cts/100mL)

Although bacteria levels are typically more of a concern for the health of humans than fisheries, high bacteria levels can be indicative of an impaired watercourse. Livestock, wildlife, pets, and septic systems are the main sources of bacteria in the SSMP study area. Levels of *Escherichia Coli* (*E. coli*) are used as a surrogate indicator for the presence of pathogenic bacteria and nitrogenous waste that impair human uses of the water. The PWQO for *E. coli* is set for the safety of recreational uses, such as swimming and other water sports, and is therefore not necessarily an appropriate objective for fisheries health. However, since the previously mentioned sources of elevated bacteria levels can also contribute excessive nutrients and oxygen demanding materials, *E. coli* can still be considered a secondary indicator for fisheries health. In addition, the PWQO is meant to be compared to the geometric mean of five samples taken simultaneously. Geometric means (or geomeans) are used to measure ‘average’ bacteria values since this bacterial growth occurs at a logarithmic scale. For this analysis, long-term geometric mean results are compared to the PWQO for comparison of bacterial levels between stations. In general, the geometric mean value for *E. coli* at the Winston Churchill Blvd. station is below the PWQO of 100 counts/100 mL. However 27% of samples that exceeded the PWQO are assumed to have been associated with precipitation and urban runoff (**Figure 2.7.17**). Trend analysis does not indicate a significant trend over the study period. This is most likely due to the large range and variation in results.

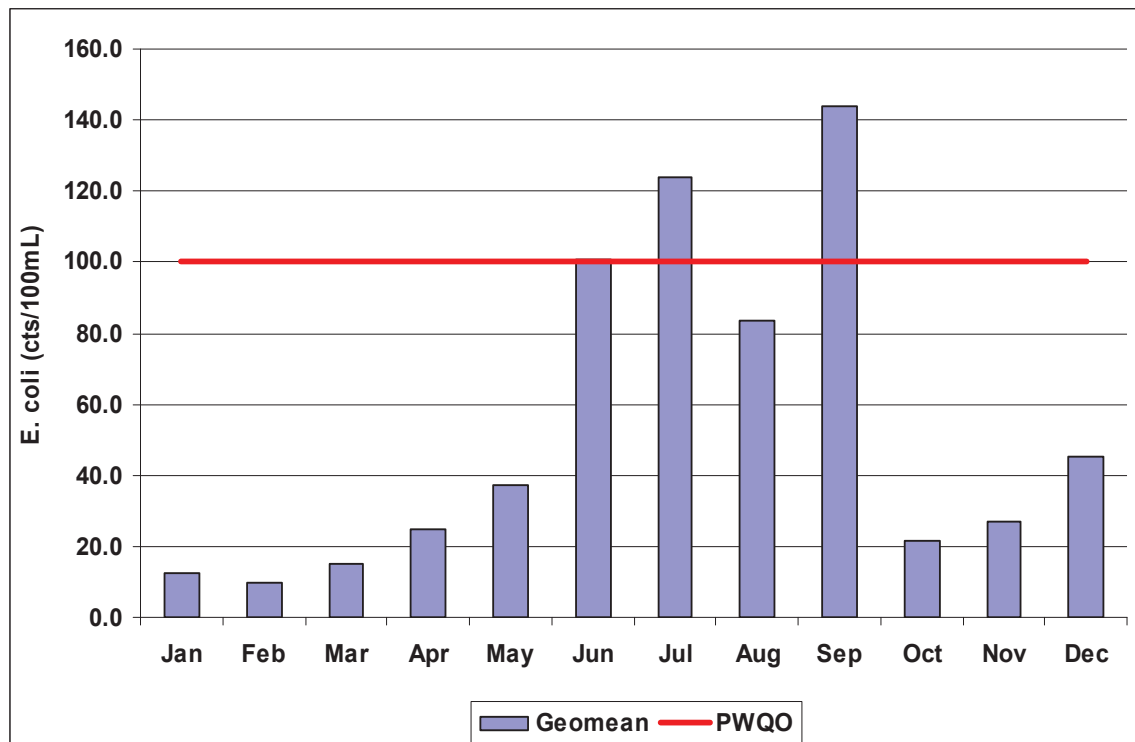
Figure 2.7.18 Monthly Geomean Values of *E. coli* Concentrations for the West Credit River at Winston Churchill Blvd. from 1996-2008 (PWQO = 100 cts/100 mL)

There is a strong seasonal distribution to the bacteria results as higher temperatures in the summer months present ideal conditions for bacterial growth. **Figure 2.7.18** portrays the elevated bacteria concentrations found in the summer months at the West Credit River at Winston Churchill Blvd. station with exceedances to the PWQO occurring in June, July and September. It could be associated with increased biological activity from such sources as waterfowl, domestic animals, and livestock occurring in and around watercourses.

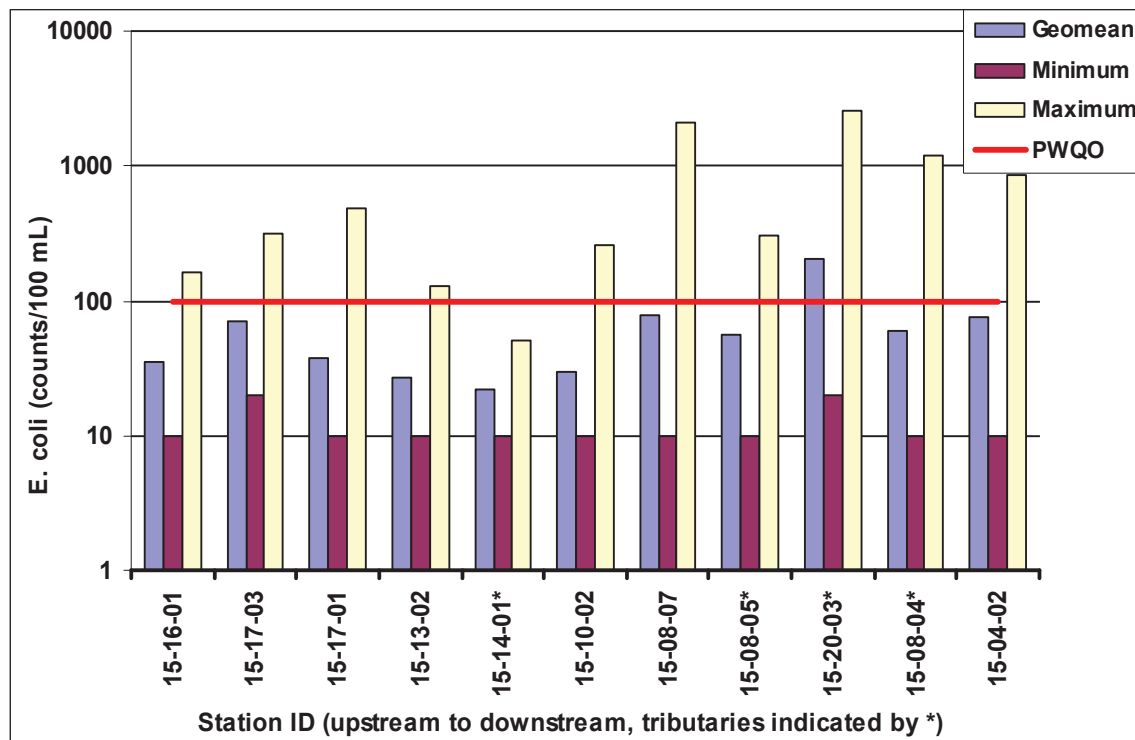
Figure 2.7.19 *E. coli* Concentrations on Logarithmic Scale for the SSMP Study Stations from 2007-2008 (PWQO = 100 cts/100 ml)

E. coli data collected through the SSMP fieldwork in 2007-2008 revealed slight differences between concentrations at the eleven stations distributed throughout the study area (**Figure 2.7.19**). Elevated concentrations were found in the urban Villages of Erin and Hillsburgh which is possibly associated with urban runoff, pet and wildlife feces, and effluent from septic systems. The relative rural station, East Branch downstream Wellington Rd 124 (15-20-03), recorded the highest concentrations in the study area. Specific sources are not able to be isolated in this study but waterfowl, septic effluent, and agricultural fertilizing practices are possible sources of bacterial contamination.

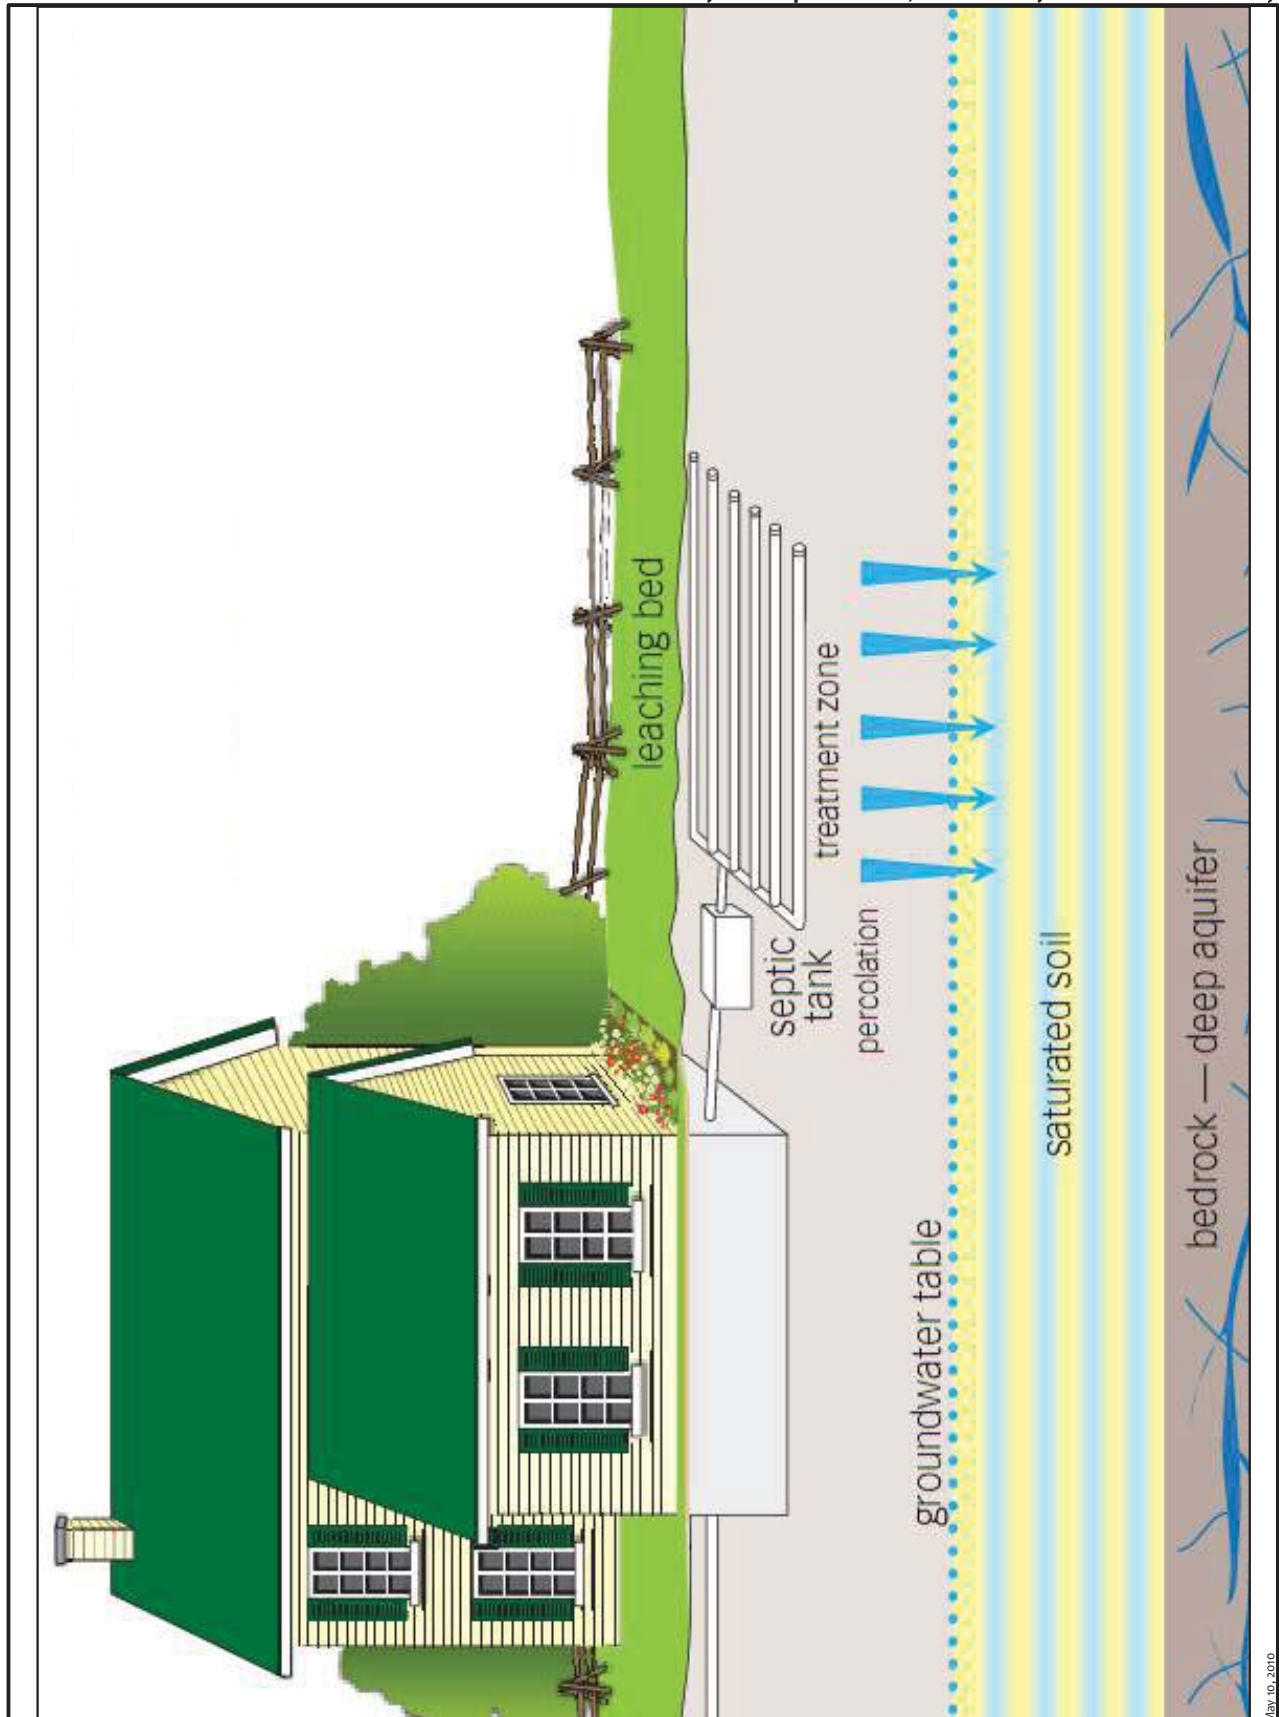
Figure 2.8.1a Schematic View of a Septic System (Adapted from Septic Smart, Province of Ontario Publication)

very specific design criteria for septic systems, which are regulated under the Ontario Building Code.

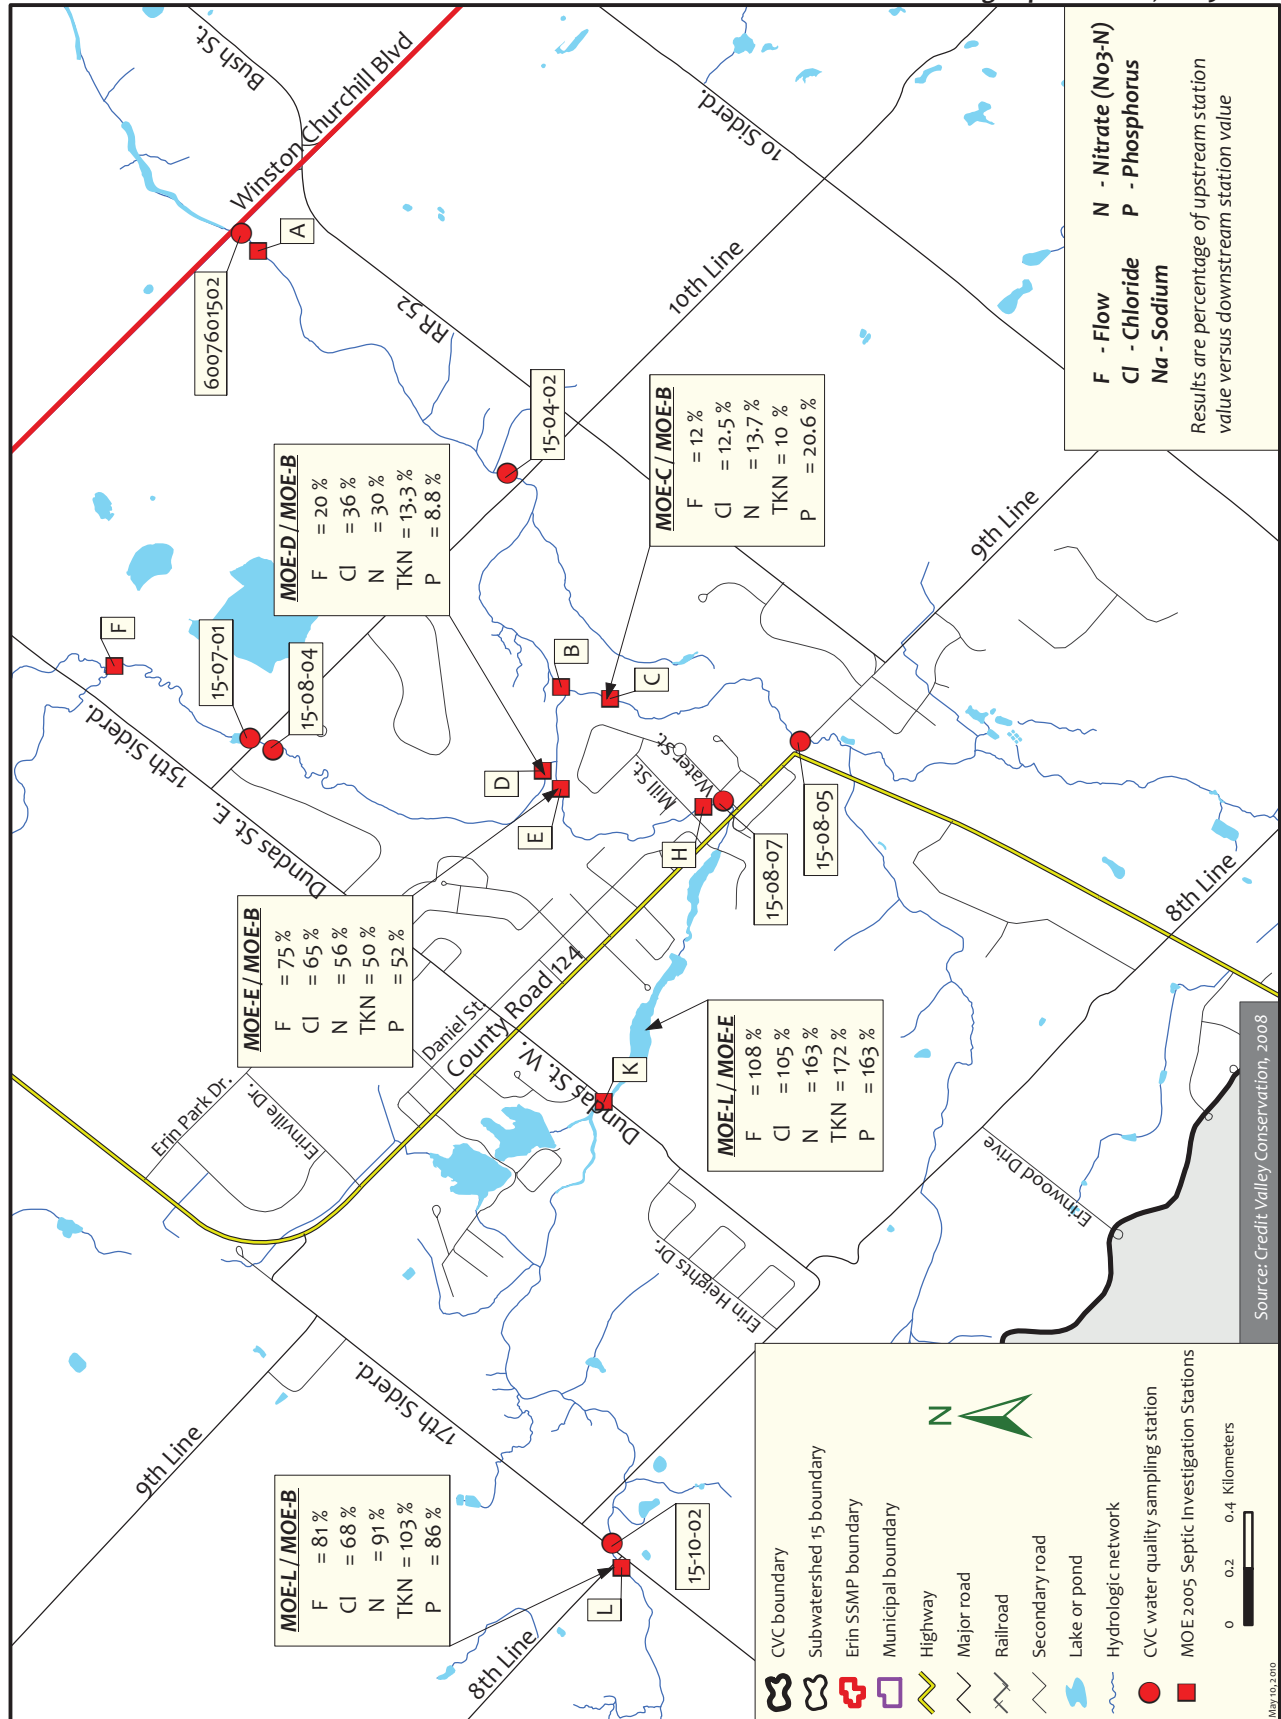
Figure 2.8.29 Comparison of Flow/Mass Loading Between MOE Stations Using September 18, 2009 Data

- **Figure 2.8.29** also shows the variation in flow and mass loading between the two tributaries downstream of Erin Village. The south tributary (MOE C) was only 12% of the flow at MOE-B and had similar percentages of mass loadings as the flow percentage, with the exception of phosphorus which had a much higher contribution from upstream. In contrast, the northern tributary (MOE D) provided 20% of the flow at MOE B but also provided 36% of the chloride mass loading and 30% of the nitrate loading, indicating a significant source contribution to the water quality impacts on the West Credit River, along this reach. The percentages of TKN and phosphorus loadings however, were much lower than the flow percentage.

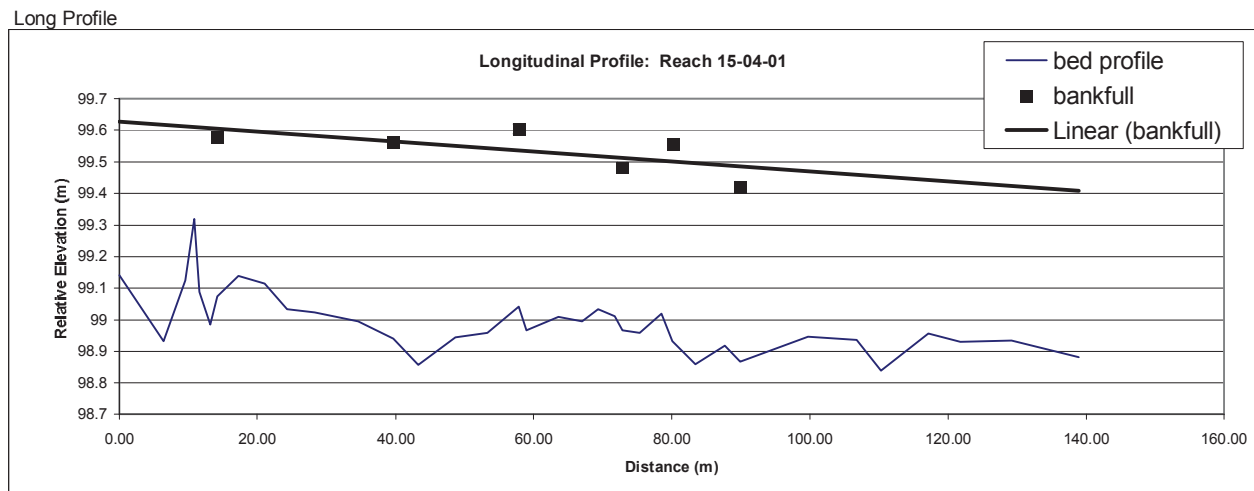
Figure D3.5.2_15-04-01.xls

Notes: Large fluctuations in profile caused by accumulations of large woody debris

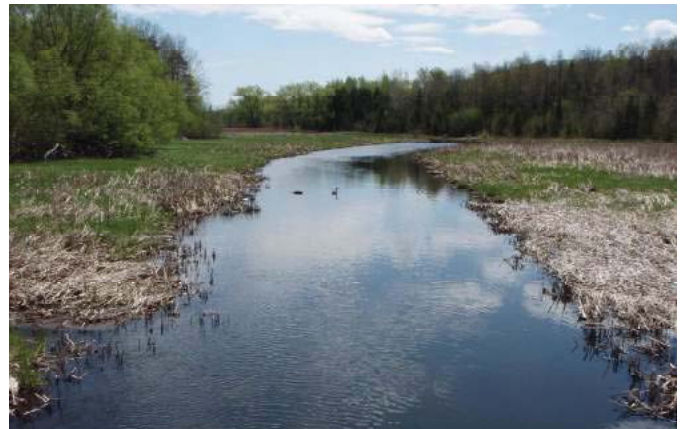
Backwater / wetland conditions upstream of Hall's Dam (Reach 15-038B)

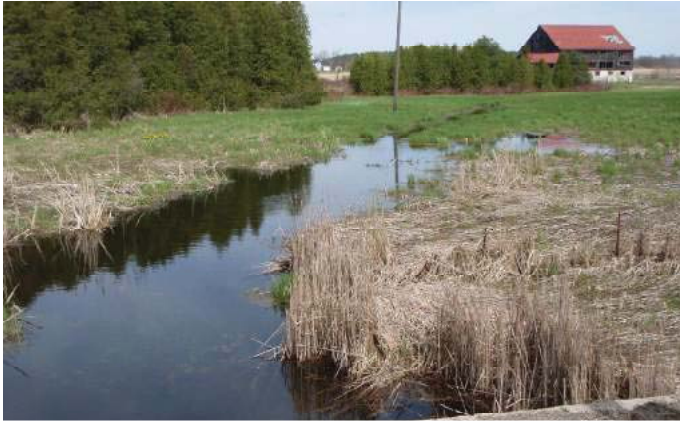
Wetland / backwater conditions upstream of Highway 24 (Reach 15-087B)

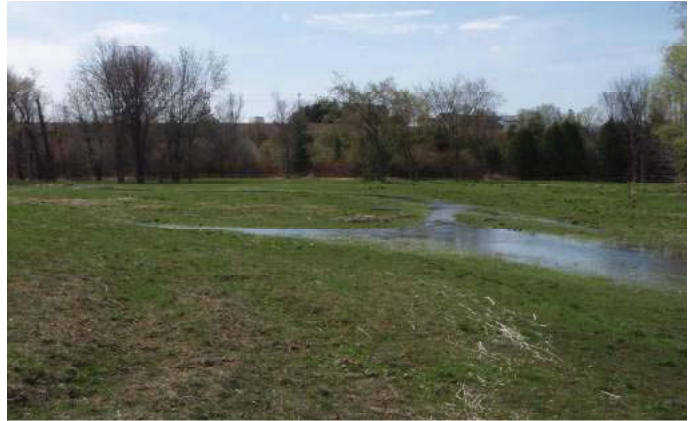
Meandering / braided channel through agricultural pasture (Reach 15-093)

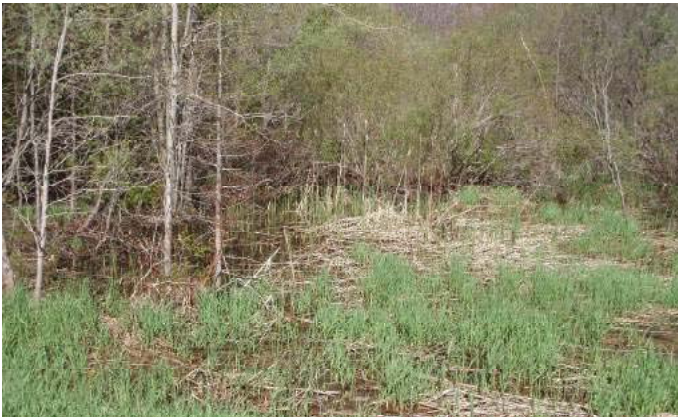
Cedar / poplar / birch wetland conditions (Reach
10-159)

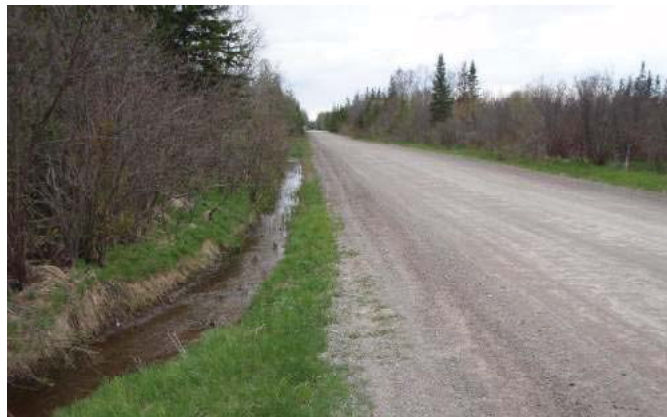
Roadside ditch with backwater conditions (Reach not labeled)
