# **APPENDIX C**

## **Background Studies**

## **APPENDIX C-1**

### **Hydrologic Investigation Technical Memo**

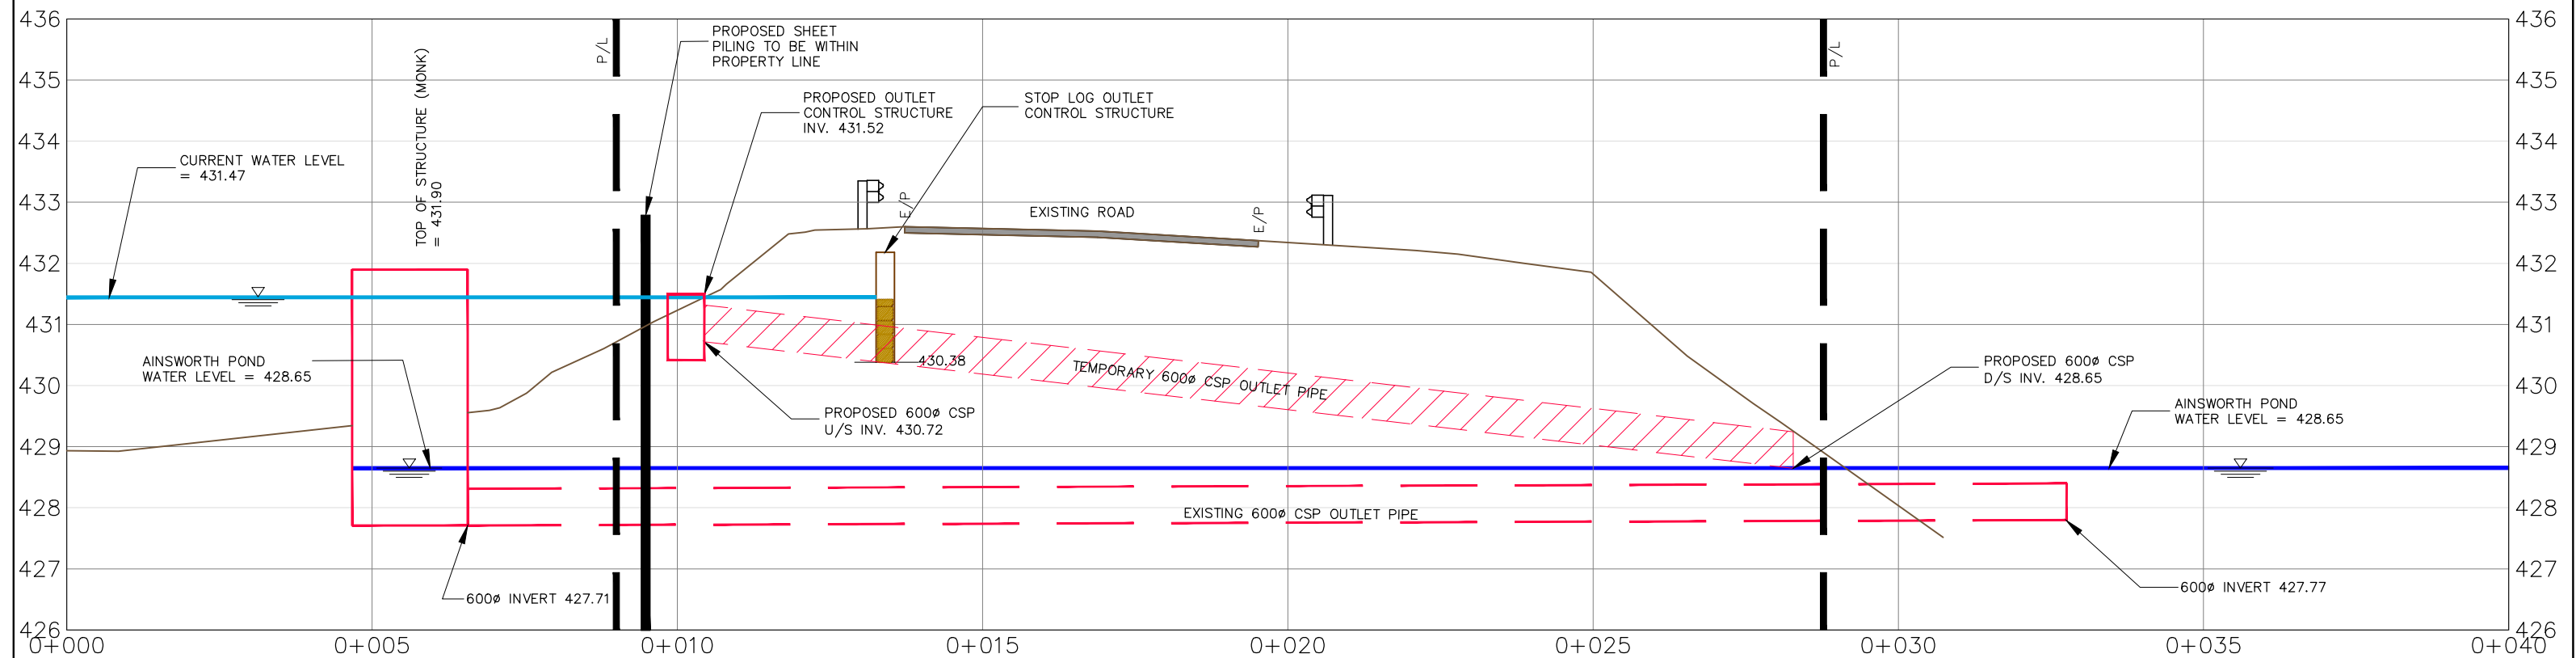
SECTION VIEW

The existing conditions of the dam, bridge and surrounding area are as follows:

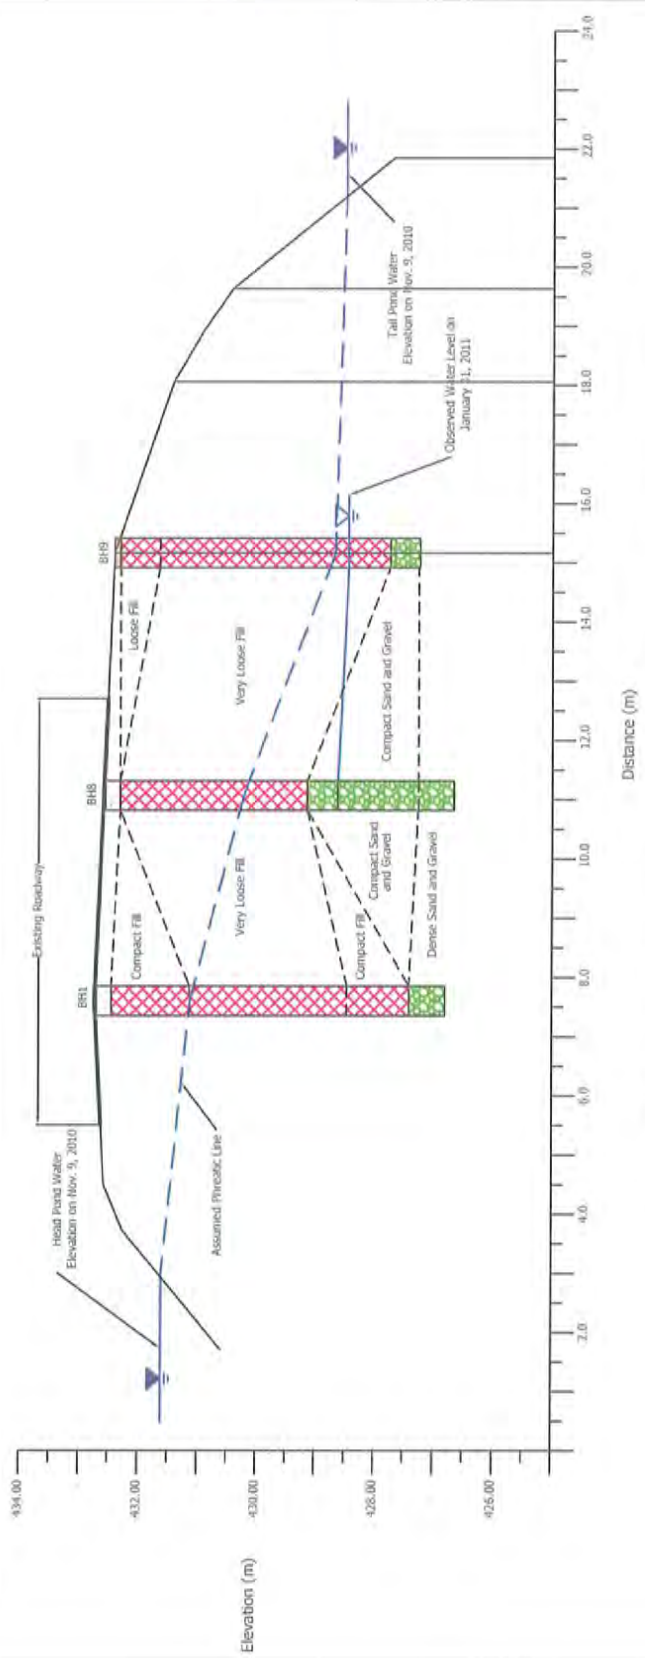
Project: 12-015	Drawing: 2
Date: February 2012	Sheet: 1
Scale: N.T.S.

It was noted that the soil in the upper 1.2 m of the dam roadway was relatively compact and the moisture contents were also relatively low. Below the upper compact layer, the moisture content increases significantly, and as a result the SPT N-values are also lower than the values obtained in the upper zone. The apparent reason for this is that with time water moves through the dam from the head pond to the tailrace. The top of the water level that is established in the dam is called the phreatic surface. Saturated conditions are generally found below this level. It should also be noted that less dense fill is found on the east side of the dam where loose fill was apparently placed in the 1970's so that guardrails could be placed along the road. With reference to Drawing 1, Drawings 2 to 5 show typical cross-sections through the dam at various locations.

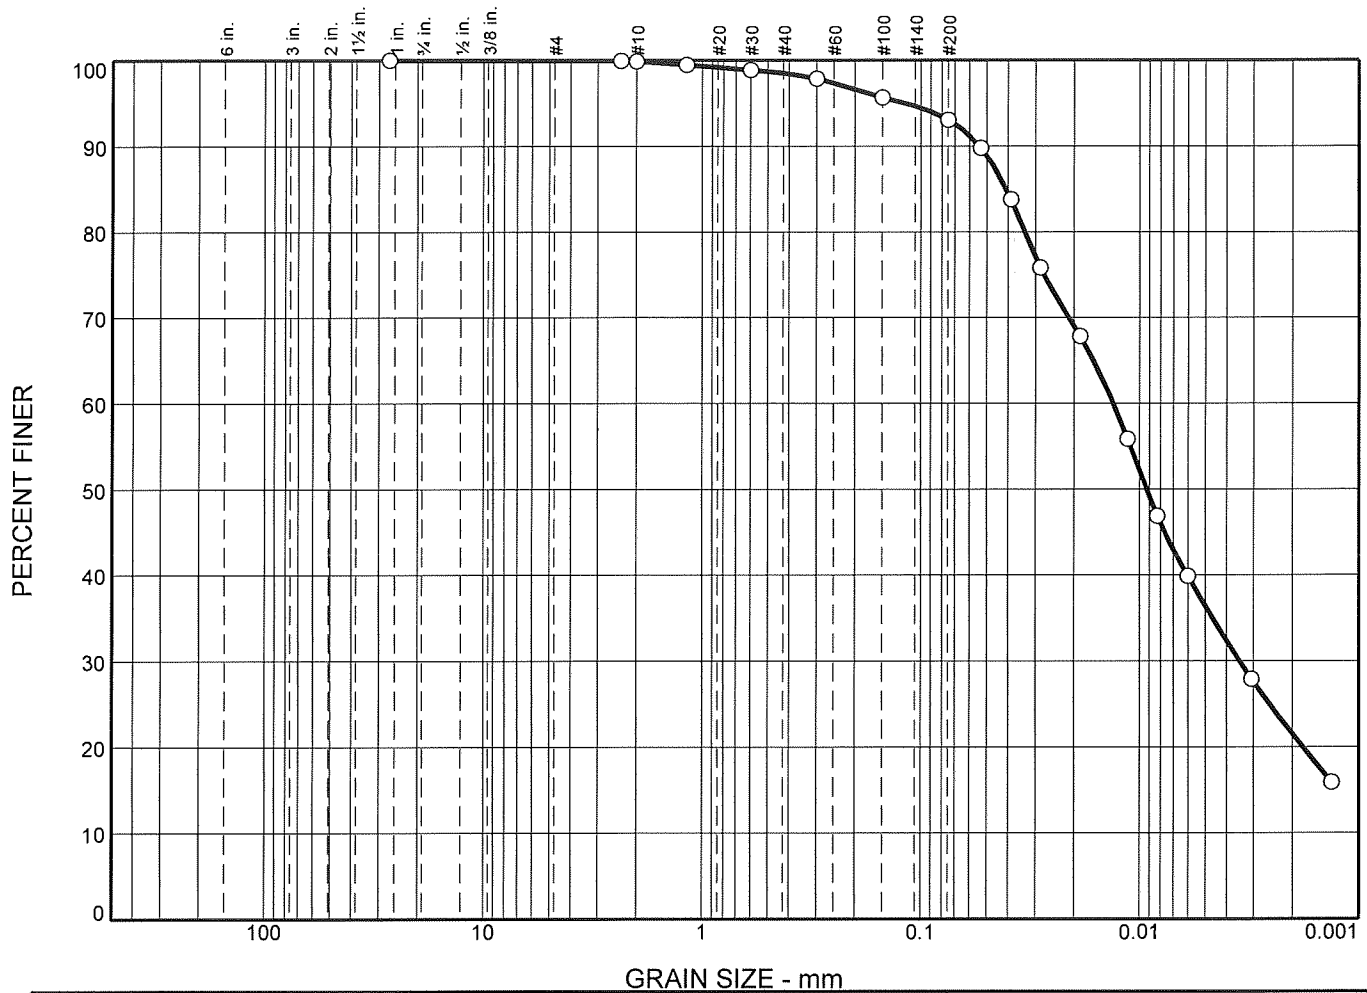
# Particle Size Distribution Report

% Cobbles	% Gravel		% Sand			% Fines	
		Coarse	Fine	Coarse	Medium	Fine	Silt	Clay
○	0.0	0.0	0.1	0.0	1.4	5.4	71.6	21.5

SOIL DATA					
SYMBOL	SOURCE	SAMPLE NO.	DEPTH (ft.)	Material Description	USCS
○	BH2	4	2.3-2.9 m	clayey silt, trace sand	ML
				Tested by JH of CMT Engineering Inc. February 14, 2012	
				estimated hydraulic conductivity $K = 1.0 \times 10^{-6}$ cm/sec

All of the samples obtained from between depths 2.3 m to 2.9 m were taken from the dam fill material. The estimated hydraulic conductivity for the fill material ranged from  $1.0 \times 10^{-4}$  cm/sec to  $1.0 \times 10^{-6}$  cm/sec (average:  $4.6 \times 10^{-5}$  cm/sec). The two samples taken from depths between 5.3 m and 5.9 m were taken from the foundation soils. The estimated hydraulic conductivity ranged from  $3.0 \times 10^{-3}$  cm/sec to  $4.0 \times 10^{-4}$  cm/sec (average:  $3.4 \times 10^{-3}$  cm/sec).

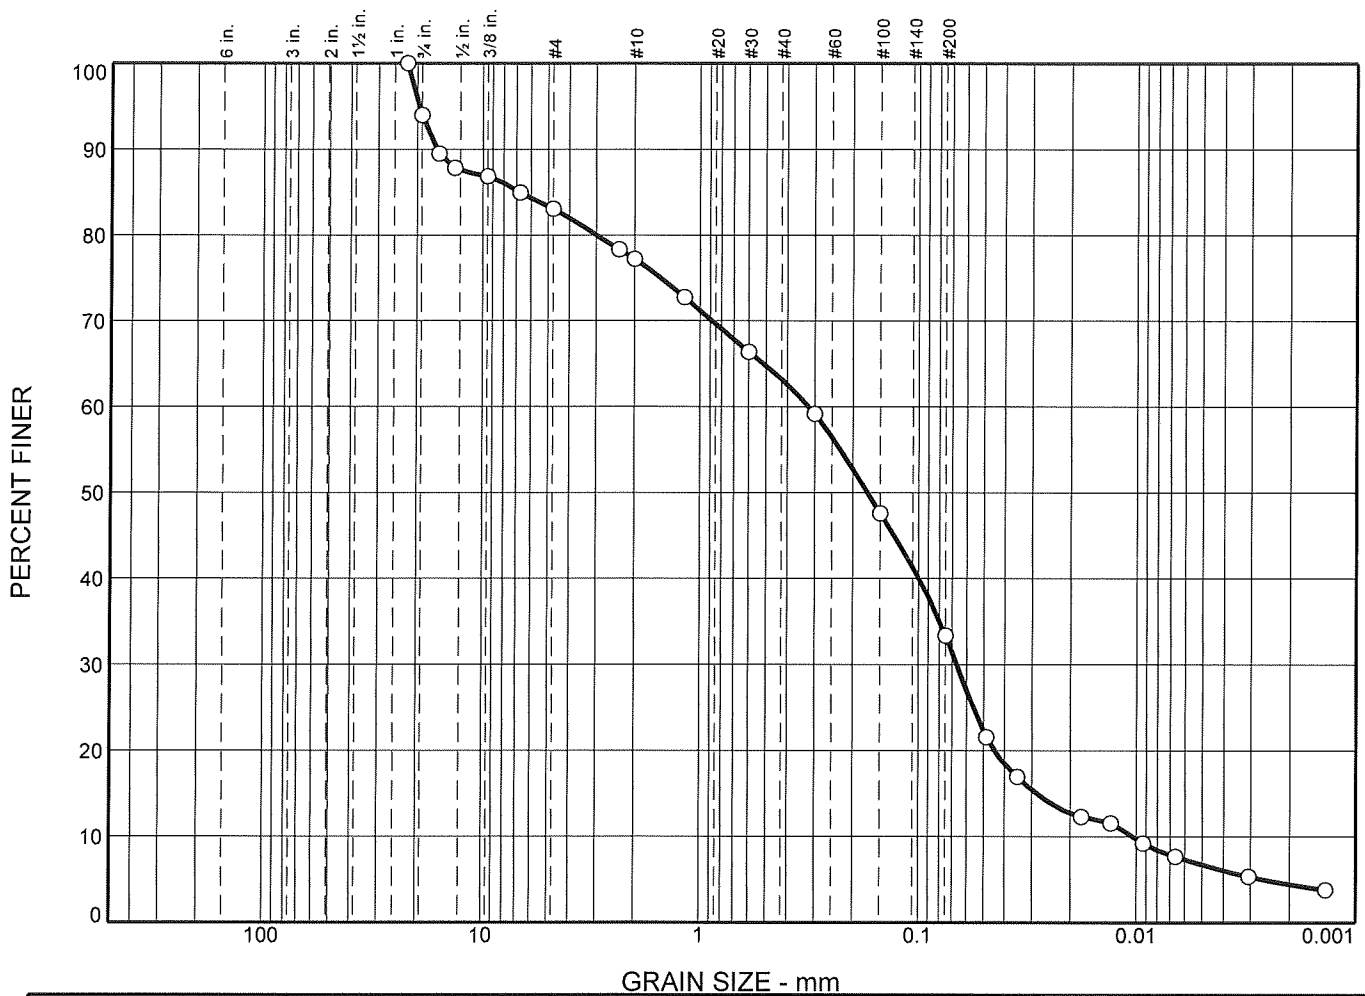
# Particle Size Distribution Report

GRAIN SIZE - mm								
	% Cobbles	% Gravel		% Sand			% Fines	
		Coarse	Fine	Coarse	Medium	Fine	Silt	Clay
○	0.0	6.0	11.0	5.8	14.0	29.9	28.9	4.4

SOIL DATA					
SYMBOL	SOURCE	SAMPLE NO.	DEPTH (ft.)	Material Description	USCS
○	BH3	4	2.3-2.9 m	silty sand, some gravel, trace clay	SM
				Tested by JH of CMT Engineering Inc. February 14, 2012	
				estimated hydraulic conductivity $K = 1.0 \times 10^{-4}$ cm/sec

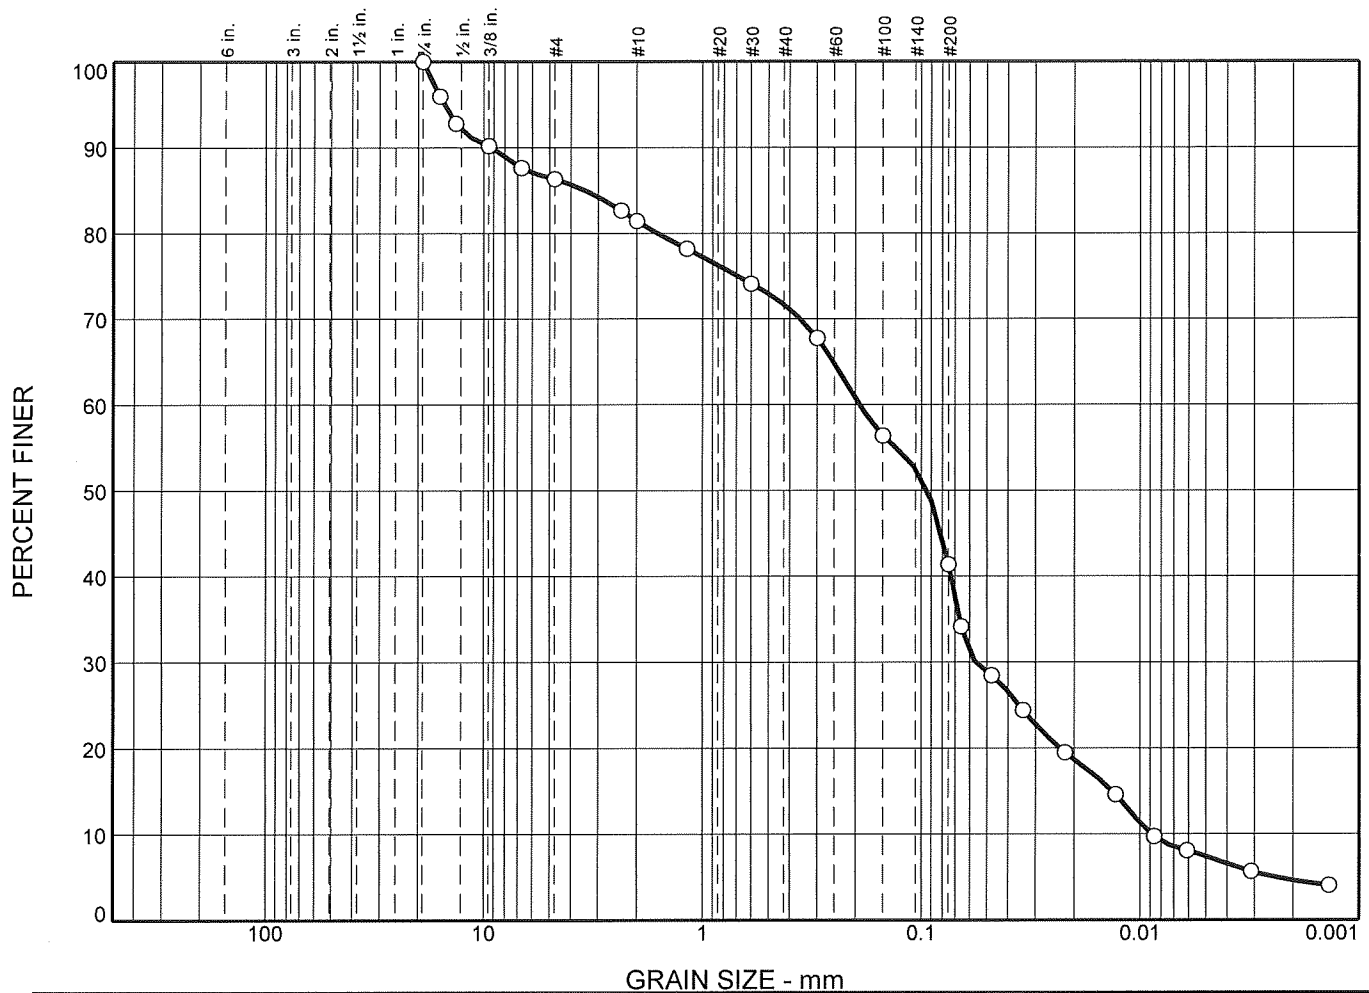
# Particle Size Distribution Report

% Cobbles	% Gravel		% Sand			% Fines	
		Coarse	Fine	Coarse	Medium	Fine	Silt	Clay
○	0.0	0.0	13.7	4.9	9.7	30.3	36.8	4.6

SOIL DATA					
SYMBOL	SOURCE	SAMPLE NO.	DEPTH (ft.)	Material Description	USCS
○	BH6	4	2.3-2.9 m	silty sand, some gravel, trace clay	SM
				Tested by JH of CMT Engineering Inc. February 14, 2012	
				estimated hydraulic conductivity $K = 8.0 \times 10^{-5}$ cm/sec

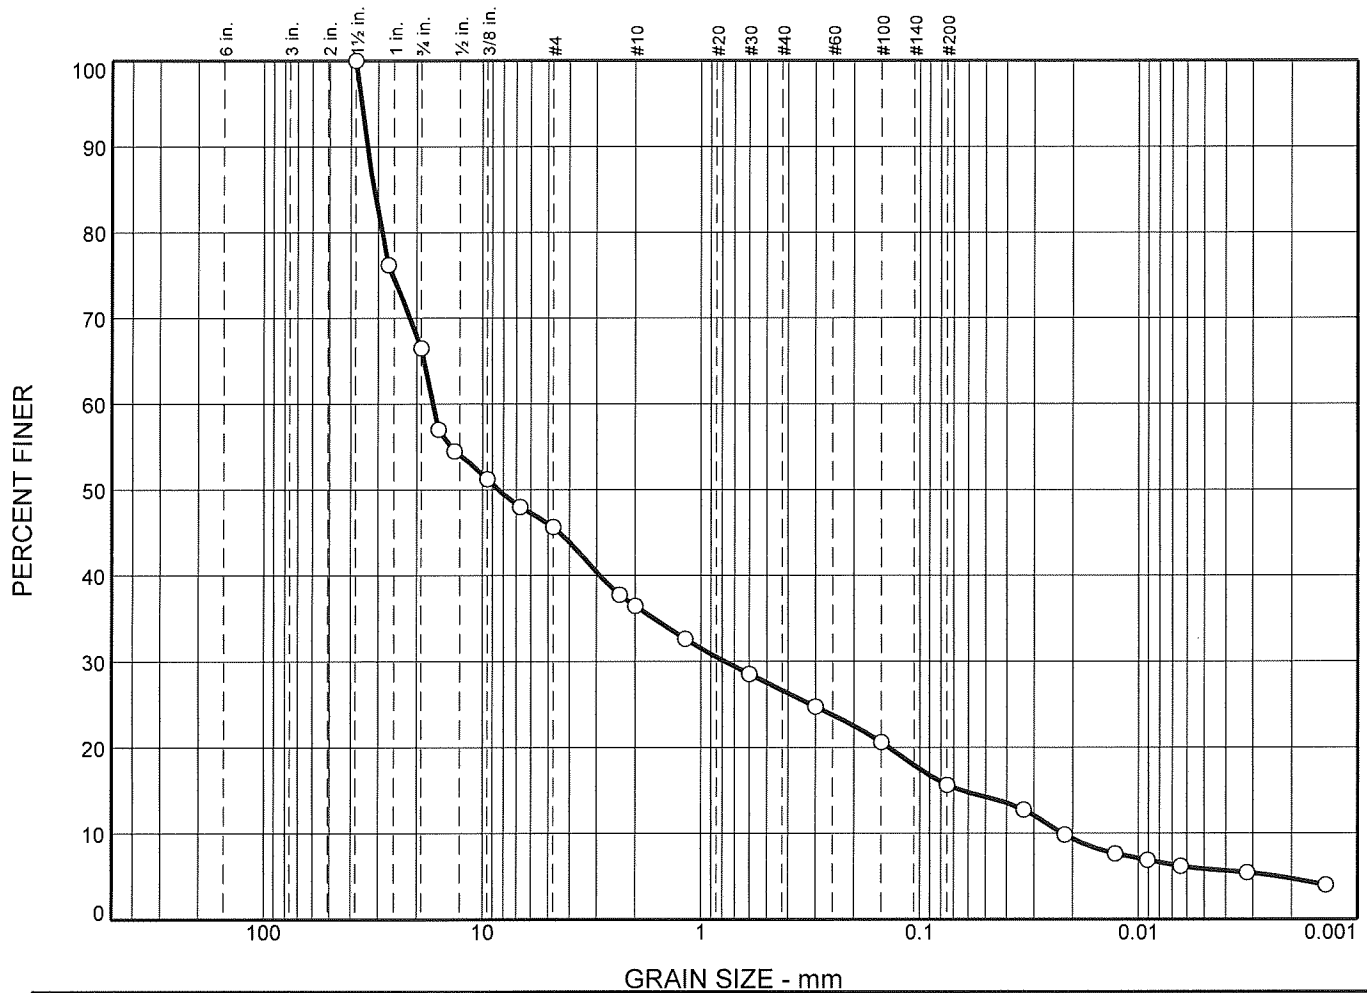
# Particle Size Distribution Report

% Cobbles	% Gravel		% Sand			% Fines	
		Coarse	Fine	Coarse	Medium	Fine	Silt	Clay
○	0.0	33.5	20.9	9.1	9.9	11.0	10.9	4.7

SOIL DATA					
SYMBOL	SOURCE	SAMPLE NO.	DEPTH (ft.)	Material Description	USCS
○	BH6	8	5.3-5.9 m	sandy gravel, some silt, trace clay	GM
				Tested by JH of CMT Engineering Inc. February 14, 2012	
				estimated hydraulic conductivity $K = 4.0 \times 10^{-4}$ cm/sec

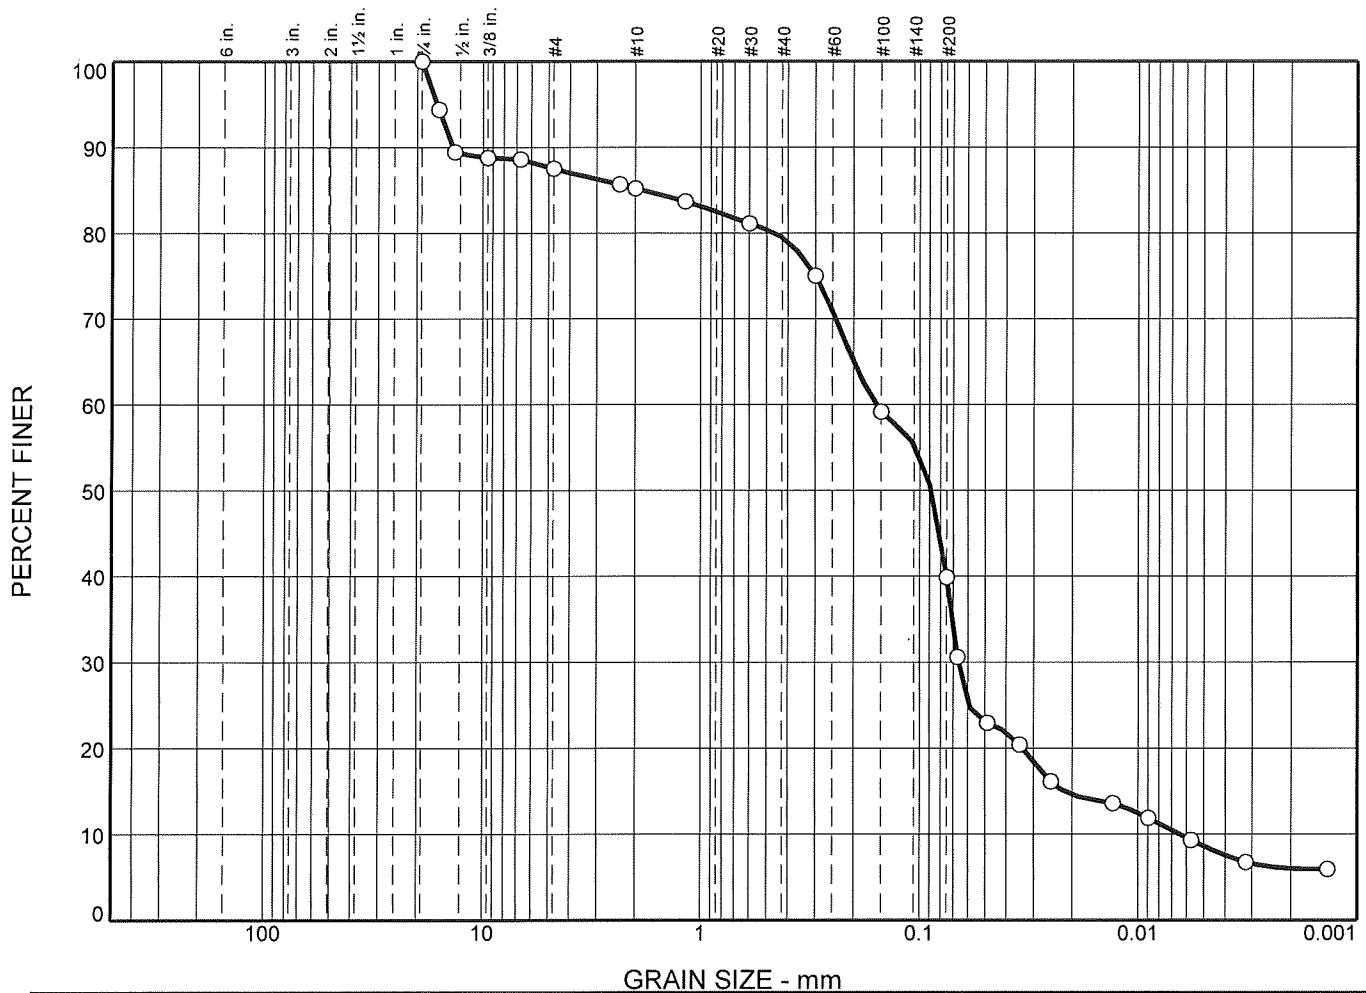
# Particle Size Distribution Report

% Cobbles	% Gravel		% Sand			% Fines	
		Coarse	Fine	Coarse	Medium	Fine	Silt	Clay
○	0.0	0.0	12.5	2.3	5.8	39.5	33.9	6.0

SOIL DATA					
SYMBOL	SOURCE	SAMPLE NO.	DEPTH (ft.)	Material Description	USCS
○	BH10	4	2.3-2.9 m	silty sand, some gravel, trace clay	SM
				Tested by JH of CMT Engineering Inc. July 9, 2012	
				estimated hydraulic conductivity $K = 3.6 \times 10^{-5}$ cm/sec

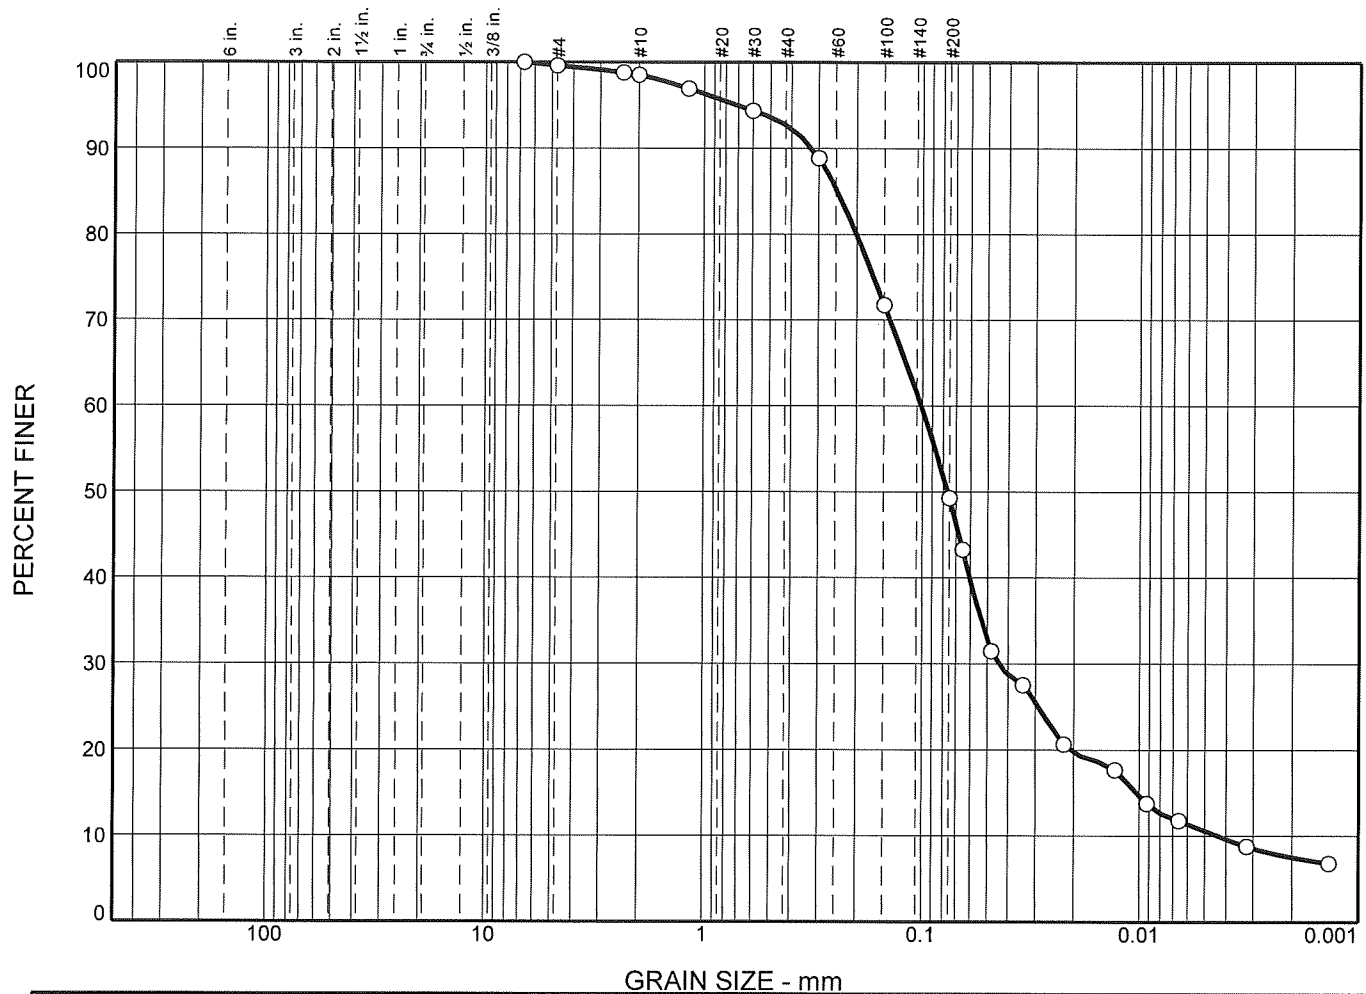
# Particle Size Distribution Report

% Cobbles	% Gravel		% Sand			% Fines	
		Coarse	Fine	Coarse	Medium	Fine	Silt	Clay
○	0.0	0.0	0.4	1.1	5.8	43.4	41.8	7.5

SOIL DATA					
SYMBOL	SOURCE	SAMPLE NO.	DEPTH (ft.)	Material Description	USCS
○	BH11	4	2.3-2.9 m	sand and silt, trace gravel	SM
				Tested by JH of CMT Engineering Inc. February 14, 2012	
				estimated hydraulic conductivity $K = 2.0 \times 10^{-5}$ cm/sec

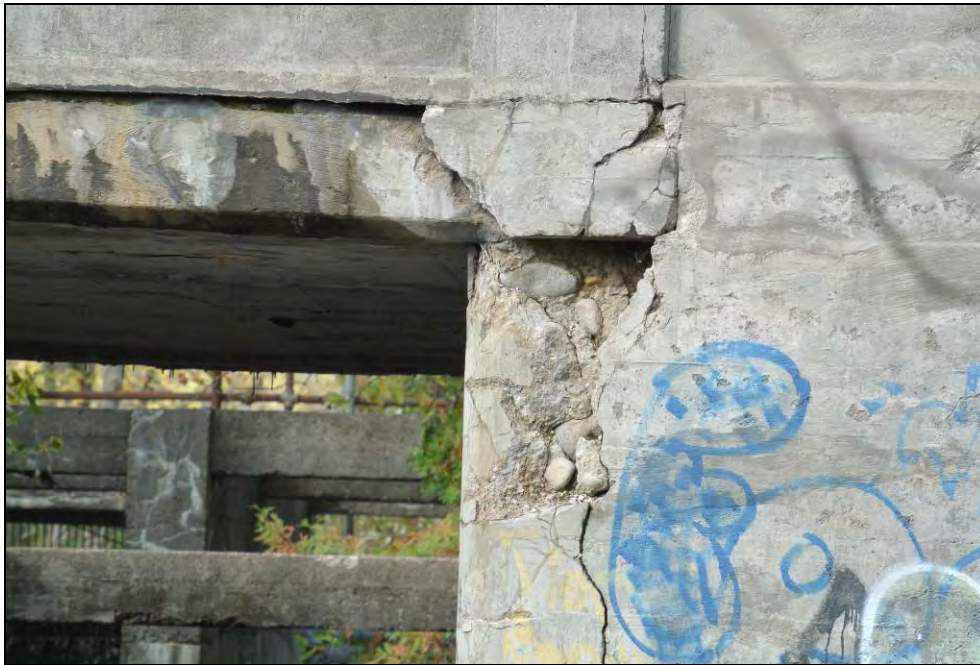
Plate 15: Detail of concrete deterioration at east side of north abutment.

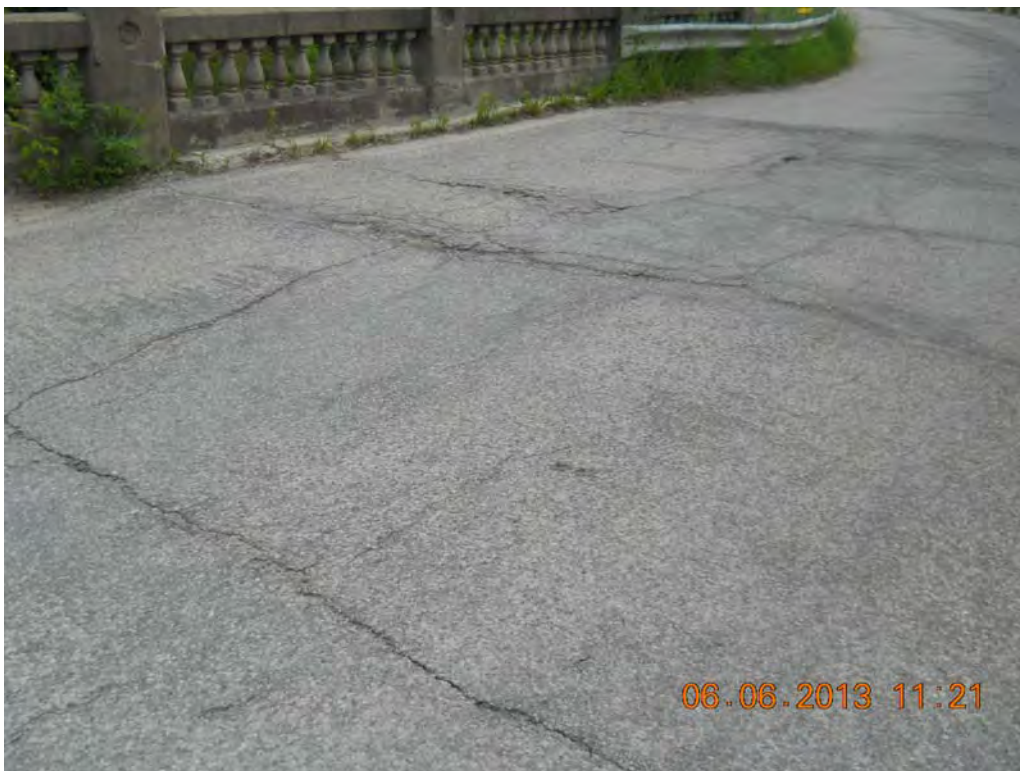
**Narrow to wide cracks on wearing surface.**

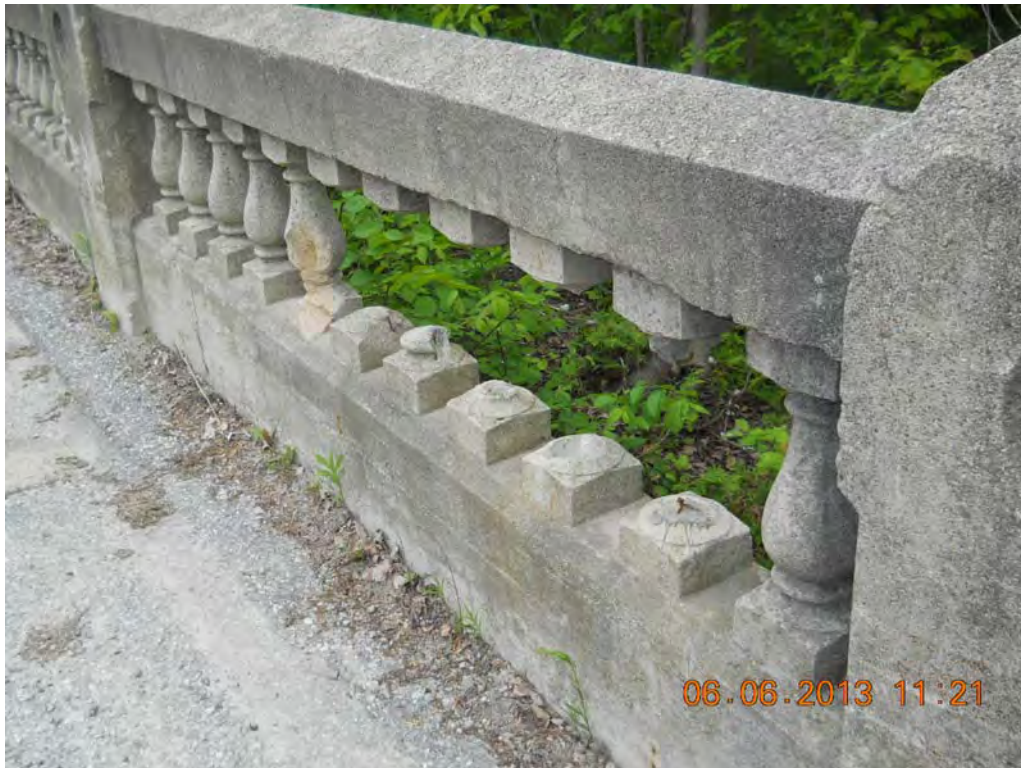
**Missing spindles on barrier.**

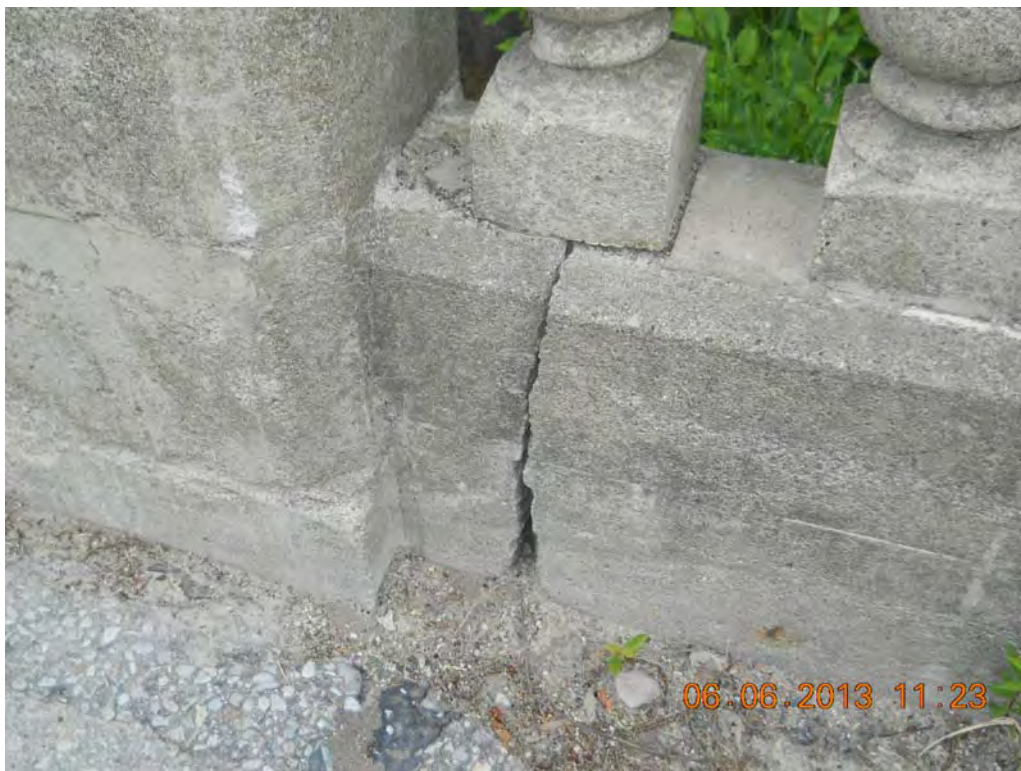
**Wide crack on barrier.**

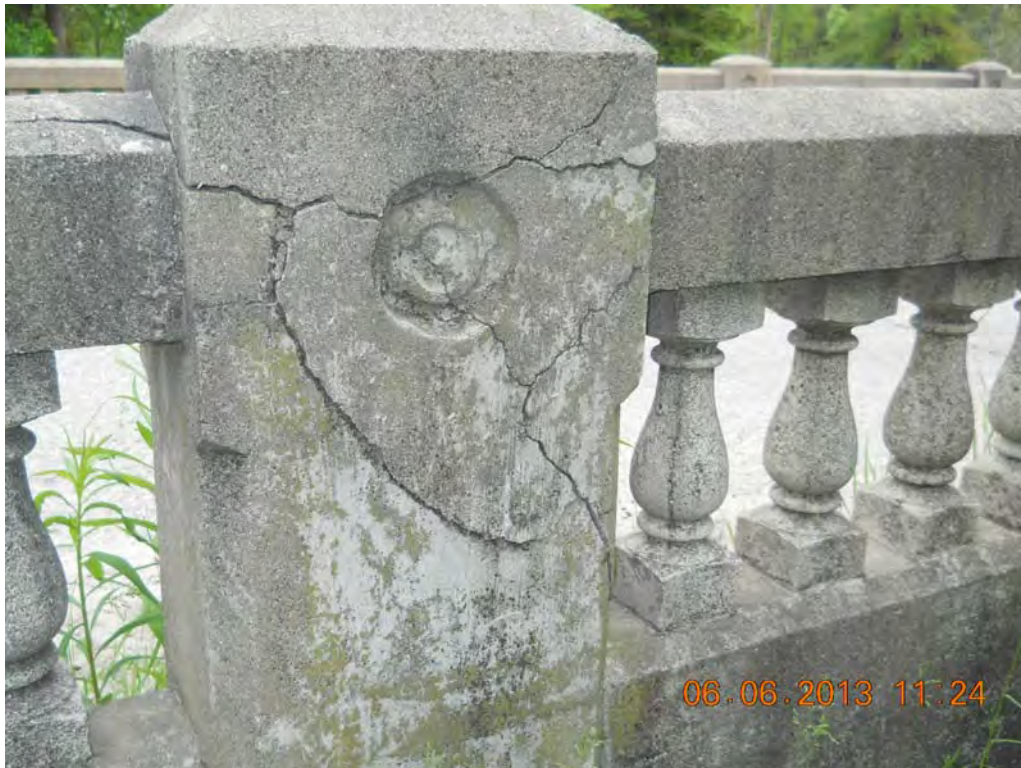
**Delaminations, wide cracks on barrier post.**

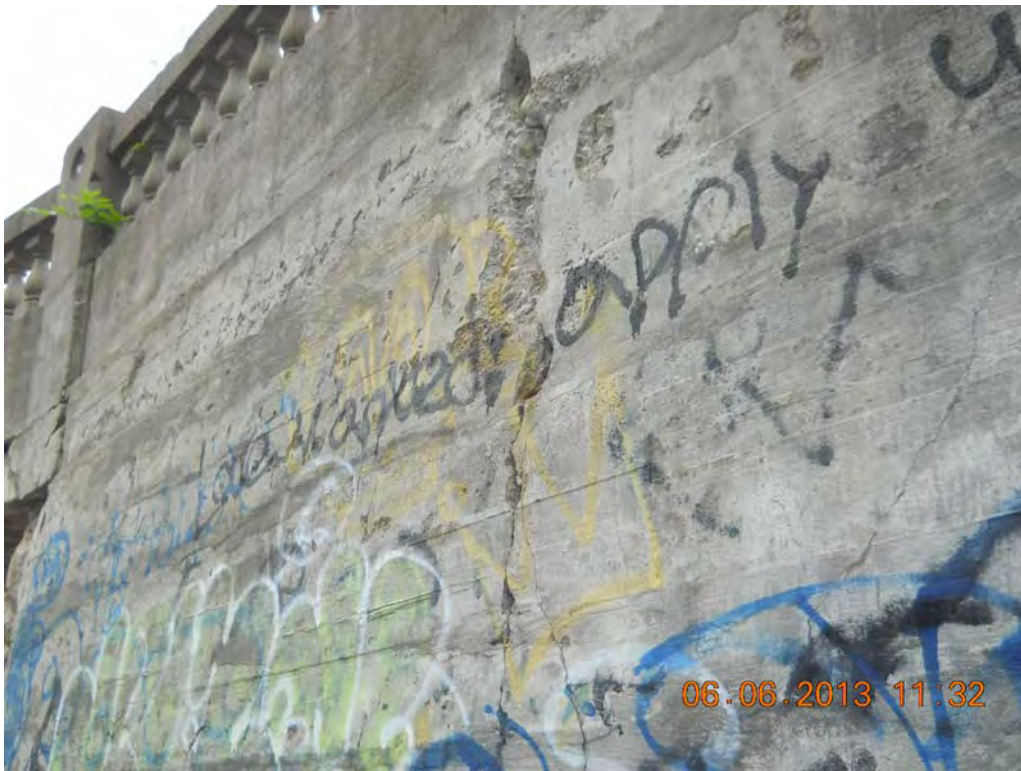
**Spalls, wide crack on wingwall.**

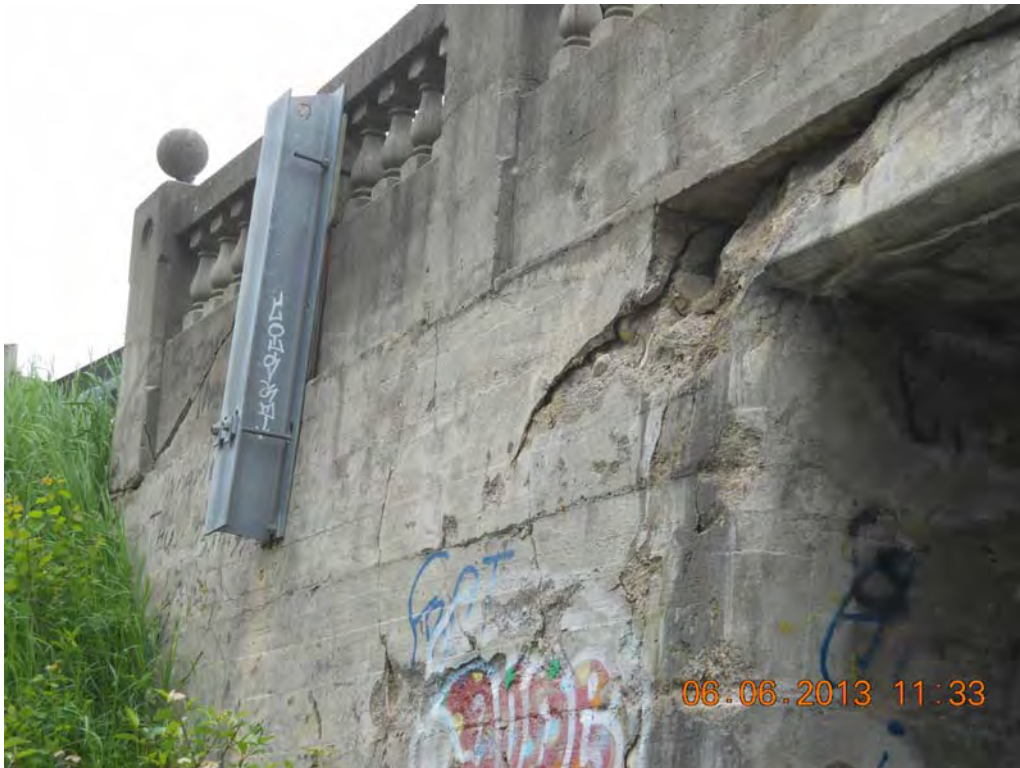
**Spalls, delamination on wingwall and fascia.**

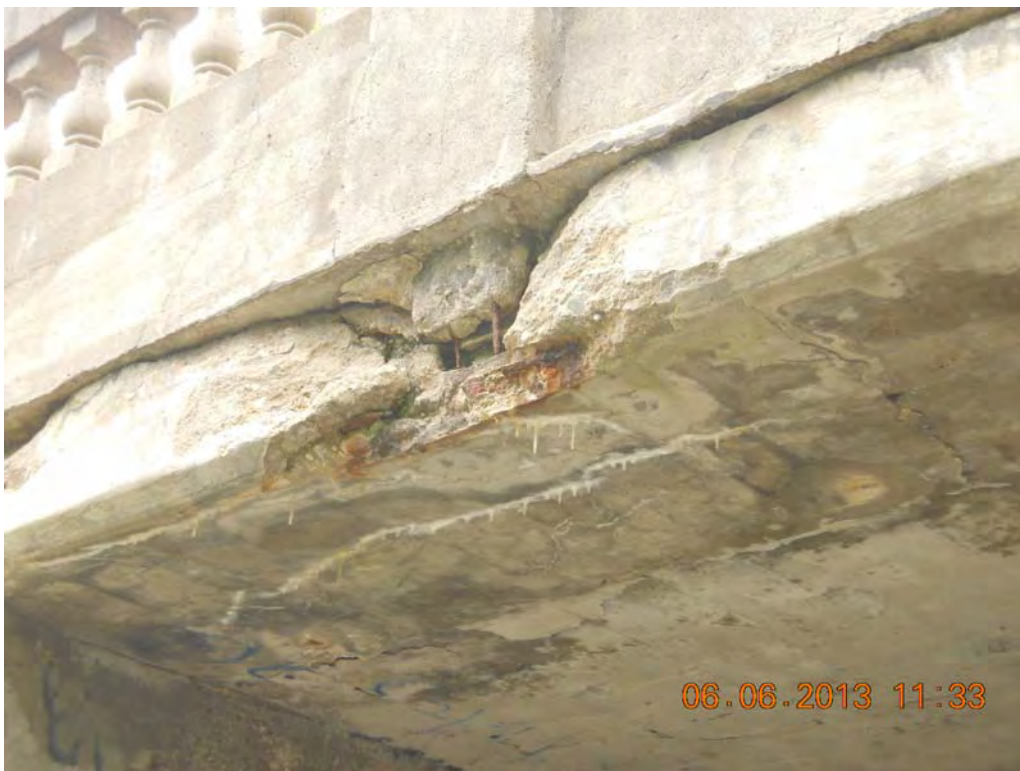
**Spalls, exposed corroded rebar on fascia.**

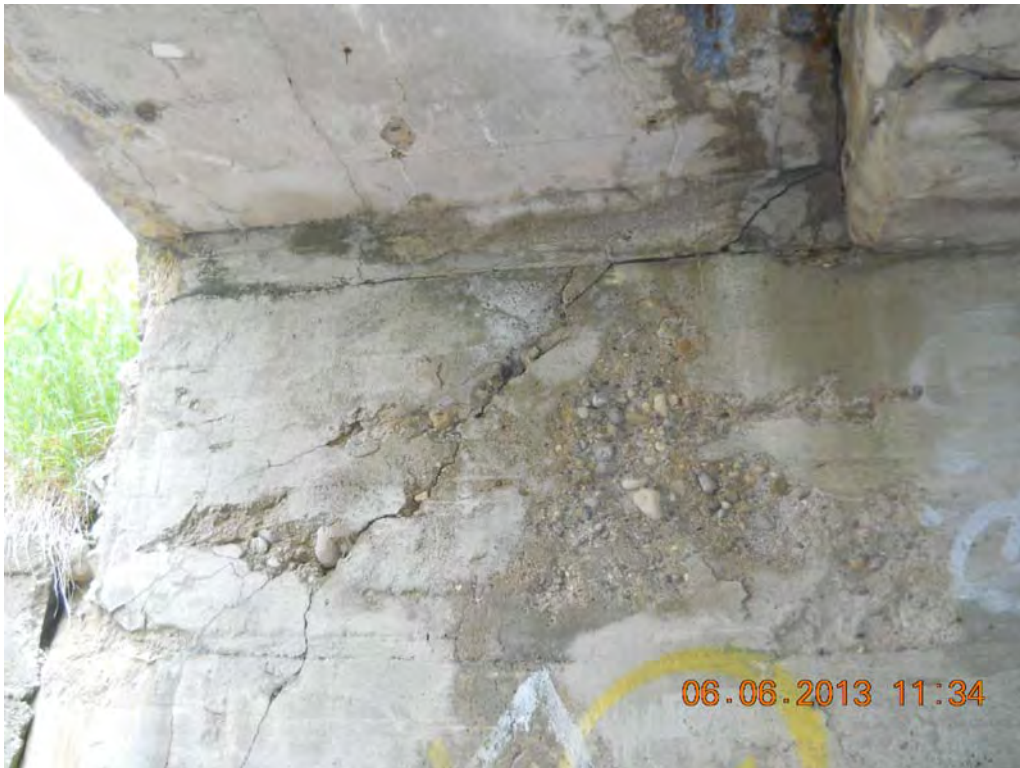
**Delamination, spalling and scaling on abutment.**

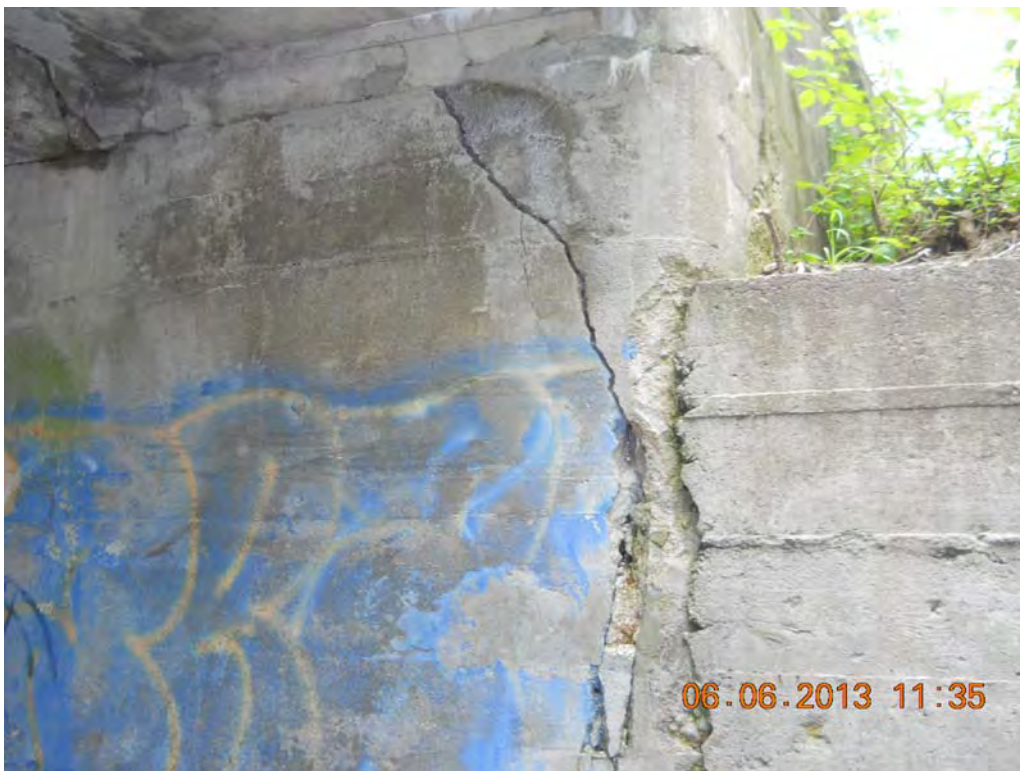
**Wide crack on abutment.**

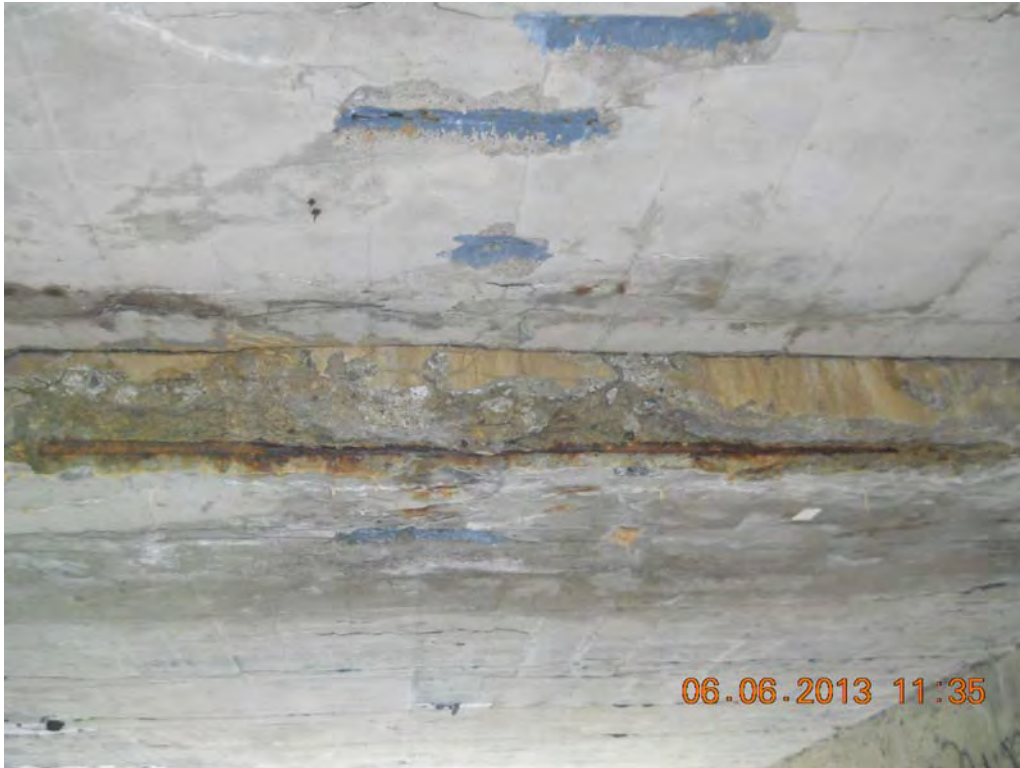
**Delamination, spalling and exposed corroded rebar on soffit.**
