**HYDROGEOLOGICAL INVESTIGATION  
PROPOSED BRIARWOOD HILLSBURGH DEVELOPMENT  
5916 Trafalgar Road North, Town of Erin, Ontario**

**Project No. 2100428AH**

**RE: Hydrogeological Investigation for Proposed Briarwood Hillsburgh Development  
5916 Trafalgar Road North, Town of Erin, Ontario**

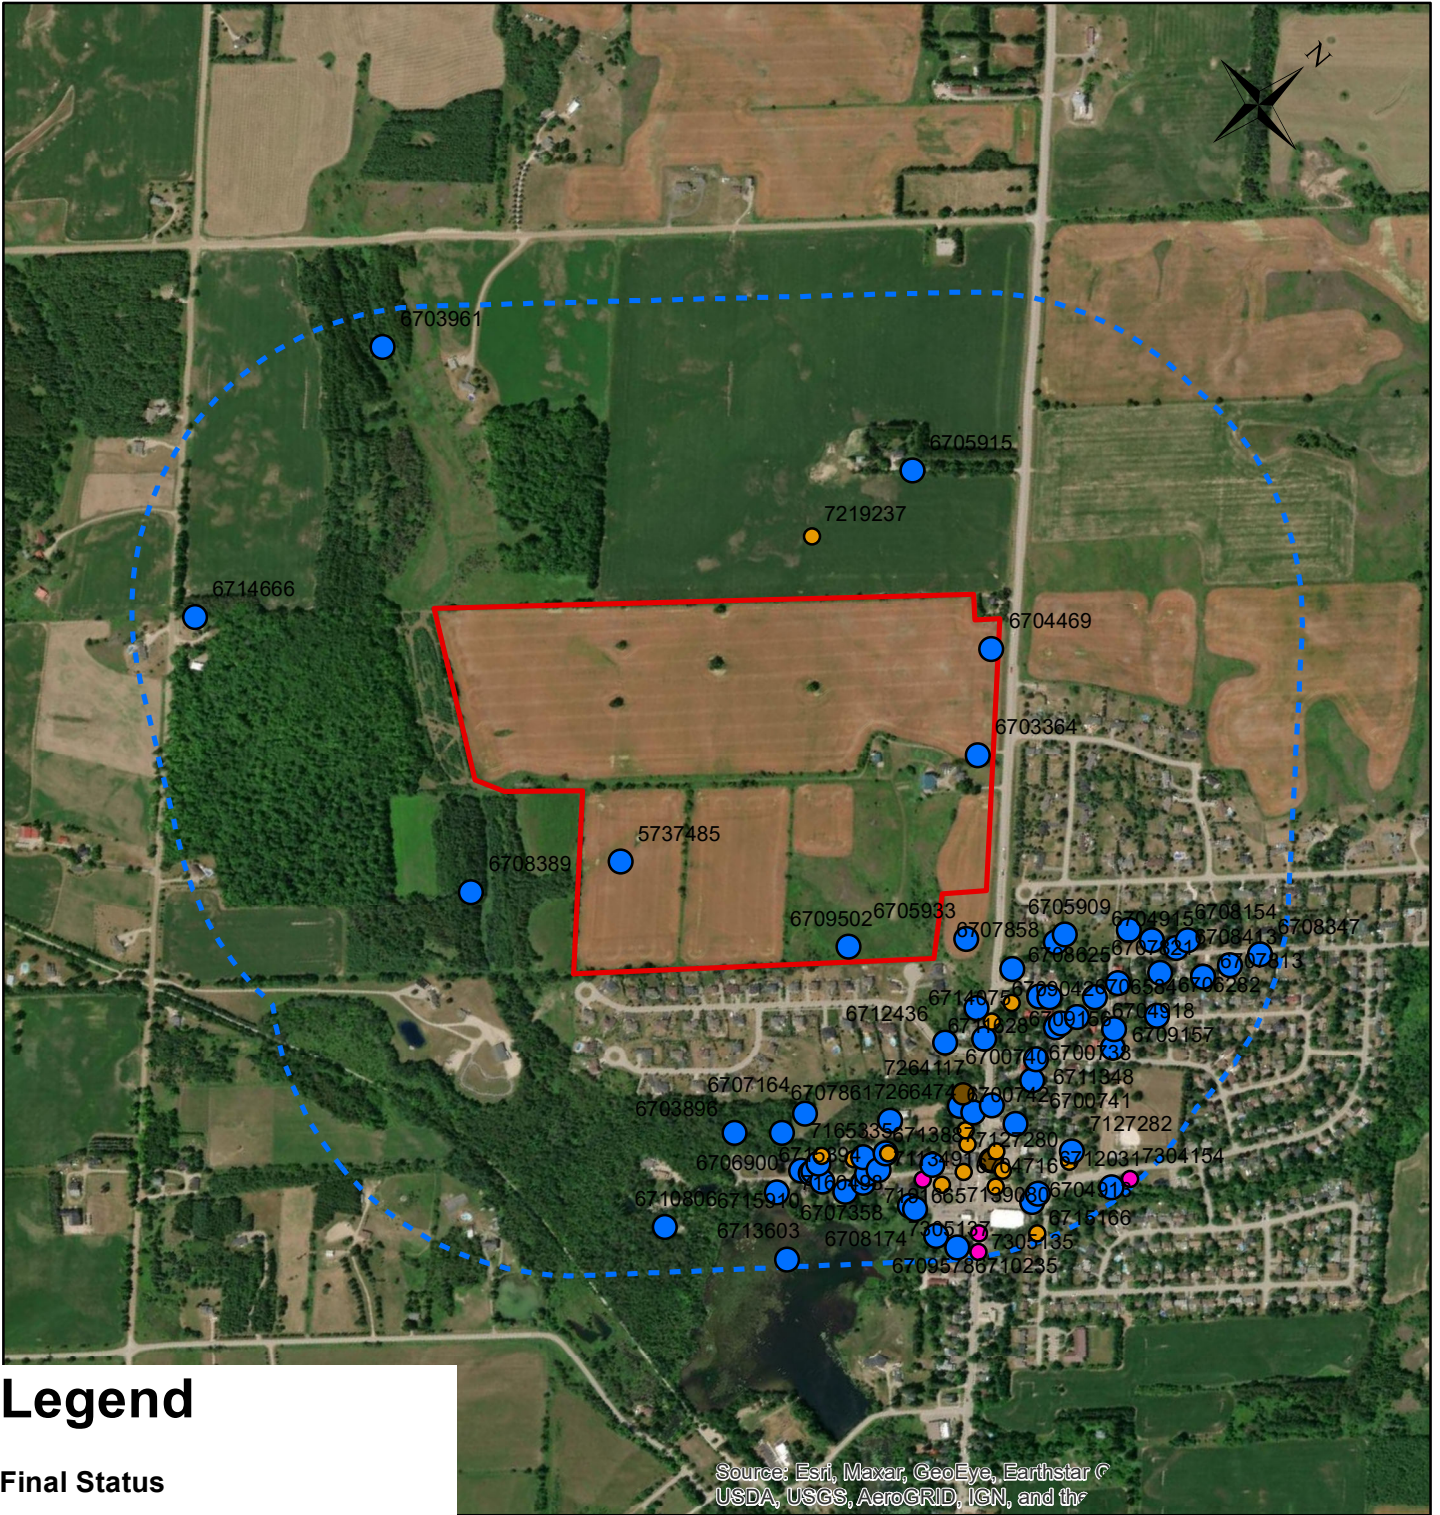
Drawn: MM	Title WATER WELL USE MAP
Approved: KM	Project
Date: SEP. 2021	HYDROGEOLOGICAL INVESTIGATION 5916 Trafalgar Road North, Town of Erin, Ontario
Project No.: 2100428AH	
	Client Hillsburgh Heights Inc.
	<b>FIGURE 6</b>

The monitoring wells/test holes identified in the database search are typically interpreted as geotechnical/geological boreholes and normally no water would be obtained or used from these boreholes. The search revealed the presence of 68 domestic water wells or other water supply wells potentially in use in the area of the Site. If groundwater use or dewatering is required for the Site, a door-to-door well survey is recommended.

As indicated in Section 4.3, the search of the MECP water well records indicated 68 water supply wells within approximately 500 m of the Site. The area of the Site is currently serviced with a municipal water supply. The groundwater depth at the site is expected to be below basement floor and foundation. However, if groundwater dewatering and/or use is considered for this development, a door-to-door survey is recommended.
