# Erosion Mitigation Assessment West Credit River (Erin Branch)

**Town of Erin, Wellington County**

June 8, 2022  
PN21060

Report Title: Erosion Mitigation Assessment  
Credit River Tributary  
Town of Erin, Wellington County

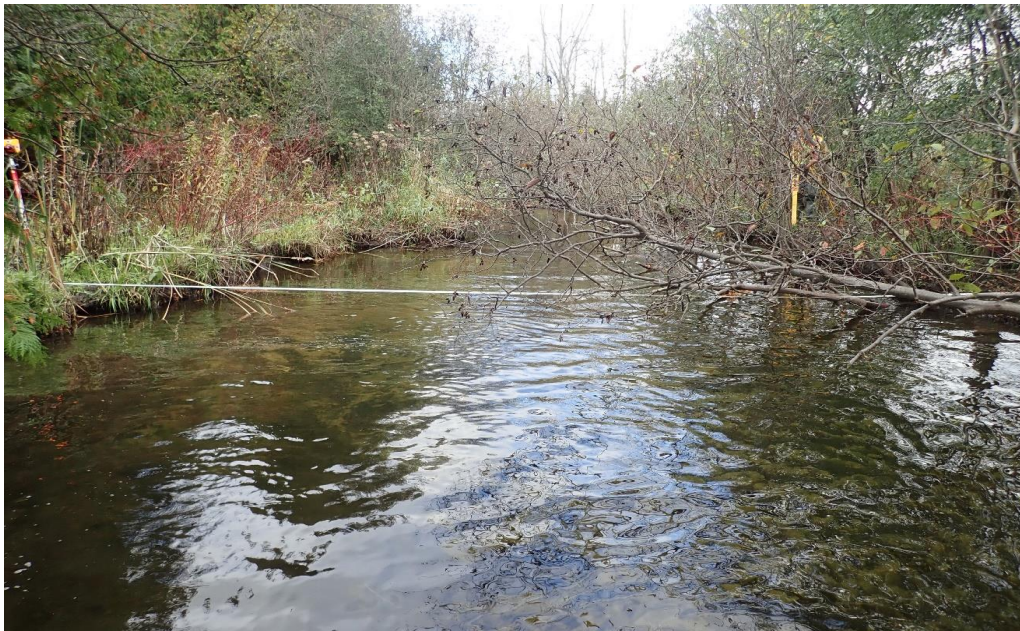
#### Cross Section 4 - Facing Upstream

Reach **TCR-1** is a meandering channel with a low gradient conveying flows within an unconfined valley. The channel's riparian buffer is composed of trees and shrubs, with moderate encroachment along the margins of the bankfull channel. The reach has fairly defined riffle-pool sequences with several instances of deep, slow-velocity pools. The bed substrate is primarily composed of sand with isolated pockets of loose silt deposits. Gravel and cobbles were observed within the channel adjacent to the bridge crossing. The average width of the bankfull channel is 6.94 m, and the average maximum bankfull depth is 0.98 m. On the day of the assessment the average wetted width was 6.50 m and the average wetted depth was 0.44 m.
