# Heritage Impact Assessment

*5916 Trafalgar Road North, Town of Erin, part of Lot 26, Concession 7, former Township of Erin, Wellington County, Ontario*

21481749-1000-R01

15 July 2022

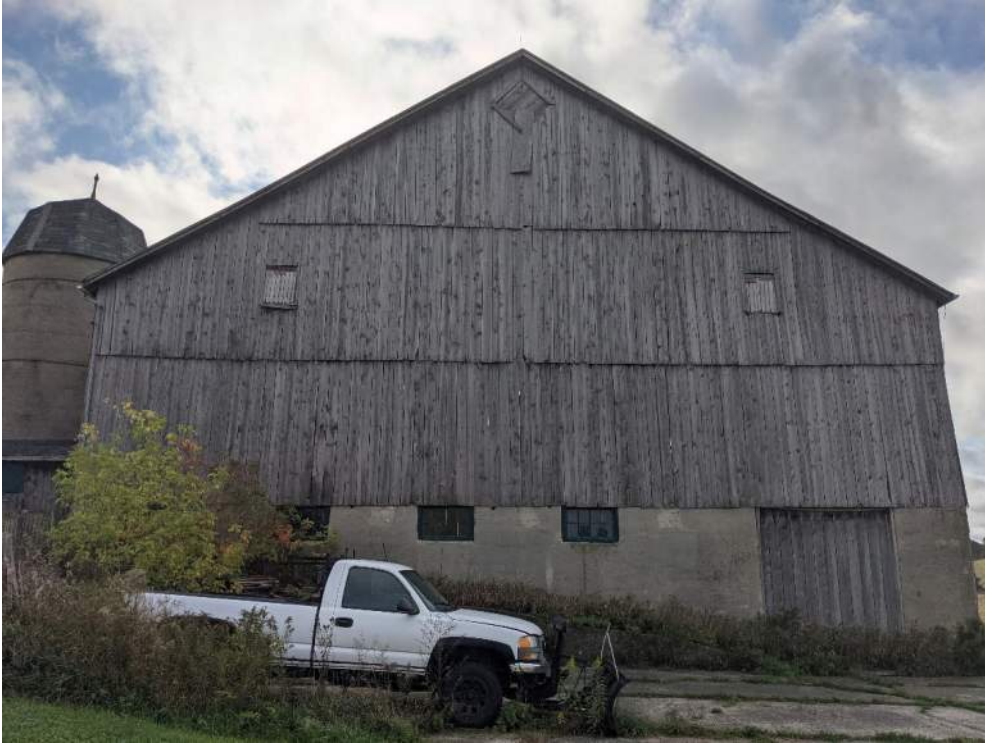
**Figure 76: North elevation of large barn**

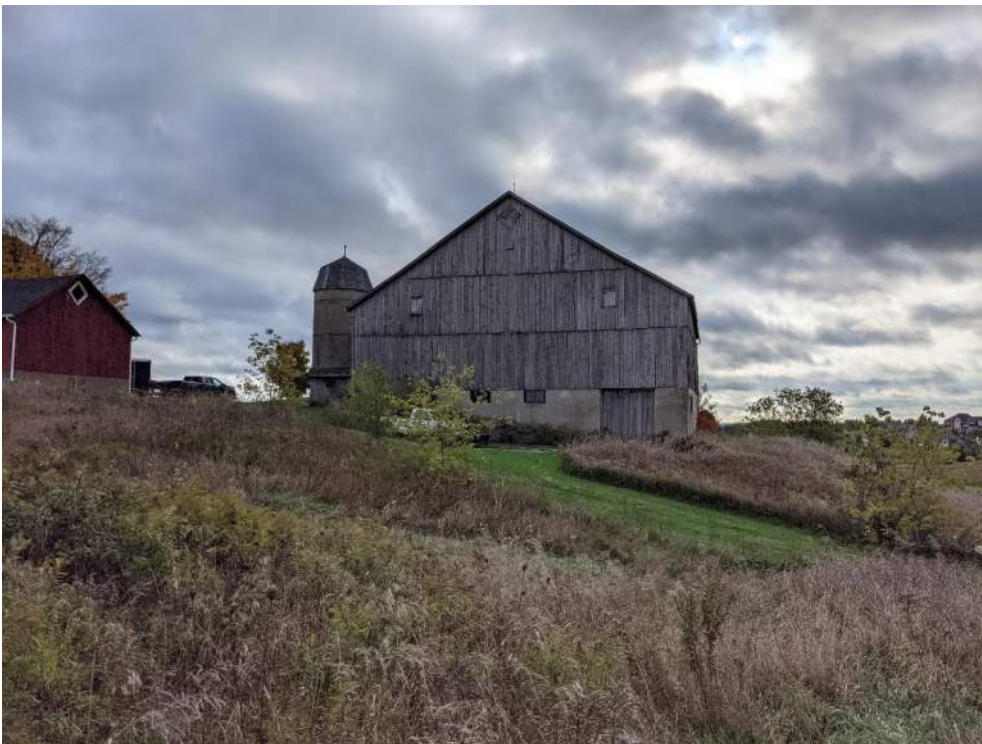
**Figure 79: South façade of the large barn**

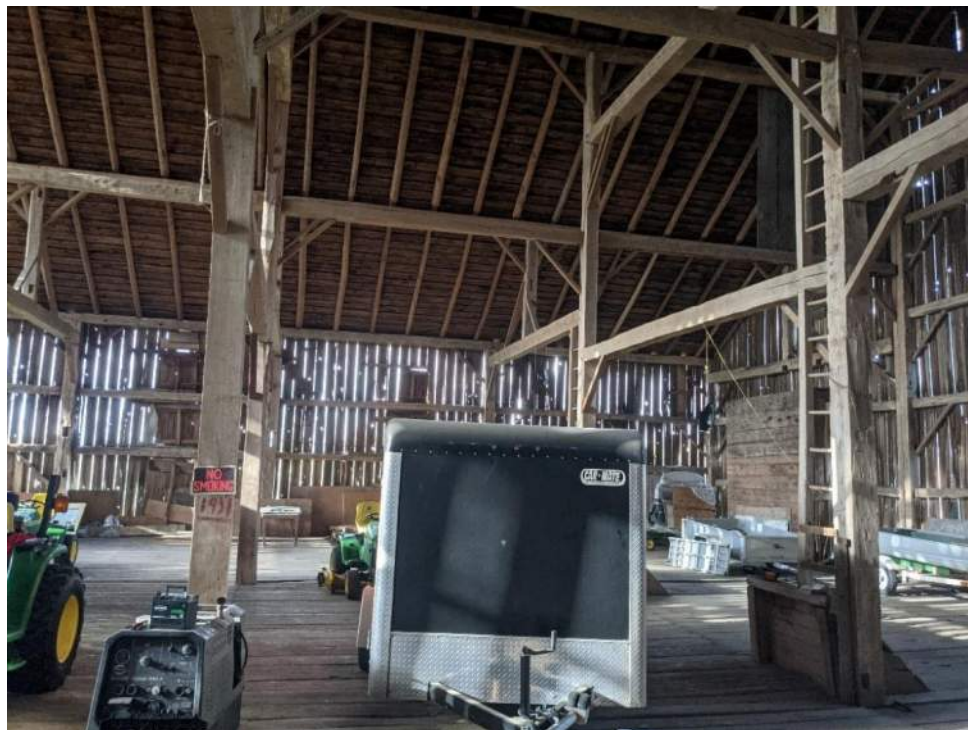
Figure 83: View of threshing floor inside the large barn

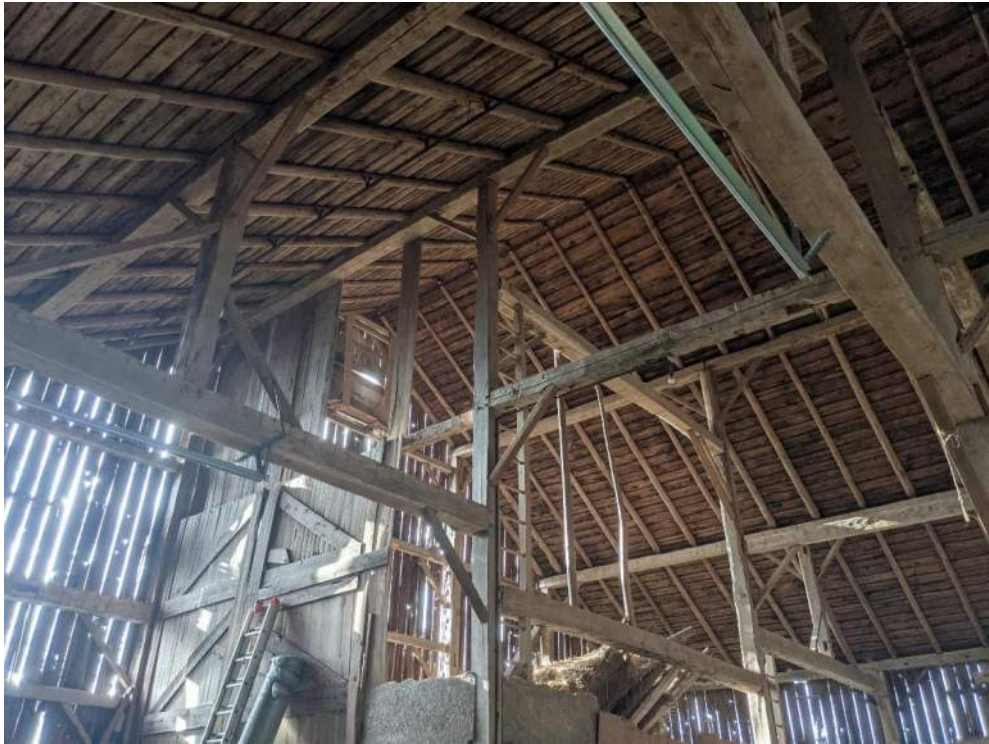
**Figure 84: View of the roof rafters inside the large barn**
