**HYDROGEOLOGICAL INVESTIGATION
PROPOSED BRIARWOOD HILLSBURGH DEVELOPMENT
5916 Trafalgar Road North, Town of Erin, Ontario**

Project No. 2100428AH

August 3, 2022

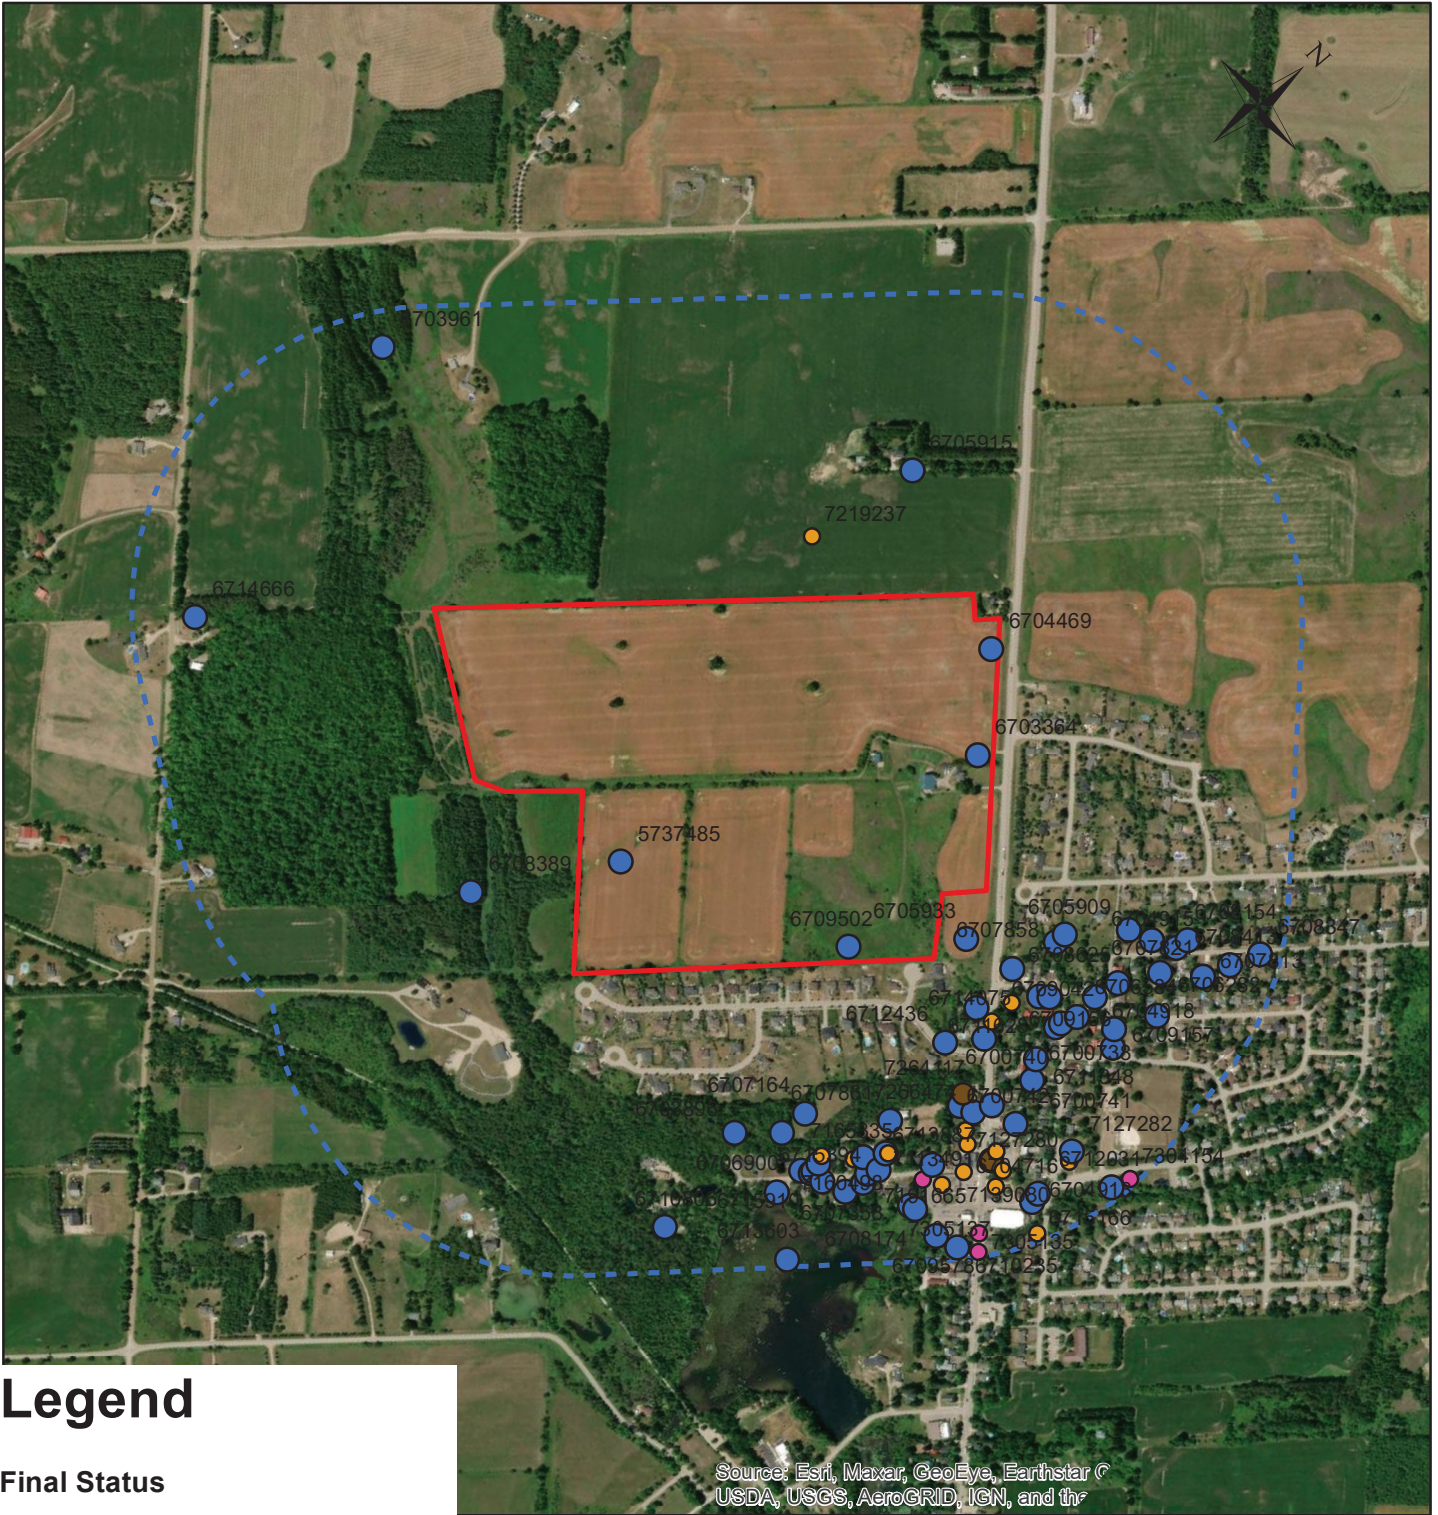
- Abandoned
- Monitoring and Test Hole
- Not Stated
- Water Supply
- 500m Buffer
- Site Boundary

Drawn: MM	Title	WATER WELL USE MAP	
Approved: KM	Project	HYDROGEOLOGICAL INVESTIGATION 5916 Trafalgar Road North, Town of Erin, Ontario	
Date: SEP. 2021	Client	Hillsburgh Heights Inc.	
Project No.: 2100428AH			
			FIGURE 6

Figure 5 presents the locations of the identified wells as well as the associated water use categories within 500 m around the Site. A detailed table showing water well record (WRR) information for these wells is provided in **Appendix C**. The classification of these wells is as follows:

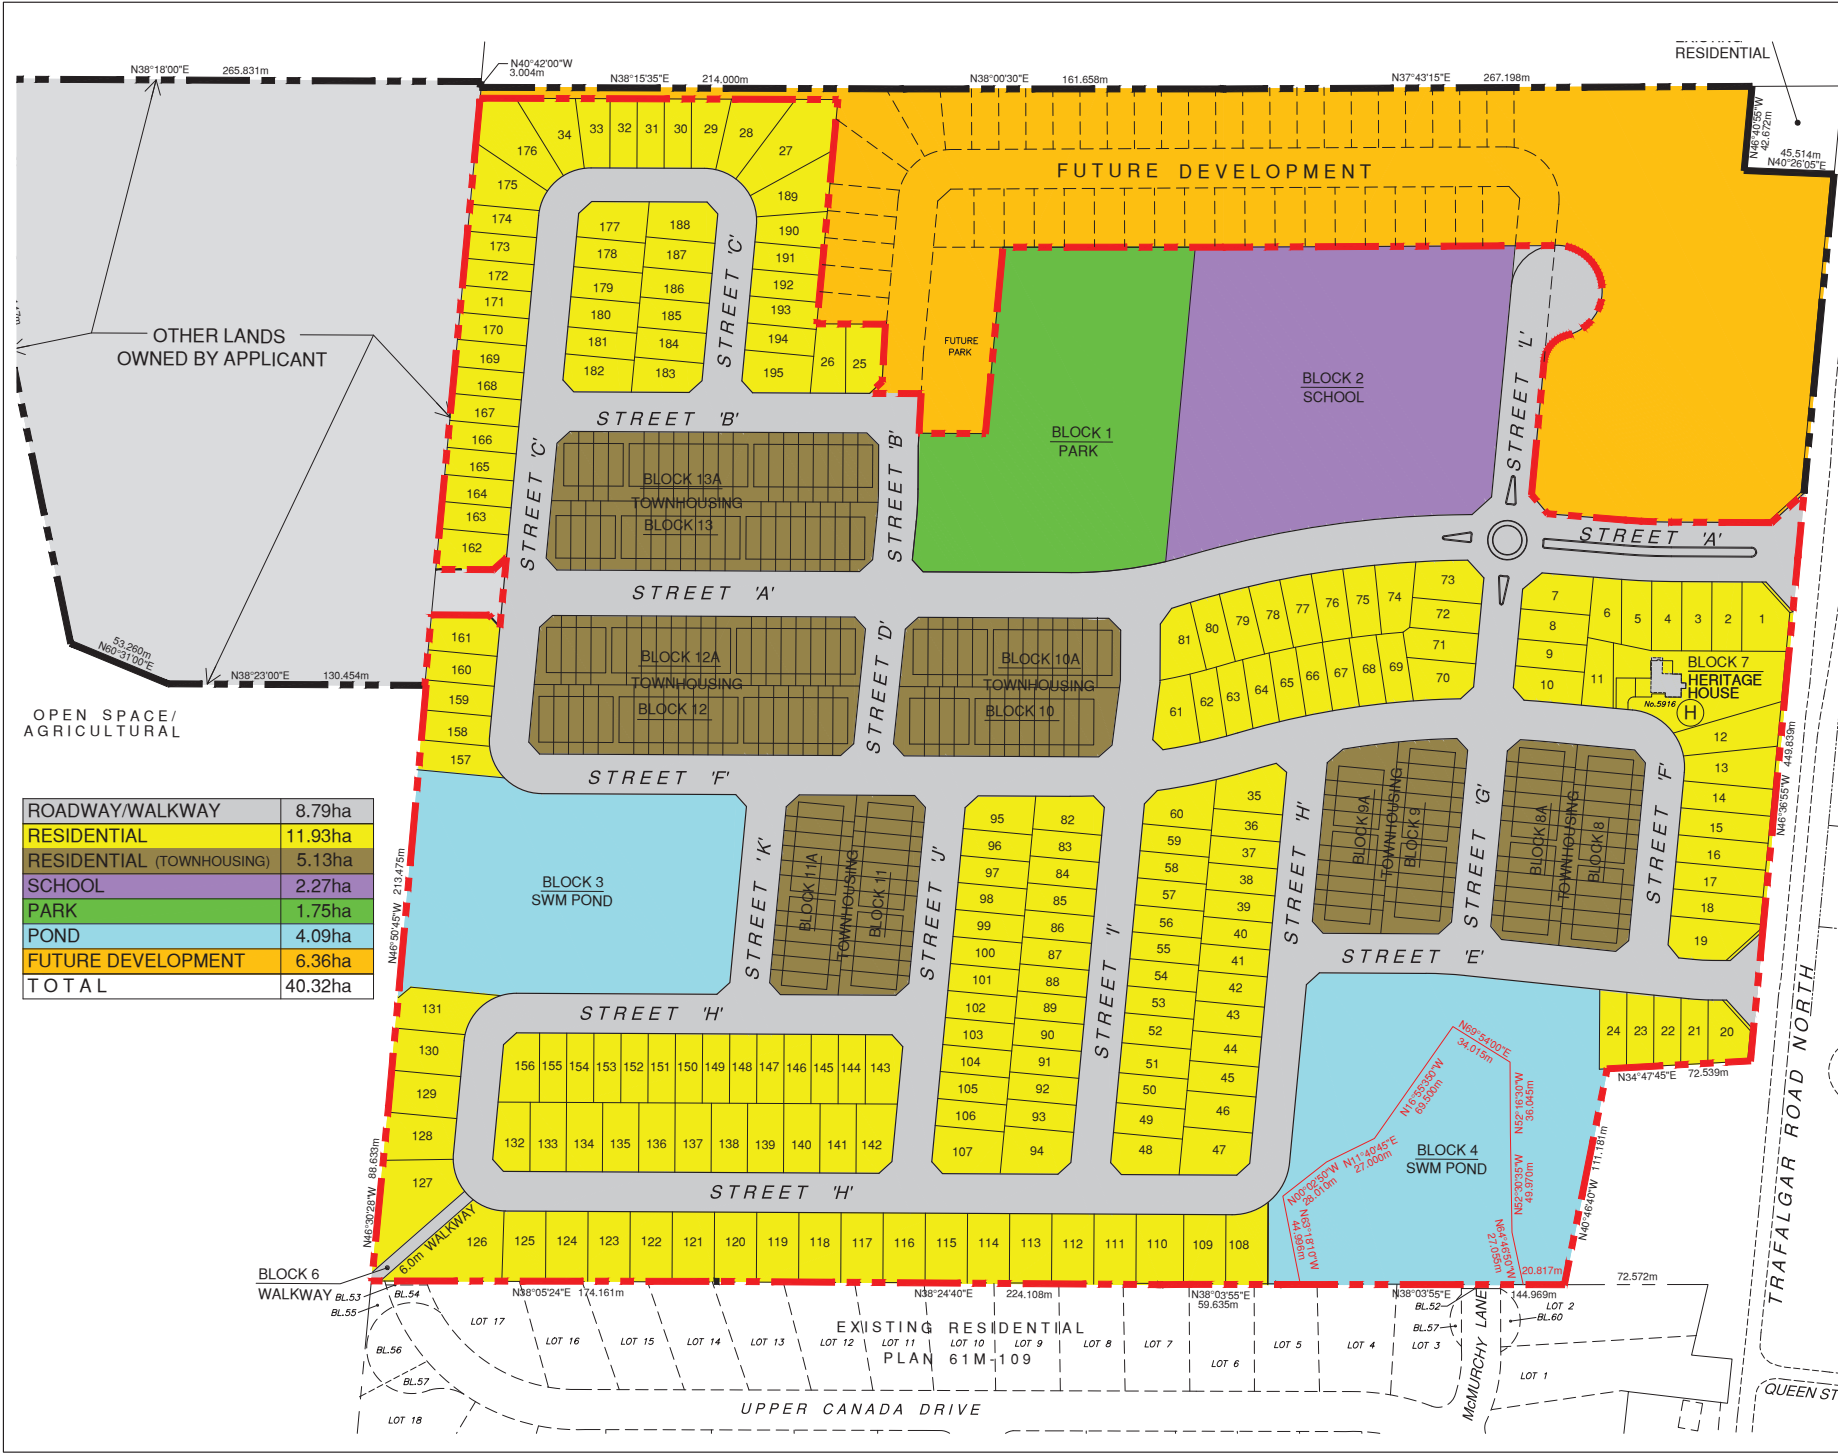
DRAWINGS PROVIDED BY THE CLIENT

ROADWAY/WALKWAY	8.79ha
RESIDENTIAL	11.93ha
RESIDENTIAL (TOWNHOUSING)	5.13ha
SCHOOL	2.27ha
PARK	1.75ha
POND	4.09ha
FUTURE DEVELOPMENT	6.36ha
TOTAL	40.32ha

Based on the information provided by the client, the proposed development will consist of 195 single family residential lots, 174 townhouse units, one (1) school block, one (1) heritage house, two (2) storm water management (SWM) facilities, one (1) park block, and new private roads with total area of 40.4 ha. The subdivision will be fully connected to municipal services (municipal water and sanitary sewers). The location of the Site is shown on **Figure 1**.
