THE CORPORATION OF THE TOWN OF ERIN

MUNICIPAL CLASS ENVIRONMENTAL ASSESSMENT

HILLSBURGH DAM & BRIDGE STATION STREET AT UPPER WEST CREDIT RIVER

PROJECT FILE REPORT
NOVEMBER 2016

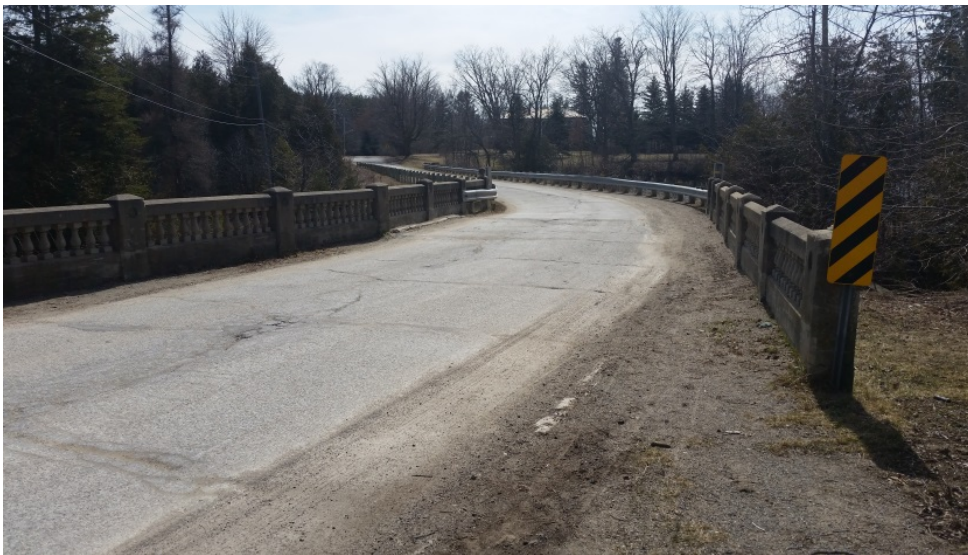
Photo 1 - Station Street Bridge, Structure 2064 – Looking west toward Cedar Valley

A bridge inspection report was completed in 2014 and is included in Appendix C-7. In terms of vehicle movement and safety, the bridge is a narrow double lane structure, generating a traffic barrier to motorists which is operationally unsafe and creates delays. This is especially apparent with the proximity of the fire hall located approximately 30m east of the bridge. The 6.0m deck width is less than the Town's Municipal Standard of 9.0m. The deck, soffit and abutments exhibit major deterioration with exposed corroded rebar and concrete spalls and delaminations. At this point, structure rehabilitation would be extensive and costly. It is recommended the bridge be replaced with a concrete rigid frame or concrete girder type structure to satisfy the current regulatory and municipal standard requirements.

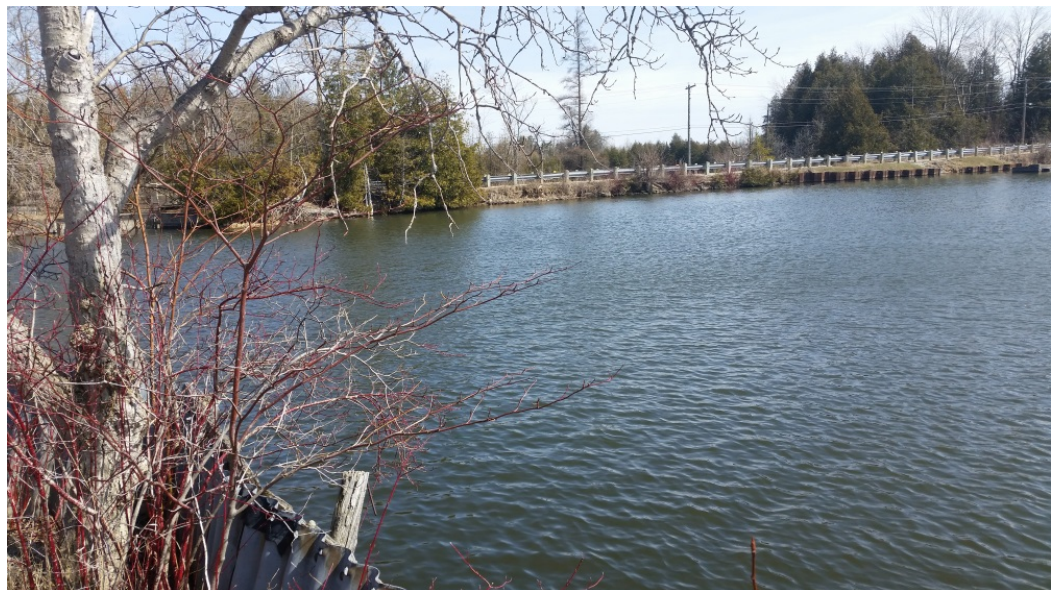
Photo 2 - Hillsburgh Dam – Looking south from east shoreline

As noted in the Embankment Dam Assessment, dated July 30, 2012 prepared by CMT Engineering Inc. (Appendix C-2) the dam foundation comprises of compacted gravel and very

dense sand. The foundation of the dam is capable of providing a very high bearing capacity, while acting as a natural drainage layer to dissipate potential excess pore pressure. The earth fill embankment dam's upper layer is comprised of compacted dry soils and lower layer dense soil with very high moisture content/saturation conditions. Soils below the phreatic surface are very moist/saturated. Test pits in the core of the dam revealed soils with higher bearing strength, which provides evidence as to the structures longevity and consolidation activity under its own weight and vehicle loading. As such it is difficult to find fault with the structure.

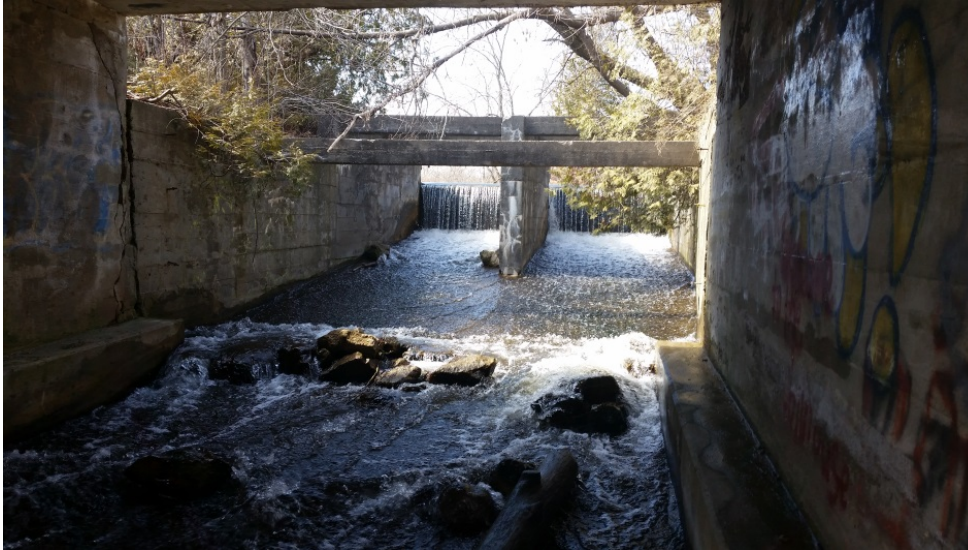
Photo 3 – Stop Log Control Structure and Spillway– Looking upstream under Bridge

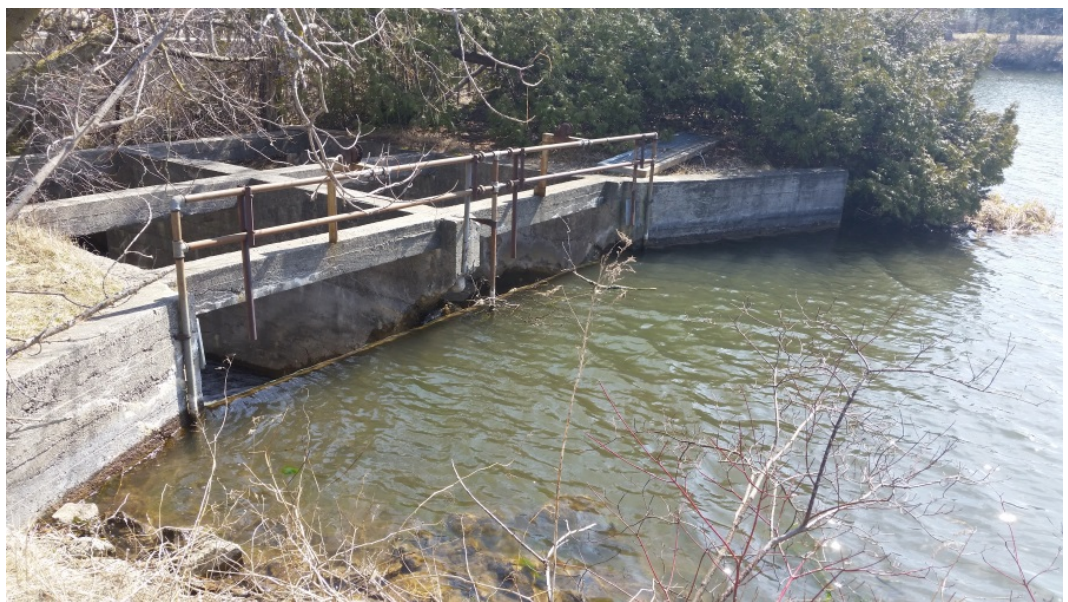
Photo 4 – Stop Log Control Structure – Looking downstream from east shoreline

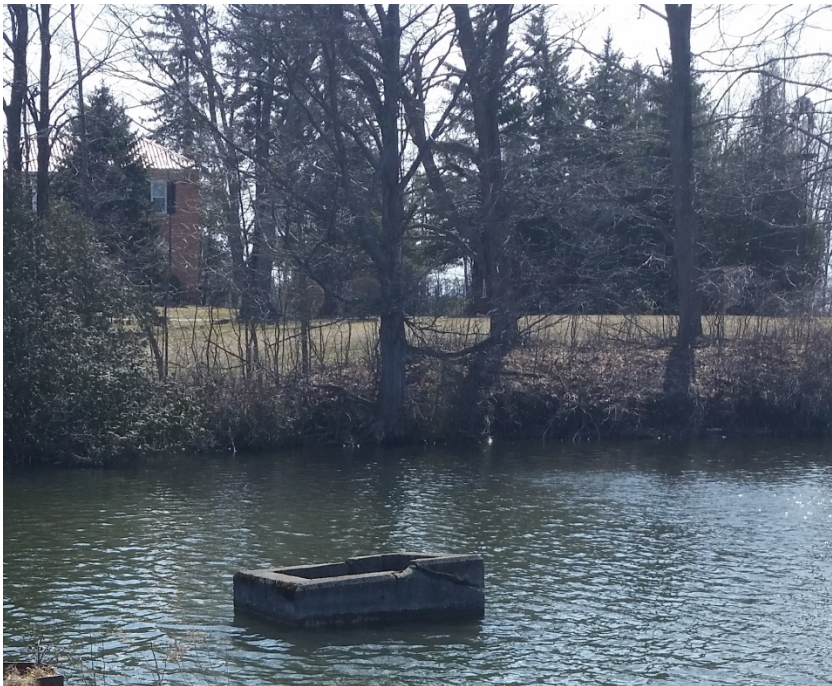
Photo 5 – Monk Riser Structure – Looking upstream from Station Street

At the time of the investigation, the dam featured a stop-log outlet control structure as well as a monk feature, which also had stop logs that regulated flow. The Monk facility was in poor condition and was abandoned in favour of a new outlet control structure with a front mounted sluice gate. At this time there have been no reported failures or distress to the dam as a result of overtopping. As a result of the temporary repairs the Monk facility has since been abandoned.

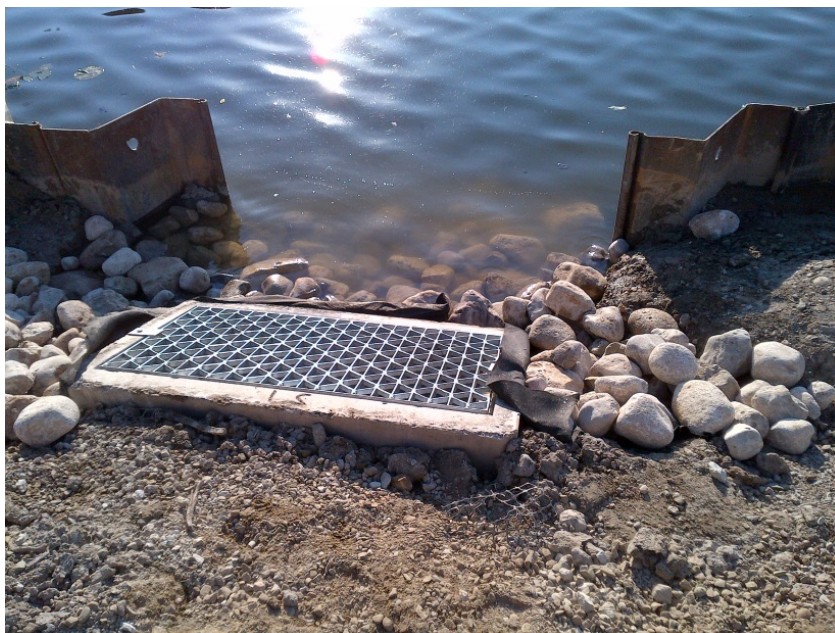
Photo 6 – New Ditch Inlet – Within Town road right-of-way installed as part of the Non-Application Emergency Repairs

The emergency repairs included the removal of the existing outlet pipe and installation of a new ditch inlet. This process decommissioned the existing monk-riser structure within the Hillsburgh Pond. The ditch inlet was set within the Town's road right-of-way. The new outlet pipe was encased with concrete and the section of excavated earthen berm dam was filled using blue clay fill to reinforce the dam's core at this section. The upstream face of the dam was lined with metal sheet piles, temporarily improving this section of the earthen berm.

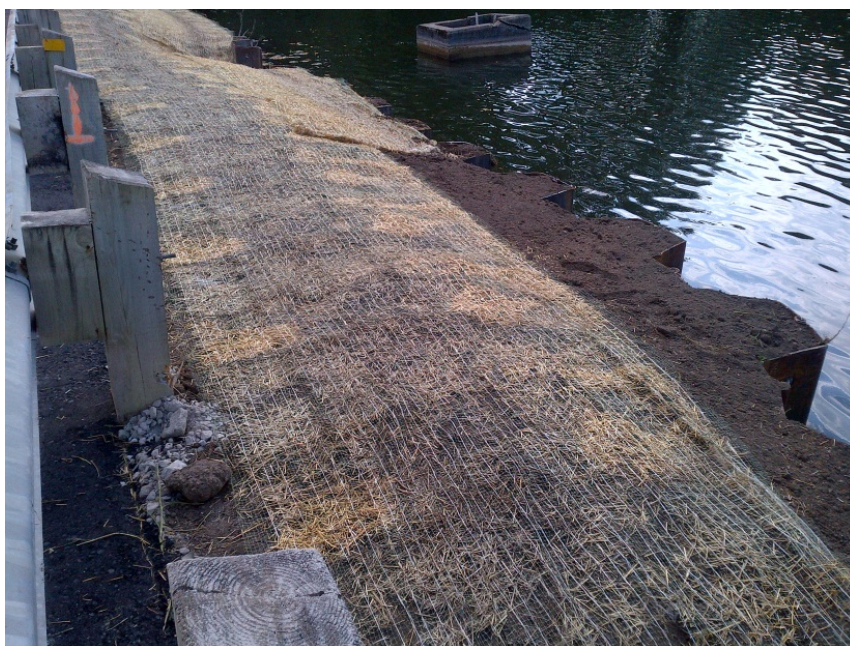
Photo 7 – Corrugated Metal Sheet Piles – Installed along the upstream side of the Hillsburgh Dam within repaired area as part of the Non-Application Emergency Repairs.

The installation of a cut-off wall in the form of metal sheet piles, installed on the upstream side of the dam, would reduce/eliminate the potential for erosion to occur. This would also minimize the potential for slope failure in the event of a rapid draw down condition. It is recommended to extend a sheet pile cut-off wall across the front of the dam since the presence of the cut-off feature appears to be lacking.
