# Heritage Impact Assessment

*5916 Trafalgar Road North, Town of Erin, part of Lot 26, Concession 7, former Township of Erin, Wellington County, Ontario*

21481749-1000-R01

15 July 2022

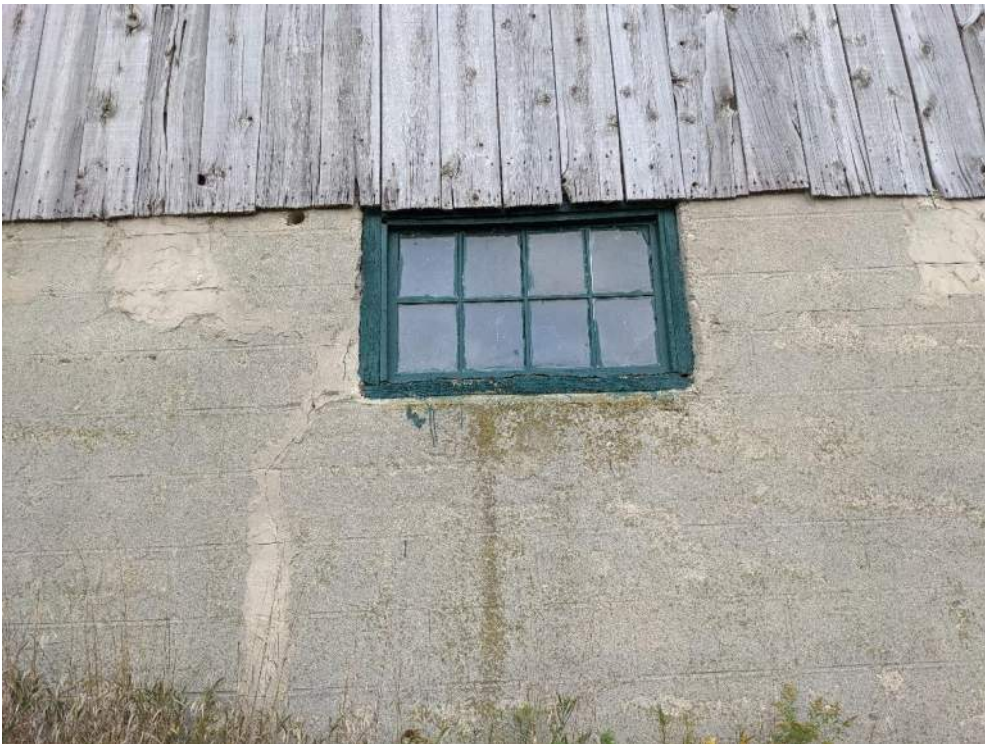
**Figure 77: Typical window on the north elevation of the large barn**

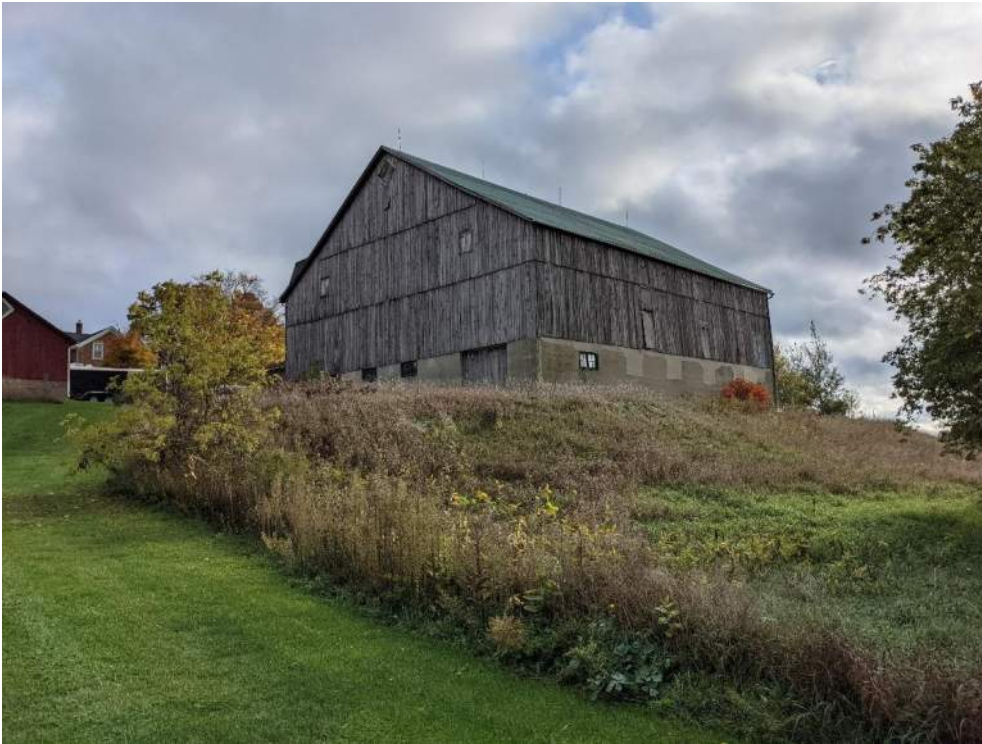
**Figure 78: West and south façades of the large barn**

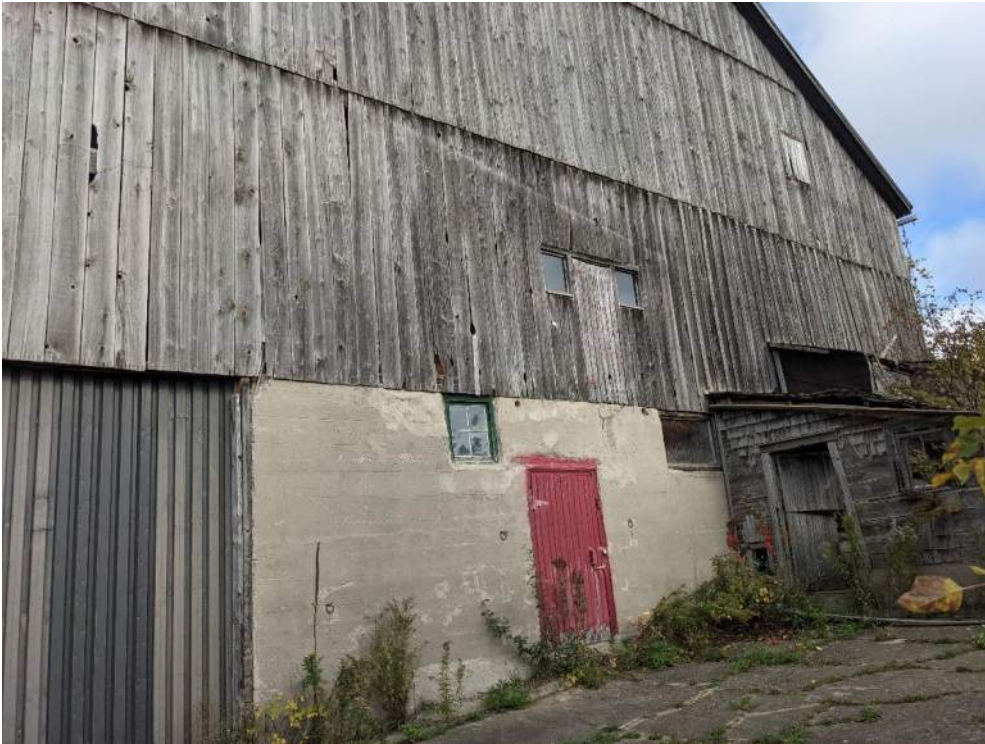
**Figure 80: Lower level of the south façade of the large barn**

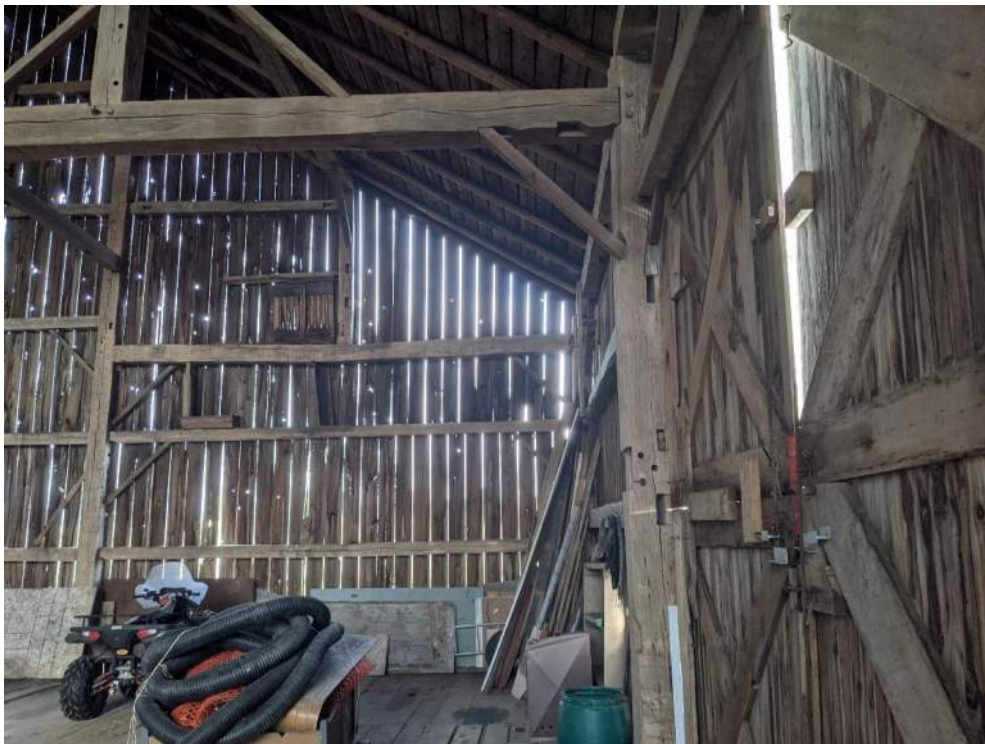
**Figure 81: Interior of the large barn, note the extra mortises in the hand-hewn beams**

According to the Centennial History prepared for Erin Township, the large barn was constructed in 1911. Concrete blocks were introduced after 1900 which rendered stone foundations for barns unpopular (McIlwraith, 1997:180). The redundant mortices visible in the hand-hewn components and empty pin holes indicates the barn was likely composed of salvaged material. As such, while construction of the barn likely dates to 1911, the hand-hewn components were likely taken from an earlier barn that date from the nineteenth century.

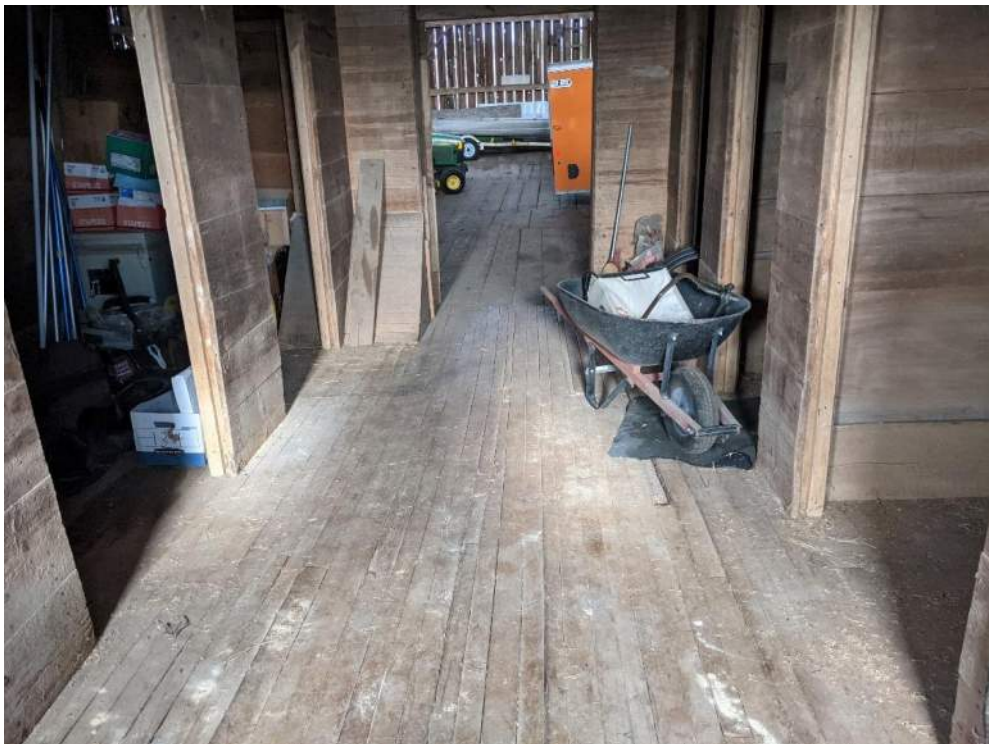
**Figure 85: View inside the granary in the large barn**

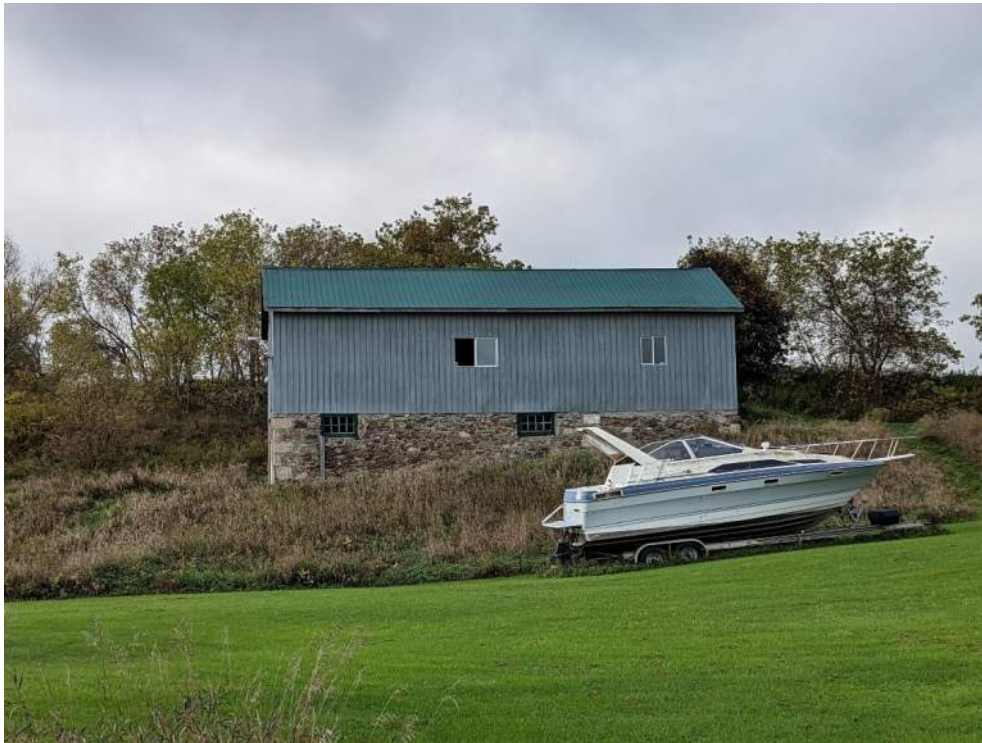
Figure 86: Small Barn

The small barn is located west behind the large barn (Figure 86). It has a rectangular footprint, with a medium sloped gable roof that is clad in metal sheeting. Sitting on a nineteenth century field stone foundation with large stone quoins, the upper level is clad in metal siding. Six-paned wood windows are located in the stone foundation and modern windows are located in the upper level.

The stone foundation on which the small barn sits was likely constructed during the mid-nineteenth century for the first barn build on the subject property.
